**Municipal Structure Inspection Form**

**Structure Number: B 100021**

Structure Name	East Cross Creek Bridge, Lot 9, Conc VI		
Main Hwy/Road #	<input type="text"/>	On <input checked="" type="checkbox"/> Under <input type="checkbox"/>	Crossing Type <input type="text"/> Non-navig water
Road Name	River Road		Municipal Road ID <input type="text"/> RIVER RD OPS
Structure Location	1.91 km S of Lot 10/11		
Latitude	<input type="text"/> 49 063.40 N	Longitude	<input type="text"/> 17 680.482 E
Owner(s)	<input type="text"/> City Of Kawartha Lakes		
Heritage Designation	<input type="text"/> Not "Cons"		
Road Class:	<input type="text"/> Arterial		
MTO Region	<input type="text"/> Eastern		
MTO District	<input type="text"/> Bancroft		
Old County	<input type="text"/> Victoria		
Geographic Twp	<input type="text"/> Ops		
Structure Type	<input type="text"/> T-Beam		
Total Deck Length	<input type="text"/> 14	(m)	Posted Speed <input type="text"/> 80
Overall Str Width	<input type="text"/> 6.7	(m)	No of Lanes <input type="text"/> 2

Date of Inspection: 13/09/2011 Temperature: 20° C  
 Inspected By: D.M. Wills Associates Ltd.  
 Inspector: Ghassan Zanzoul, P.Eng  
 Others in Party: Wes Kingdon  
 Equip

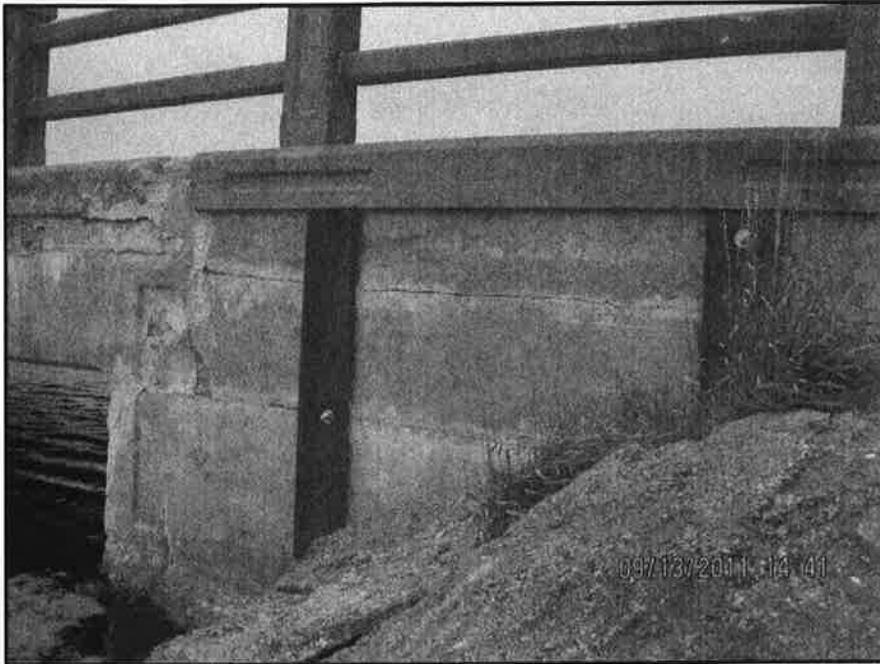
<table border="1" style="width:100%; border-collapse: collapse;"> <tr><td>Element Group:</td><td>Abutments</td></tr> <tr><td>Element Name:</td><td>Wingwalls</td></tr> <tr><td>Location:</td><td>Each Quadrant</td></tr> <tr><td>Material:</td><td>Cast-in-place concrete</td></tr> <tr><td>Element Type:</td><td>Cast-in-place concrete on supports</td></tr> <tr><td>Environment:</td><td>Benign</td></tr> <tr><td>Protection System:</td><td>None</td></tr> </table> <p>Condition Data:    Units            Exc            Good            Fair            Poor</p> <table border="1" style="width:100%; border-collapse: collapse;"> <tr> <td style="width:15%; text-align: center;">Sq. m</td> <td style="width:15%;"></td> <td style="width:15%;"></td> <td style="width:15%;"></td> <td style="width:15%; text-align: center;">25.37</td> </tr> </table> <p>Comments</p> <p>Wide cracks and spalls noted on all wingwalls.</p> <p>Recommended Work</p> <p>Replace structure</p>	Element Group:	Abutments	Element Name:	Wingwalls	Location:	Each Quadrant	Material:	Cast-in-place concrete	Element Type:	Cast-in-place concrete on supports	Environment:	Benign	Protection System:	None	Sq. m				25.37	<table border="1" style="width:100%; border-collapse: collapse;"> <tr><td>Length:</td><td style="text-align: right;">4.7</td></tr> <tr><td>Width:</td><td></td></tr> <tr><td>Height:</td><td style="text-align: right;">1.35</td></tr> <tr><td>Count:</td><td style="text-align: right;">4</td></tr> <tr><td>Total Quantity:</td><td style="text-align: right;">25.37</td></tr> </table> <p>Limited Inspection <input type="checkbox"/></p> <p>Maint. Needs</p> <p>Perform. Deficiencies</p> <p>Load carrying capacity</p> <p>Estimated Construction Cost:</p> <p>Priority</p> <table border="1" style="width:100%; border-collapse: collapse;"> <tr><td>None</td></tr> <tr><td>6-10 yrs</td></tr> <tr><td>1-5 yrs</td></tr> <tr><td>Within 1 yr</td></tr> <tr><td>Urgent</td></tr> </table>	Length:	4.7	Width:		Height:	1.35	Count:	4	Total Quantity:	25.37	None	6-10 yrs	1-5 yrs	Within 1 yr	Urgent

Photo 3: Wide cracks and spalls on northeast wingwall

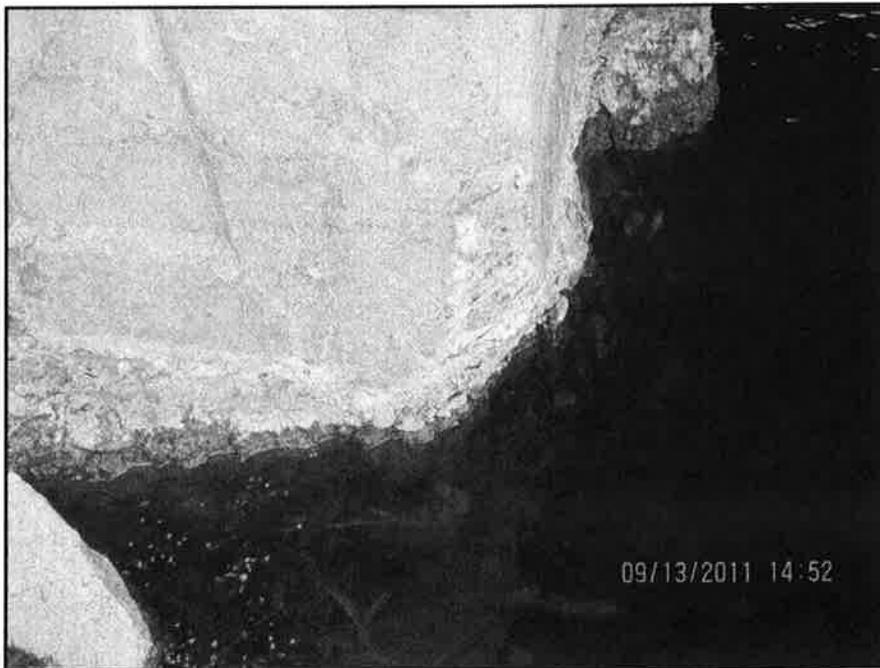
<table border="1" style="width:100%; border-collapse: collapse;"> <tr><td>Element Group:</td><td>Abutments</td></tr> <tr><td>Element Name:</td><td>Abutment walls</td></tr> <tr><td>Location:</td><td>Each End</td></tr> <tr><td>Material:</td><td>Cast-in-place concrete</td></tr> <tr><td>Element Type:</td><td>Cast-in-place concrete on supports</td></tr> <tr><td>Environment:</td><td>Benign</td></tr> <tr><td>Protection System:</td><td>None</td></tr> </table> <p>Condition Data:    Units            Exc            Good            Fair            Poor</p> <table border="1" style="width:100%; border-collapse: collapse;"> <tr> <td style="width:15%; text-align: center;">Sq. m</td> <td style="width:15%;"></td> <td style="width:15%; text-align: center;">10.73</td> <td style="width:15%; text-align: center;">2</td> <td style="width:15%; text-align: center;">2</td> </tr> </table> <p>Comments</p> <p>Severe erosion of the abutments</p> <p>Recommended Work</p> <p>Replace structure</p>	Element Group:	Abutments	Element Name:	Abutment walls	Location:	Each End	Material:	Cast-in-place concrete	Element Type:	Cast-in-place concrete on supports	Environment:	Benign	Protection System:	None	Sq. m		10.73	2	2	<table border="1" style="width:100%; border-collapse: collapse;"> <tr><td>Length:</td><td></td></tr> <tr><td>Width:</td><td style="text-align: right;">6.7</td></tr> <tr><td>Height:</td><td style="text-align: right;">1.1</td></tr> <tr><td>Count:</td><td style="text-align: right;">2</td></tr> <tr><td>Total Quantity:</td><td style="text-align: right;">14.73</td></tr> </table> <p>Limited Inspection <input type="checkbox"/></p> <p>Maint. Needs</p> <p>Perform. Deficiencies</p> <p>Estimated Construction Cost: \$480,000.00</p> <p>Priority</p> <table border="1" style="width:100%; border-collapse: collapse;"> <tr><td>None</td></tr> <tr><td>6-10 yrs</td></tr> <tr><td>1-5 yrs</td></tr> <tr><td>Within 1 yr</td></tr> <tr><td>Urgent</td></tr> </table>	Length:		Width:	6.7	Height:	1.1	Count:	2	Total Quantity:	14.73	None	6-10 yrs	1-5 yrs	Within 1 yr	Urgent

Photo 4: Severe erosion of north abutment footing

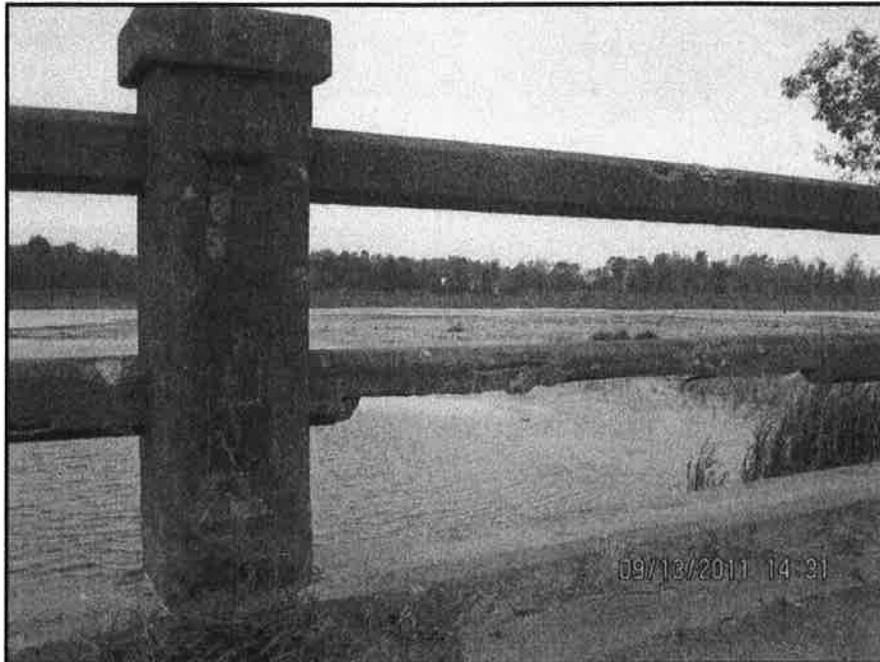
<table border="1" style="width:100%; border-collapse: collapse;"> <tr><td>Element Group:</td><td>Barriers</td></tr> <tr><td>Element Name:</td><td>Railing Systems</td></tr> <tr><td>Location:</td><td>Each Side</td></tr> <tr><td>Material:</td><td>Cast-in-place concrete</td></tr> <tr><td>Element Type:</td><td>Concrete Post and bars</td></tr> <tr><td>Environment:</td><td>Severe</td></tr> <tr><td>Protection System:</td><td>None</td></tr> </table> <p>Condition Data:    Units            Exc            Good            Fair            Poor</p> <table border="1" style="width:100%; border-collapse: collapse;"> <tr> <td style="width:15%;">Sq. m</td> <td style="width:15%;"></td> <td style="width:15%; text-align: center;">23</td> <td style="width:15%; text-align: center;">10</td> <td style="width:15%;"></td> <td style="width:15%; text-align: center;">10</td> </tr> </table> <p>Comments</p> <p>Spalls and section loss noted on railings.</p> <p>Recommended Work</p> <p>Replace structure</p>	Element Group:	Barriers	Element Name:	Railing Systems	Location:	Each Side	Material:	Cast-in-place concrete	Element Type:	Concrete Post and bars	Environment:	Severe	Protection System:	None	Sq. m		23	10		10	<table border="1" style="width:100%; border-collapse: collapse;"> <tr><td>Length:</td><td style="text-align: right;">21.5</td></tr> <tr><td>Width:</td><td></td></tr> <tr><td>Height:</td><td style="text-align: right;">1.1</td></tr> <tr><td>Count:</td><td style="text-align: right;">2</td></tr> <tr><td>Total Quantity:</td><td style="text-align: right;">43</td></tr> </table> <p>Limited Inspection <input type="checkbox"/></p> <p>Maint. Needs</p> <p>Perform. Deficiencies</p> <p>Estimated Construction Cost:</p> <p style="text-align: right;">Priority</p> <table border="1" style="width:100%; border-collapse: collapse;"> <tr><td>None</td></tr> <tr><td>6-10 yrs</td></tr> <tr><td>1-5 yrs</td></tr> <tr><td>Within 1 yr</td></tr> <tr><td>Urgent</td></tr> </table>	Length:	21.5	Width:		Height:	1.1	Count:	2	Total Quantity:	43	None	6-10 yrs	1-5 yrs	Within 1 yr	Urgent

Photo 5: Spalls and section loss on west railing

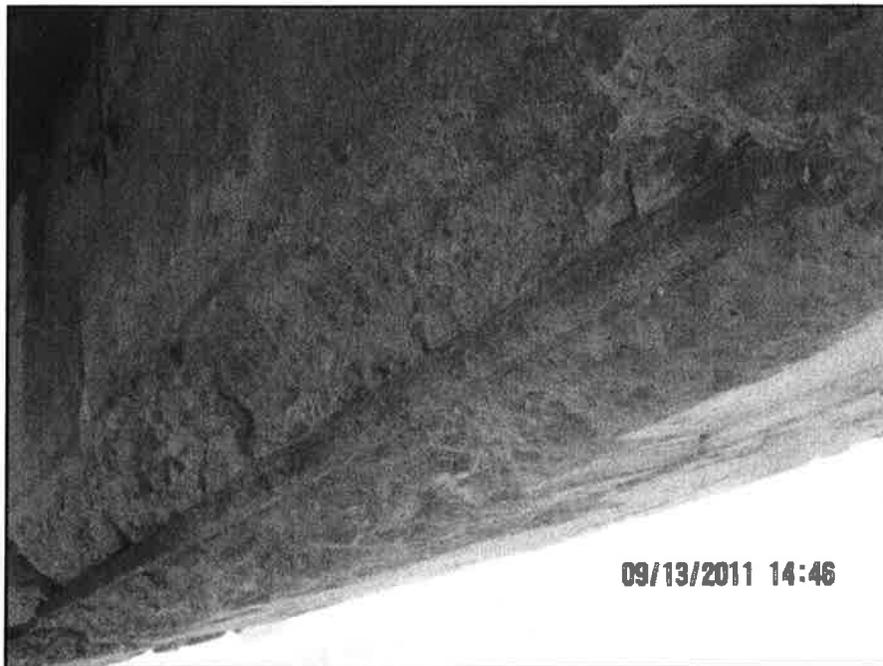
<table border="1" style="width:100%; border-collapse: collapse;"> <tr><td>Element Group:</td><td colspan="3">Beams/MLC's</td></tr> <tr><td>Element Name:</td><td>Girders</td><td colspan="2"></td></tr> <tr><td>Location:</td><td colspan="3"></td></tr> <tr><td>Material:</td><td colspan="3">Cast-in-place concrete</td></tr> <tr><td>Element Type:</td><td colspan="3">T-type</td></tr> <tr><td>Environment:</td><td colspan="3">Benign</td></tr> <tr><td>Protection System:</td><td colspan="3">None</td></tr> </table> <p>Condition Data:    Units            Exc            Good            Fair            Poor</p> <table border="1" style="width:100%; border-collapse: collapse;"> <tr> <td style="width:15%; text-align: center;">Sq. m</td> <td style="width:15%;"></td> <td style="width:15%; text-align: center;">85.2</td> <td style="width:15%; text-align: center;">3</td> <td style="width:15%; text-align: center;">3</td> </tr> </table> <p>Comments Spall and delamination at exterior west beam.</p> <p>Recommended Work Replace structure</p>	Element Group:	Beams/MLC's			Element Name:	Girders			Location:				Material:	Cast-in-place concrete			Element Type:	T-type			Environment:	Benign			Protection System:	None			Sq. m		85.2	3	3	<table border="1" style="width:100%; border-collapse: collapse;"> <tr><td>Length:</td><td style="text-align: right;">12</td></tr> <tr><td>Width:</td><td style="text-align: right;">0.5</td></tr> <tr><td>Height:</td><td style="text-align: right;">0.7</td></tr> <tr><td>Count:</td><td style="text-align: right;">4</td></tr> <tr><td>Total Quantity:</td><td style="text-align: right;">91.2</td></tr> </table> <p>Limited Inspection <input type="checkbox"/></p> <p>Maint. Needs</p> <p>Perform. Deficiencies</p> <p>Estimated Construction Cost:</p> <p style="text-align: right;">Priority</p> <table border="1" style="width:100%; border-collapse: collapse;"> <tr><td>None</td></tr> <tr><td>6-10 yrs</td></tr> <tr><td>1-5 yrs</td></tr> <tr><td>Within 1 yr</td></tr> <tr><td>Urgent</td></tr> </table>	Length:	12	Width:	0.5	Height:	0.7	Count:	4	Total Quantity:	91.2	None	6-10 yrs	1-5 yrs	Within 1 yr	Urgent

Photo 6: Spall and delamination on exterior west beam

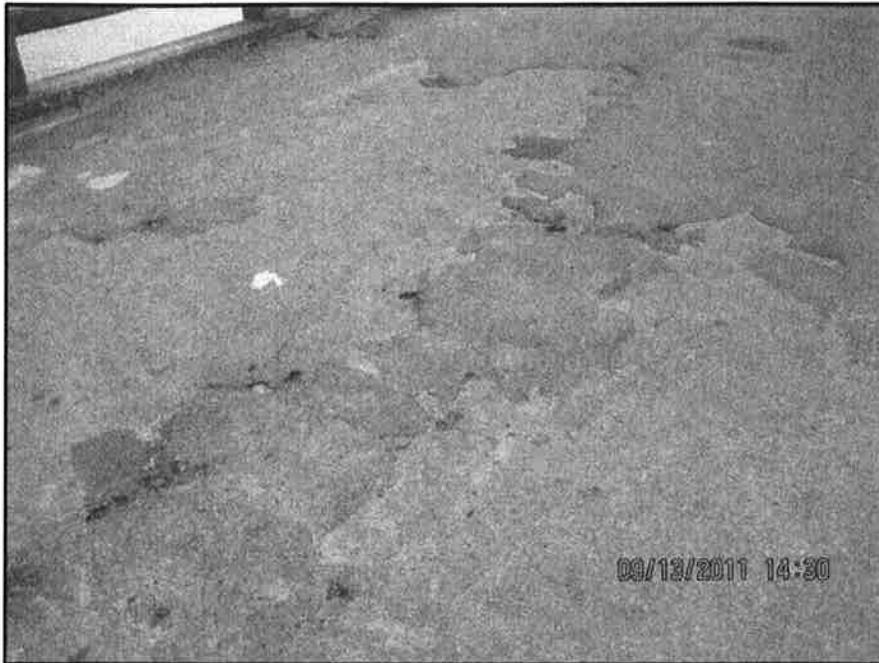
<table border="1" style="width:100%; border-collapse: collapse;"> <tr><td>Element Group:</td><td colspan="3">Decks</td></tr> <tr><td>Element Name:</td><td>Wearing surface</td><td colspan="2"></td></tr> <tr><td>Location:</td><td colspan="3"></td></tr> <tr><td>Material:</td><td colspan="3">Asphalt</td></tr> <tr><td>Element Type:</td><td colspan="3">Bituminous</td></tr> <tr><td>Environment:</td><td colspan="3">Severe</td></tr> <tr><td>Protection System:</td><td colspan="3">None</td></tr> </table> <p>Condition Data:    Units            Exc            Good            Fair            Poor</p> <table border="1" style="width:100%; border-collapse: collapse;"> <tr> <td style="width:15%; text-align: center;">Sq. m</td> <td style="width:15%;"></td> <td style="width:15%; text-align: center;">57</td> <td style="width:15%;"></td> <td style="width:15%; text-align: center;">20</td> </tr> </table> <p>Comments Extensive potholes noted.</p> <p>Recommended Work Replace structure</p>	Element Group:	Decks			Element Name:	Wearing surface			Location:				Material:	Asphalt			Element Type:	Bituminous			Environment:	Severe			Protection System:	None			Sq. m		57		20	<table border="1" style="width:100%; border-collapse: collapse;"> <tr><td>Length:</td><td style="text-align: right;">14</td></tr> <tr><td>Width:</td><td style="text-align: right;">5.5</td></tr> <tr><td>Height:</td><td></td></tr> <tr><td>Count:</td><td style="text-align: right;">1</td></tr> <tr><td>Total Quantity:</td><td style="text-align: right;">77</td></tr> </table> <p>Limited Inspection <input type="checkbox"/></p> <p>Maint. Needs</p> <p>Perform. Deficiencies</p> <p>Estimated Construction Cost:</p> <p style="text-align: right;">Priority</p> <table border="1" style="width:100%; border-collapse: collapse;"> <tr><td>None</td></tr> <tr><td>6-10 yrs</td></tr> <tr><td>1-5 yrs</td></tr> <tr><td>Within 1 yr</td></tr> <tr><td>Urgent</td></tr> </table>	Length:	14	Width:	5.5	Height:		Count:	1	Total Quantity:	77	None	6-10 yrs	1-5 yrs	Within 1 yr	Urgent

Photo 7: Typical wearing surface

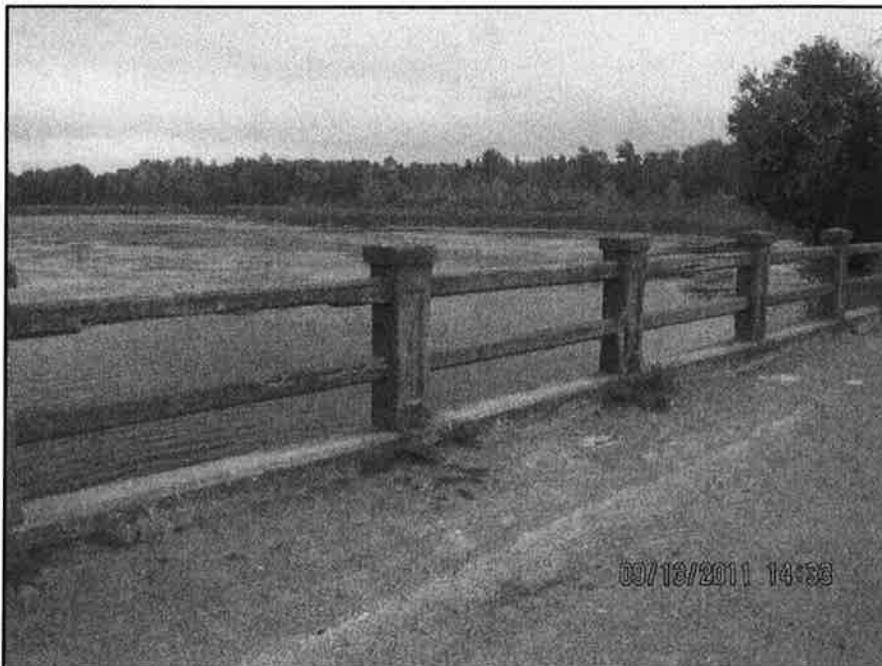
Photo 8: Localized spalls on curb and railing posts
