Council Report

Report Number BP 2016-003

Subject: Coboconk Medical Centre – Building Issues

RE: Coboconk Medical Centre
Structural Assessment Report No. 3

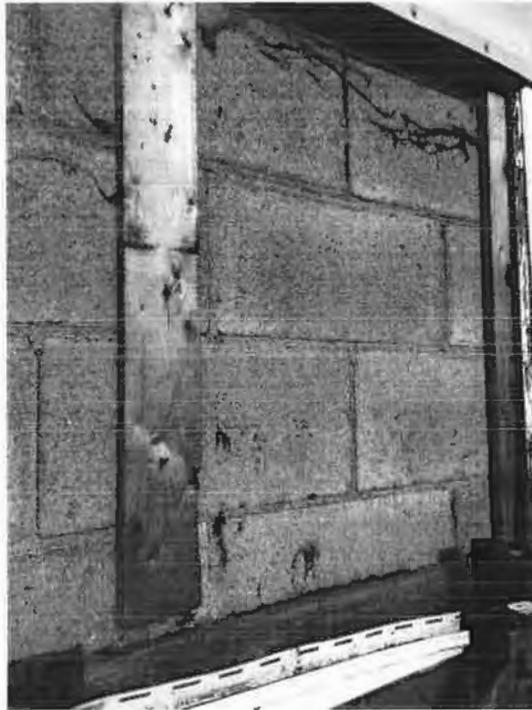
Approximately 2'-0" wide strips of exterior face bricks and rigid insulation were removed on two sides of the south-west window (consultation room #9) exposing the existing 10" block wall above the window and 6" block wall below as recommended on our second report dated October 20, 2016 (Picture #1). Adjustable jacks at two ends of window bearing on foundation wall have been provided to support the 10" block wall above (Picture #2).

Photo #1 – Exposed 10" block above window

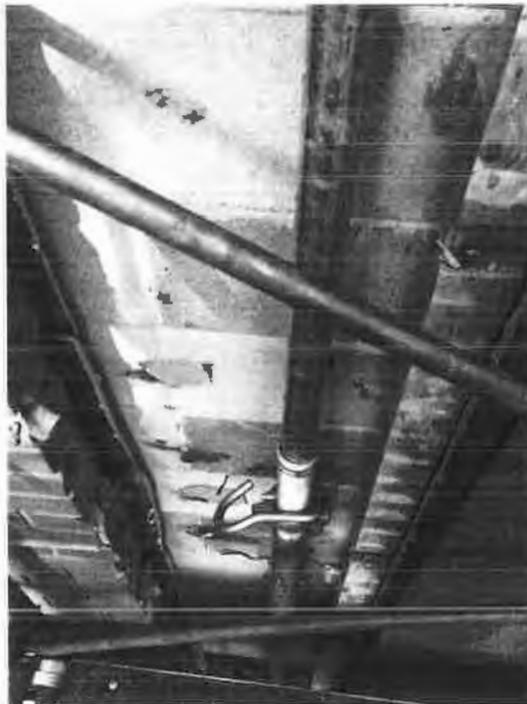
Photo #2 – Removed brick adjacent to the window

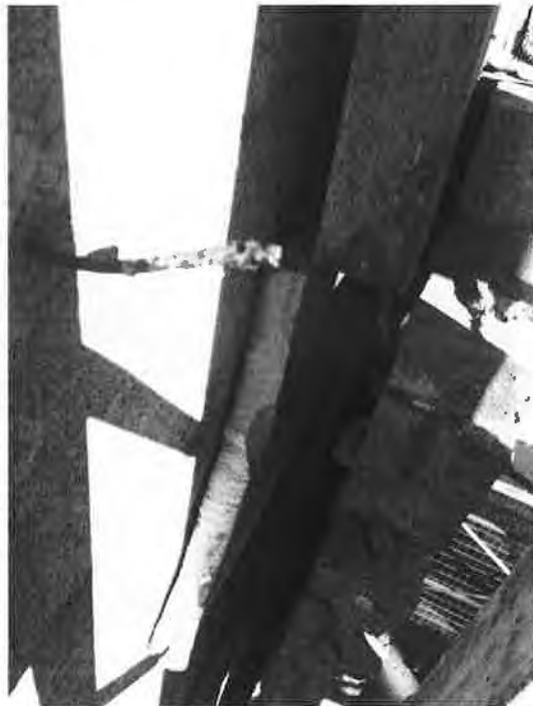
Similarly as in the areas that were previously exposed cross ties are severely corroded, elongated and have broken free from longitudinal rod in brick face (Picture #3). The existing 10" block wall above the windows that has been exposed has noticeable cracks close to the hinge location at the bottom (Picture #4). At the interior face of the hinge location there is an approximately 1" gap between the 6" block wall and the 10" block wall (Picture #5). 10" block wall and lintels above the windows appear to have turned as the bottom portion has moved outward. Lintel above the window does not have proper bearing at both ends.

Photo #3 – Portion of brick tie perpendicular to the wall

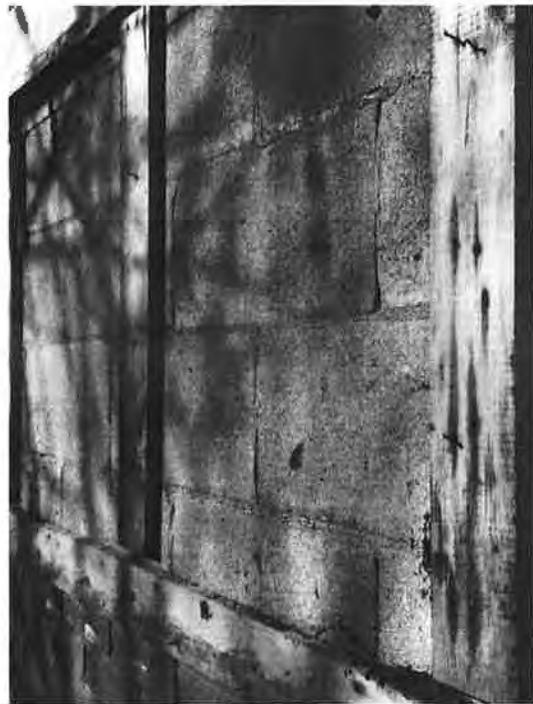
Photo #4 – Cracks at 10" block wall above the window

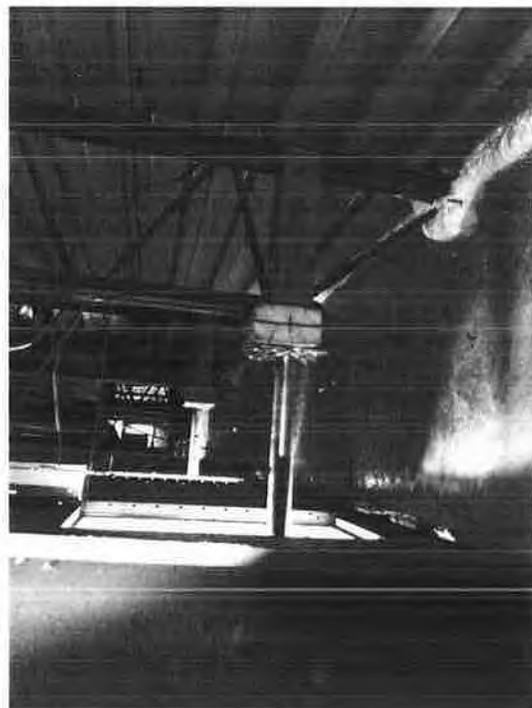
Interior temporary shoring along north and south elevations has been installed and is in general accordance with details provided in our sketches dated October 20 and 25, 2016 (Pictures #6, 7)

Photo #6 – Temporary shoring along north side

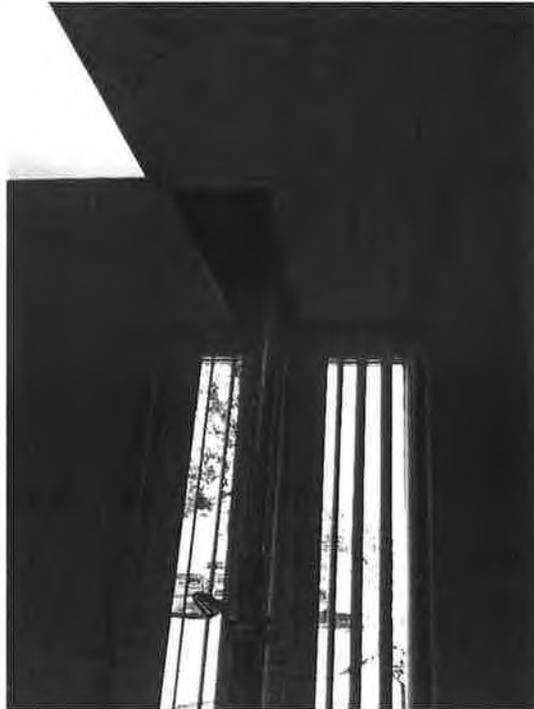
Photo #7 – Temporary shoring along south side

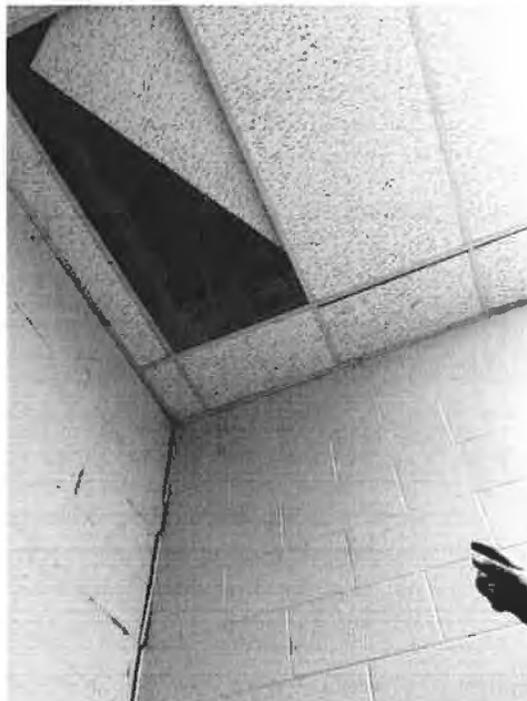
As previously noted interior 6" block has undergone some movement as evident from opening up of vertical joints on inside between south wall and 4 block partitions walls butting perpendicular to the wall. The face brick pulling appears to have pulled out interior block wythe at some locations where cross ties are still effective (Photo #8). The 6" interior block wall is on average approximately 1/2" out of plumb at the hinge location where it changes from cavity wall to 10" block wall.

Photo #8 – Gap between interior partition wall and exterior south wall
