# JAMES KNIGHT & ASSOCIATES

## SITE VISIT REPORT

Report No. 1

**Re: Rehabilitation of 100 ft. Sand Dome  
Fenelon (aka Cameron) Works Yard  
The City of Kawartha Lakes**

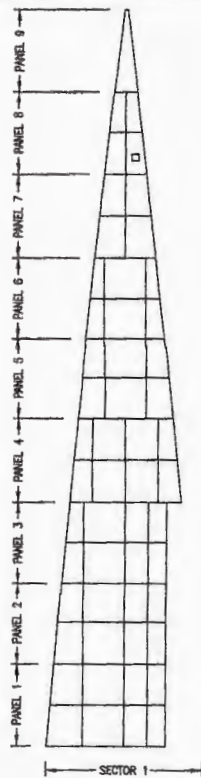
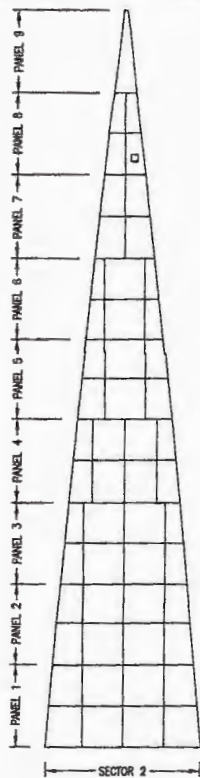
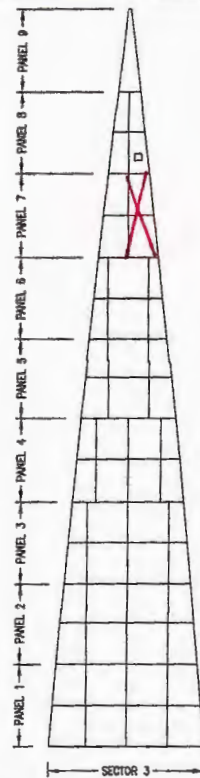
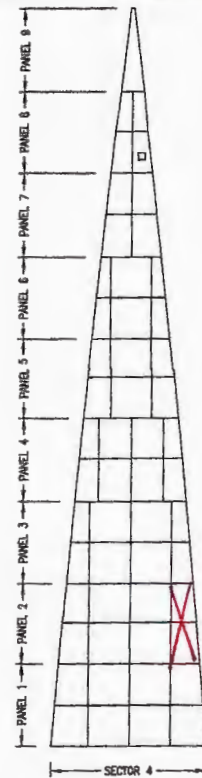
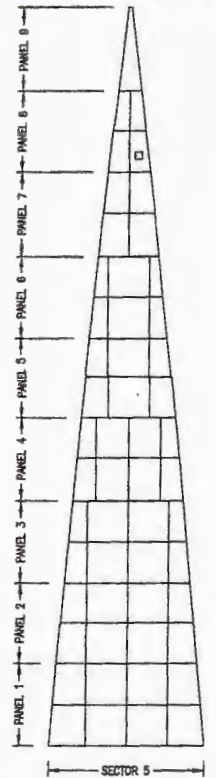
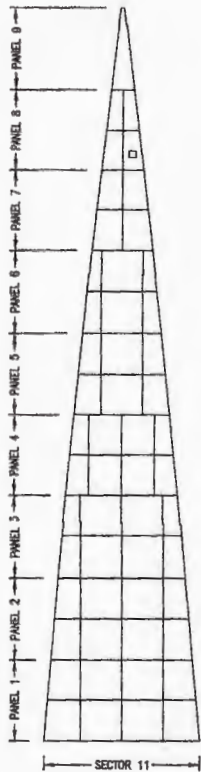
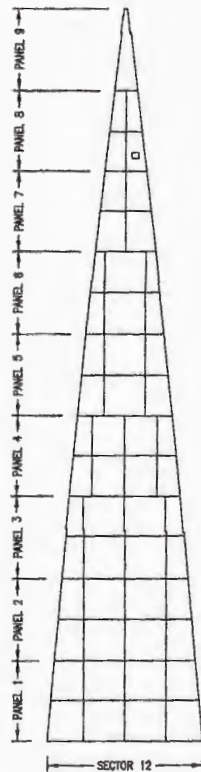
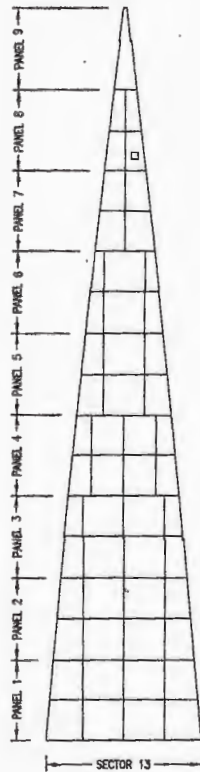
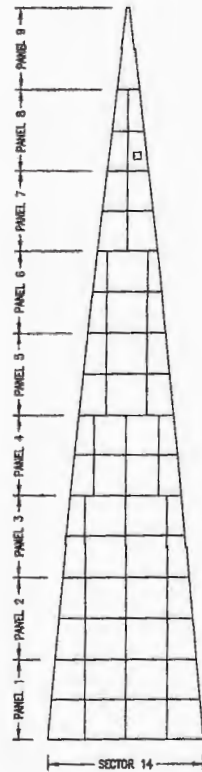
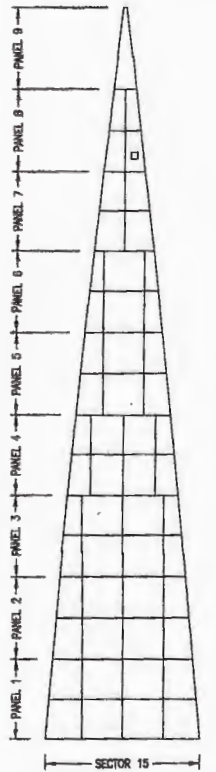
1.6 Attached is Drawing No. 17-883-4 copied as two halves and marked up in colour. Changes in the scope of work are shown in red thereon. All such additional work is to be done on the Contract's Unit Price basis.

1.7 Further to No. 1.6 the changes to the plywood repairs to be undertaken per the Unit Price provisions of the Contract are as follows.

1.8 Further to No. 1.6, the changes to the lumber repairs to be undertaken per the Unit Price provisions of the Contract are as follows.

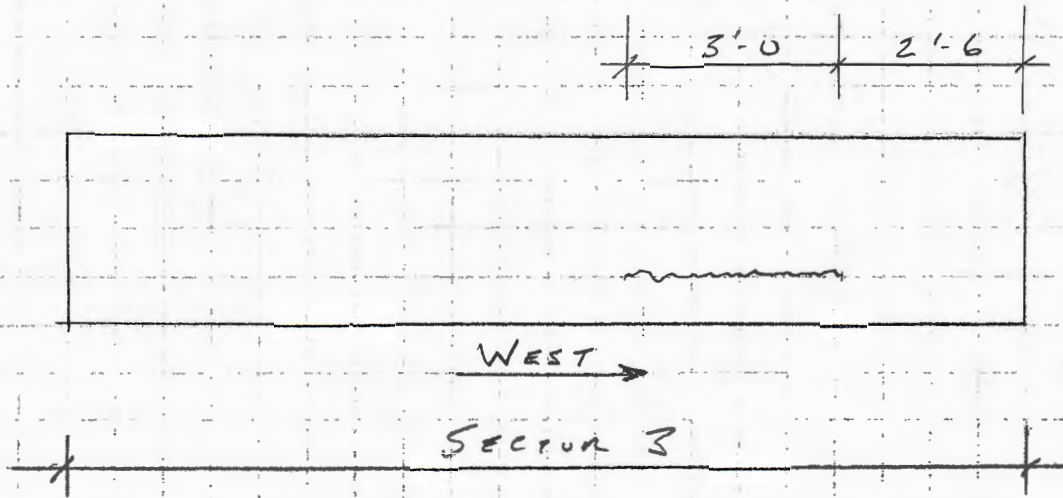
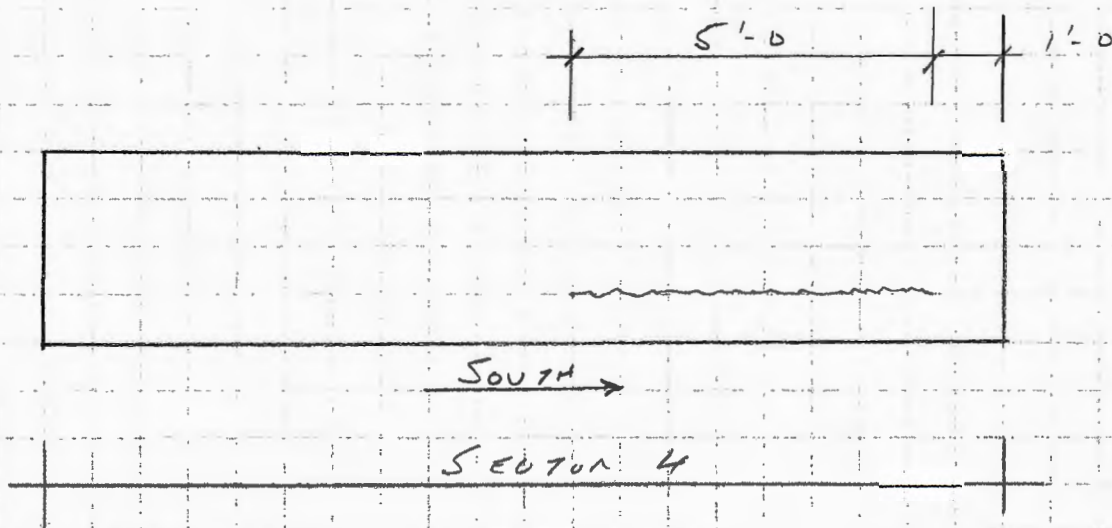
51-1  
17-883  
18/5/18

2.4 Additional epoxy repairs of some parts of some sectors are to be undertaken on the Unit Price basis of the Contract and per the procedure of No. 2.5 following. The locations and extent of such repairs are shown by the irregular lines drawn on sketches attached hereto as pages S1-1 to S1-5 inclusive. The aggregate cold-joint/crack length shown is 45 ft. to be repaired at a Unit Price of \$200.00 per foot, i.e., \$9,000.00. The total cold-joint/crack length and cost are to be confirmed by re-measurement once the work is complete.

2.5 The procedure to be followed re the Unit Price epoxy repair shall be as follows.

- a) City to dismantle bull-ring boards.
- b) City to remove sand/salt and other debris remaining behind bull-ring.
- c) City to pressure-wash inside face of concrete foundation.
- d) Contractor to undertake repairs as/where described herein.
- e) The scope of the repairs of (d) is to be increased or decreased as appropriate to the found conditions and only with the prior approval of the City. A record of any such changes is to be made and distributed.
- f) City to caulk all areas of the crack/cold joint that were not subject to epoxy repair.
- g) City to reassemble bull-ring.
