## **Appendix D**

### **Site Photographs**

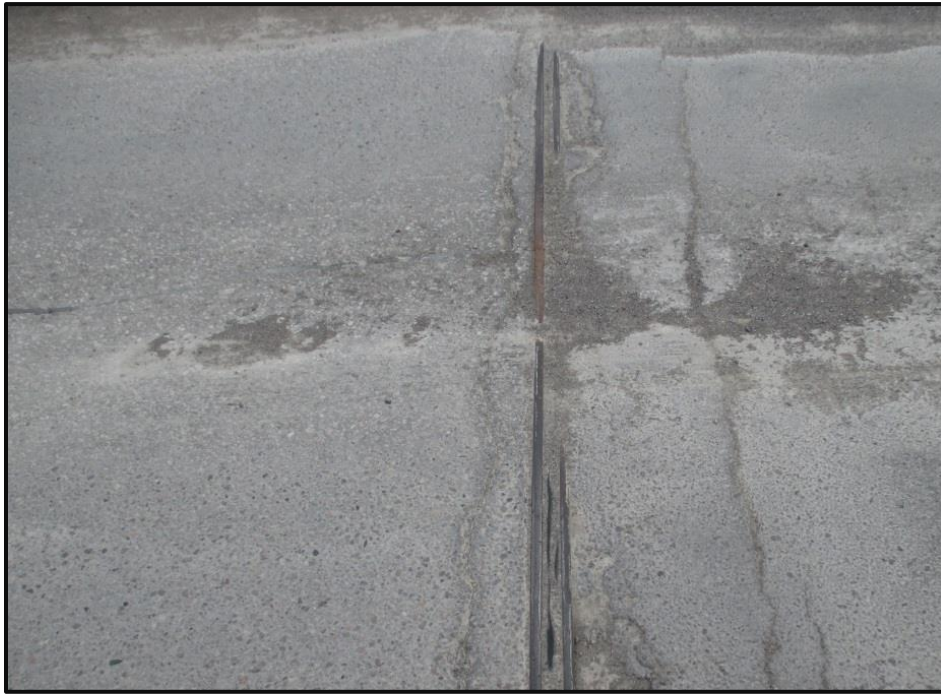
**Photo 3: Jammed joints (typical of both ends)**

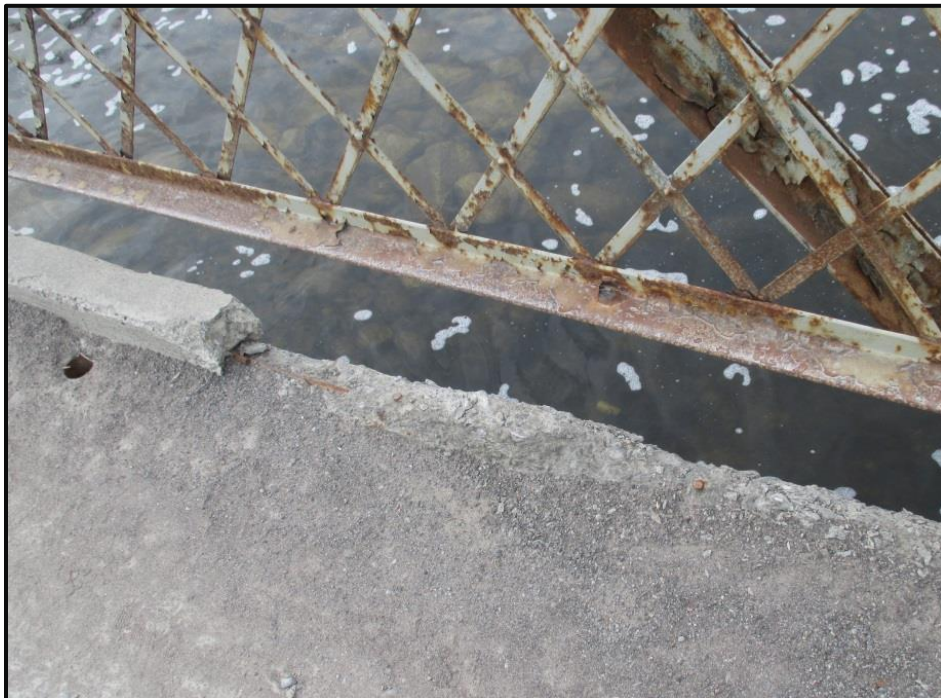
**Photo 4: Typical spalling at curb**

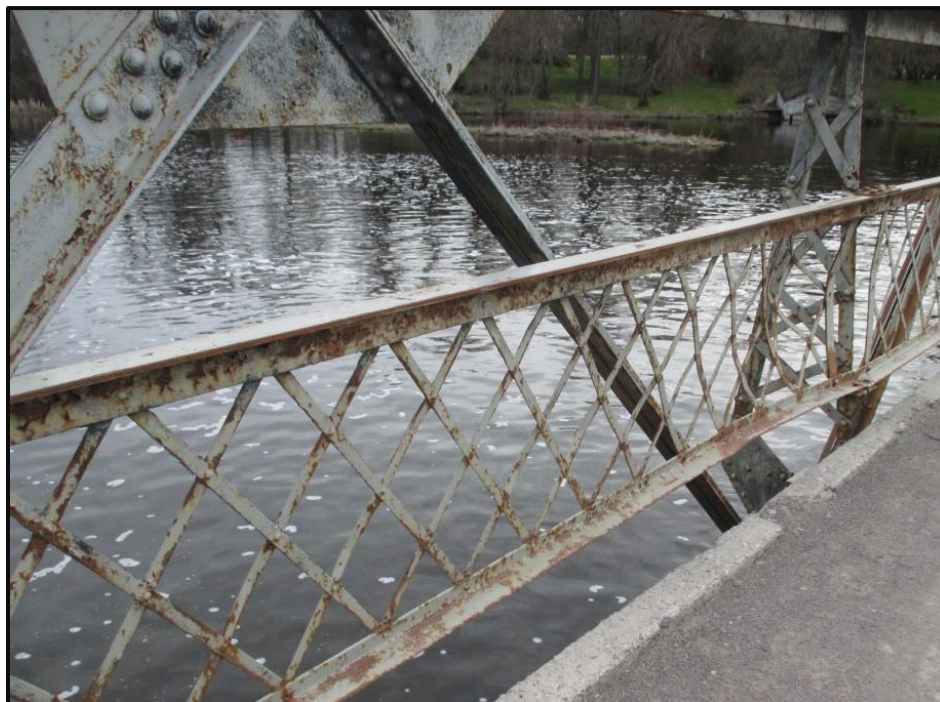
**Photo 5: Deformed railing**

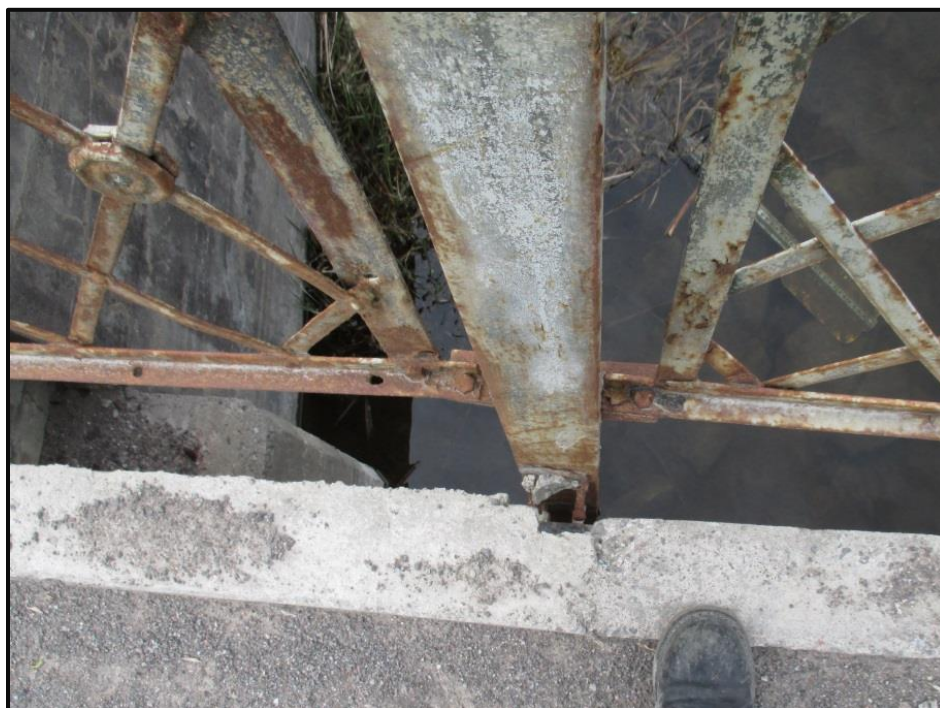
**Photo 6: Broken post at southeast**

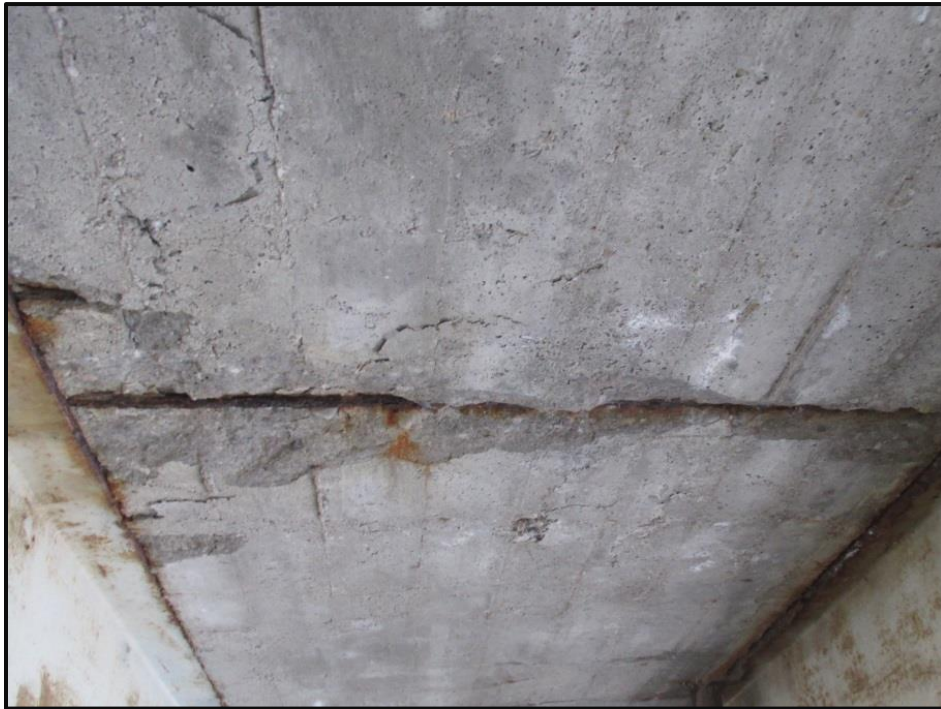
**Photo 7: Severe spall at soffit (typical of soffit)**

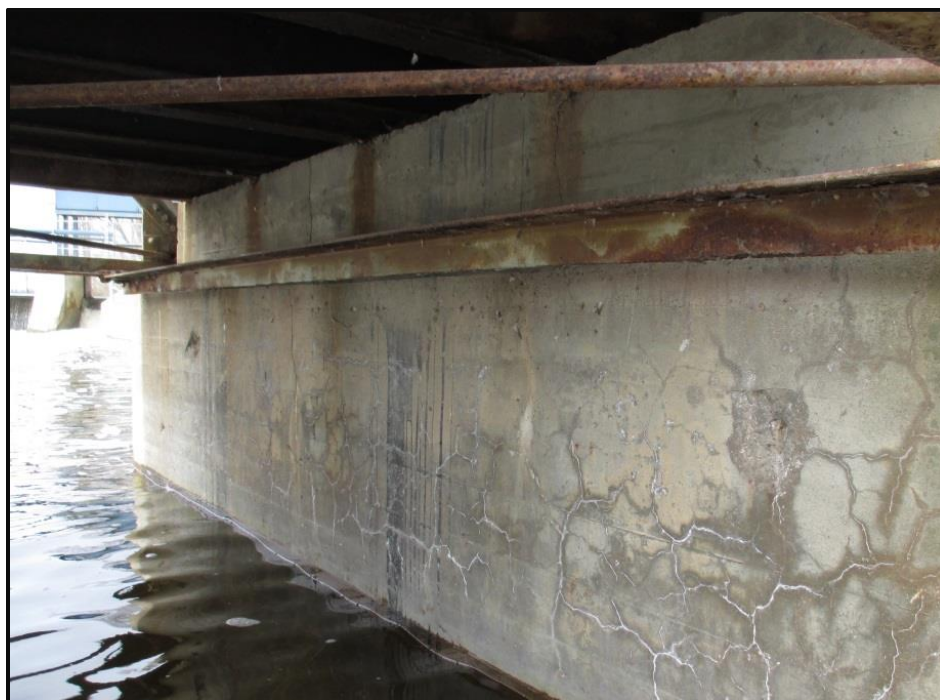
**Photo 10: Map cracking at west abutment**
