2017 OSIM Structural Inspection

Structure Number:	B 100018	MTO Site Number	100018
Structure Name	Mill Pond Bridge, Lot 7, Conc III		
Main Hwy/Rd #	<input type="checkbox"/> On <input checked="" type="checkbox"/> Under <input type="checkbox"/>	Crossing Type	Non Navig. Water
Road Name	Mary Street East		
Structure Location	0.35 km East of Sturgeon Road South		
Latitude	44.29927	Longitude	-78.55544
Owners	City of Kawartha Lakes	Heritage Status	Not Cons.
MTO Region	Eastern	Road Class	Local
MTO District	Bancroft	Posted Speed	50
Old County	Victoria	No of Lanes	1
Geographic Twp	Emily	AADT	150
Structure Type	Half-Through Truss	% Trucks	2
Total Deck Length	54.90 (m)	Special Routes	
Overall Struct. Width	4.30 (m)	Detour Length Around Bridge	(km)
Total Deck Area	236.07 (m ²)	Fill on Structure	(m)
Roadway Width	3.80 (m)	Skew Angle	(Degrees)
Span Lengths	9.60, 9.60, 9.60, 2 (m)	Direction of Structure	East / West
		Number of Spans	4

Date of Inspection	09/09/2017
Inspector	Marek Stutz, P.Eng.; AUE Structural Inc.
Others in Party	Mohamed El-Sarji, P.Eng.; AUE Structural Inc.
Equipment Used	Chest Waders, Measuring Tape and Hammer
Weather	Sunny
Temperature	15 (°C)

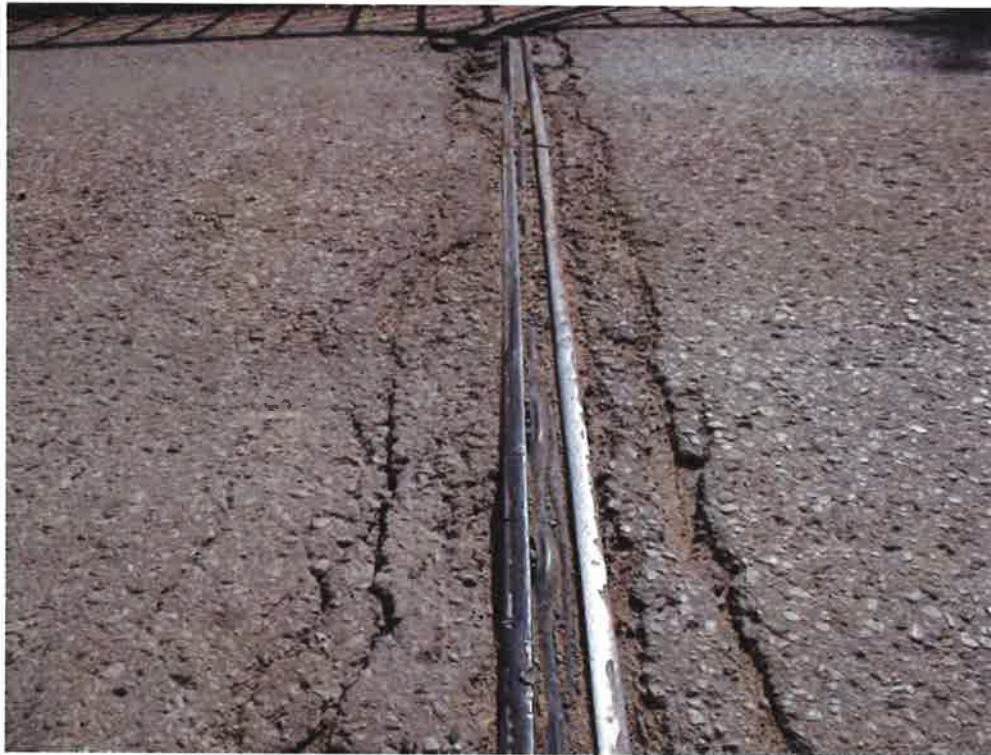
Steel armouring is broken in several locations.

- Leakage, tears and displacement
- Seals are jammed

Photo 7: Severe deterioration at expansion joint assembly

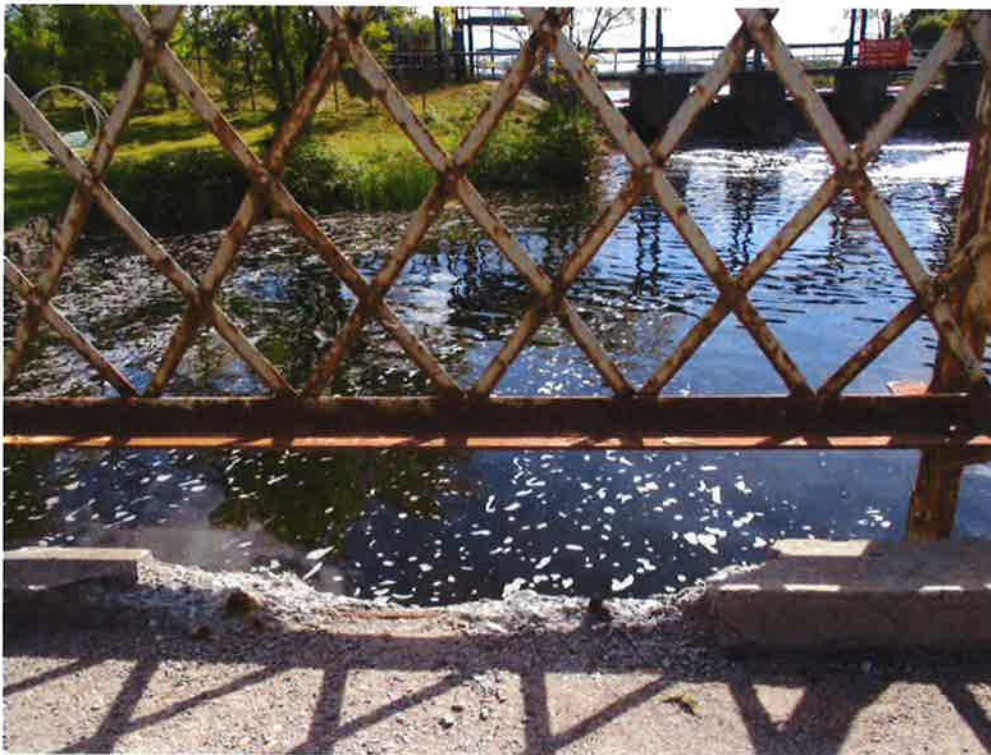
- Narrow to wide cracks
- Light to severe spalls and disintegration

Photo 8: Severe spall at curb

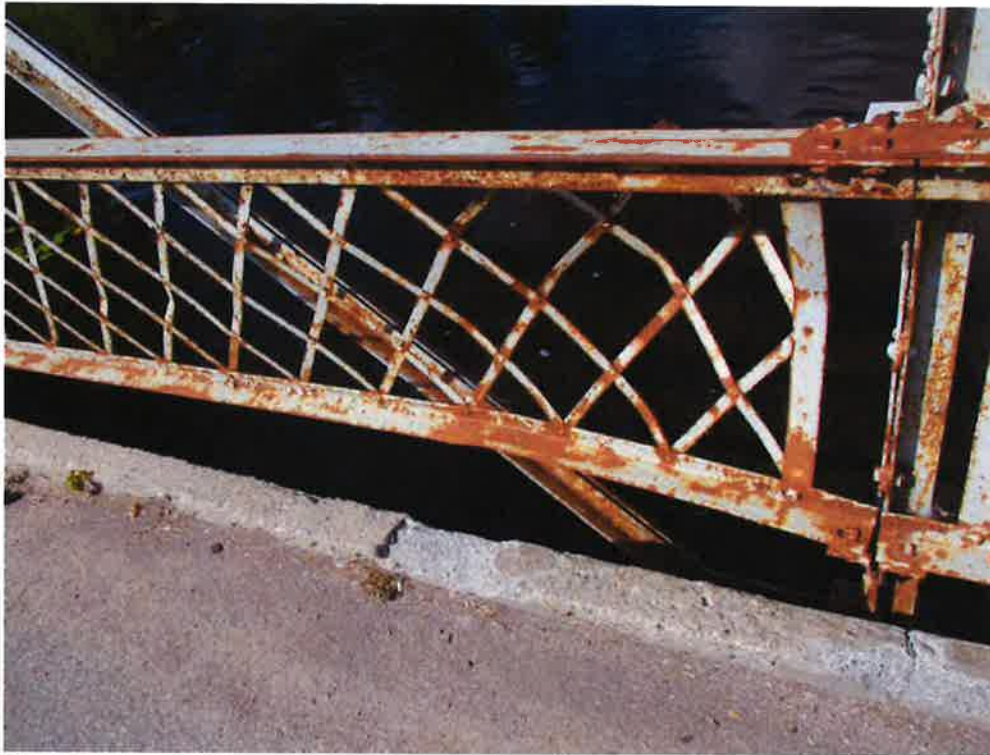
Rotation due to impact damage at top chord at northwest.

Photo 9: Impact damage at northwest

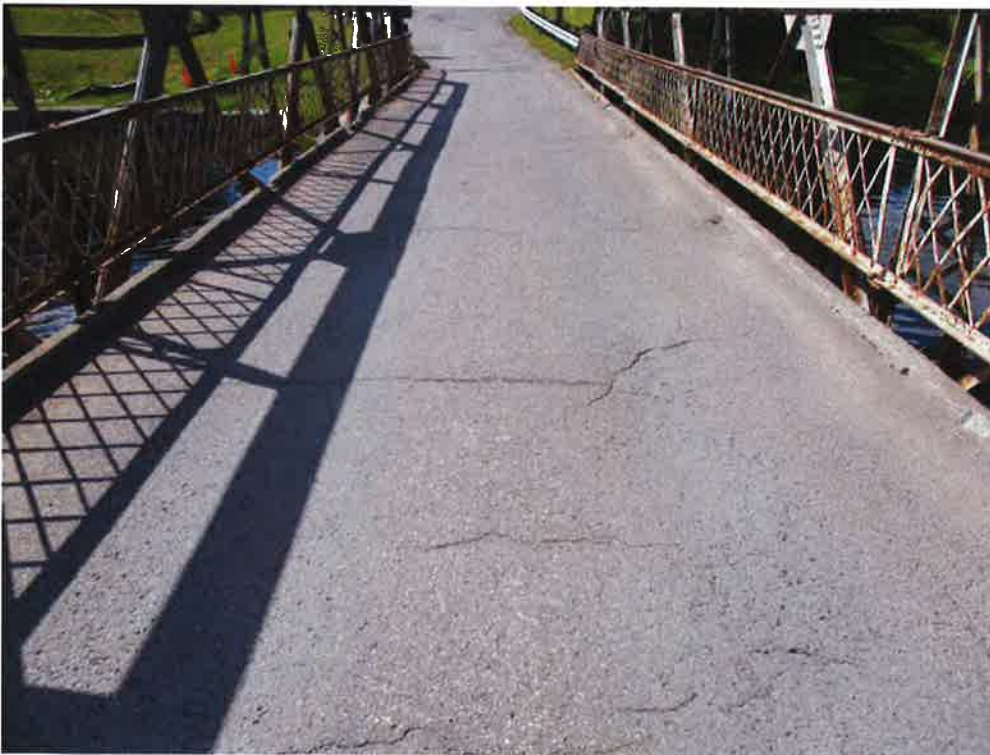
- Light ravelling
- Medium to severe cracks

Photo 10: Medium to severe cracks at deck wearing surface

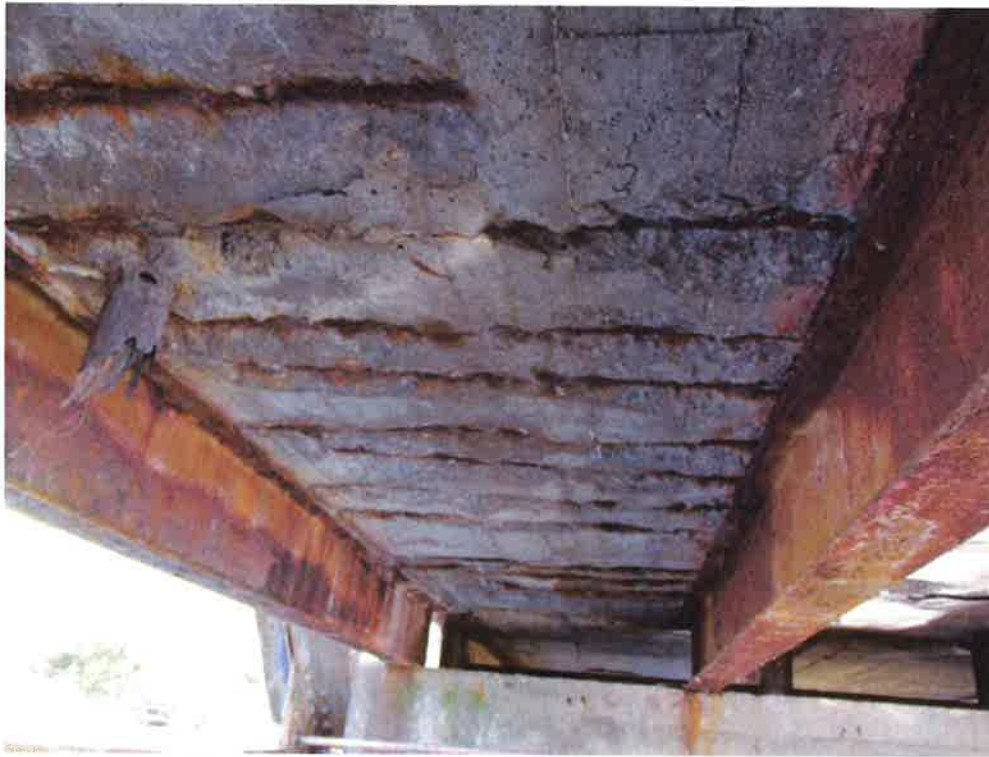
- Narrow to wide cracks, some with efflorescence
- Light to severe spalls and delaminations
- Efflorescence

Photo 13: Severe spalls at soffit interior

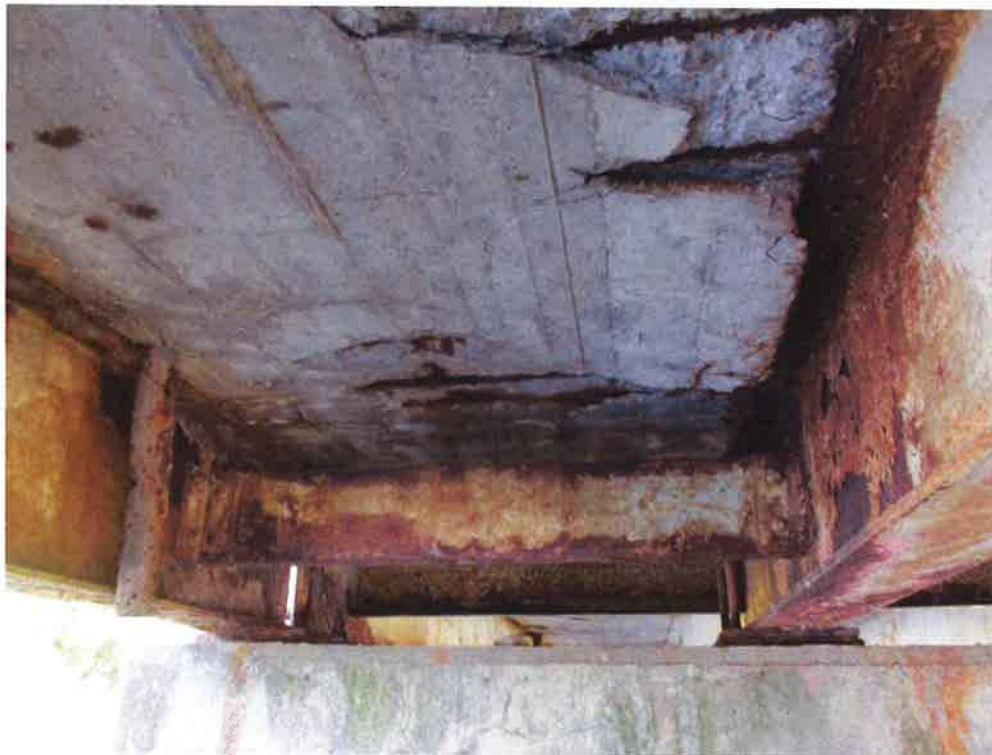
Photo 14: Severe spalls and delaminations at soffit interior

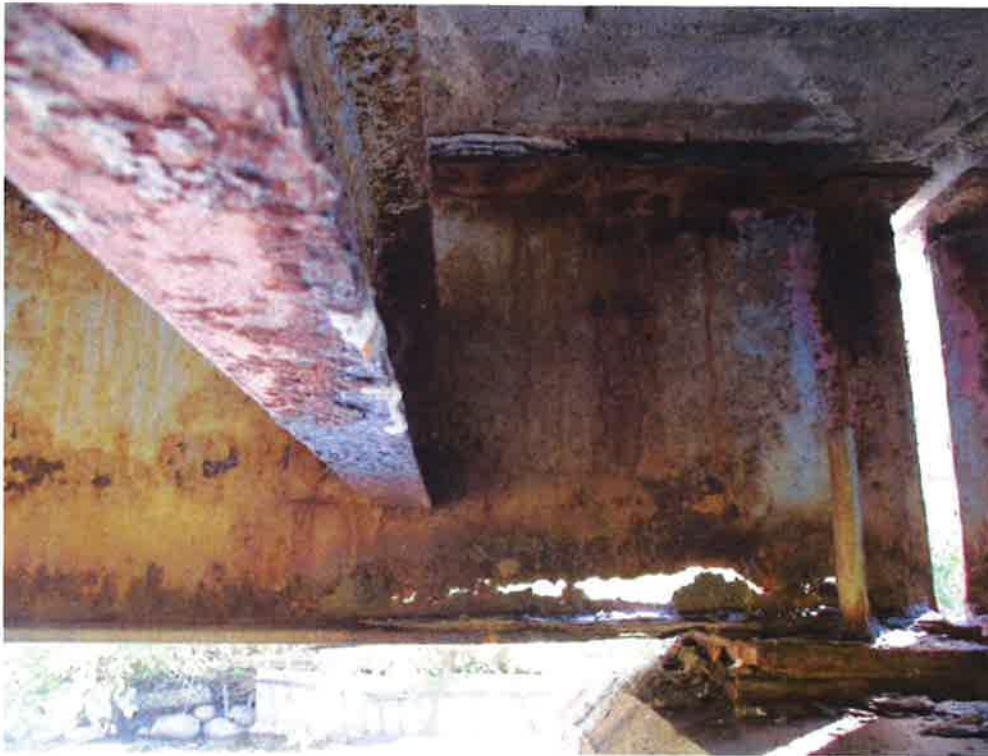
- Perforations at girder webs at northwest and southeast
- Section loss at web of north and south girders at east pier
- Severe corrosion at girder ends

Photo 15: Severe corrosion and perforation at girder

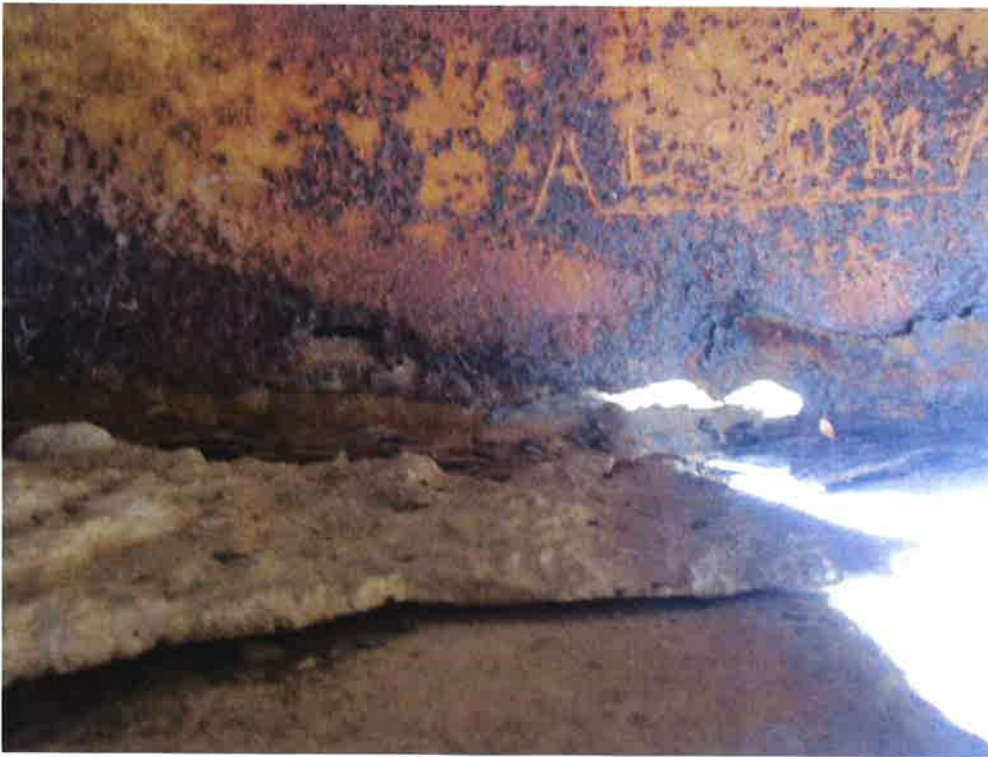
- Additional stringers were previously installed
- Light to medium corrosion noted

Photo 16: Severe corrosion and perforation at stringer
