**Bobcaygeon Composite Elevated Tank
Remotely Operated Vehicle Inspection and Report
July 16, 2018**

Re: **LMS Job #LM18041**
Remote Inspection & Report - Bobcaygeon Composite Elevated Tank

COMPOSITE ELEVATED TANK INSPECTION REPORT

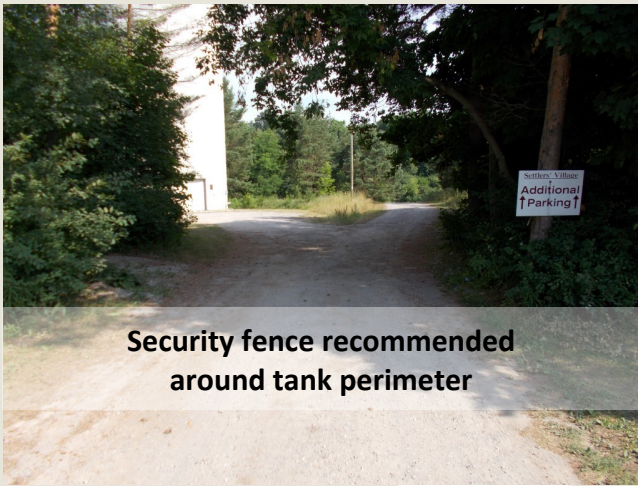
1

Security fence recommended
around tank perimeter

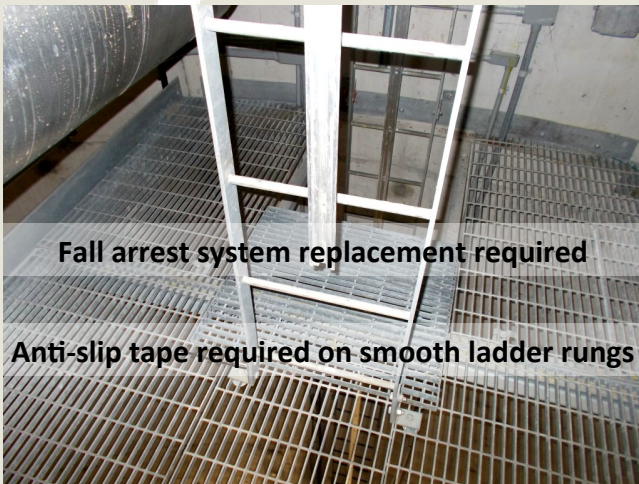
61

Fall arrest system replacement required
Anti-slip tape required on smooth ladder rungs

Remove and replace fall arrest system

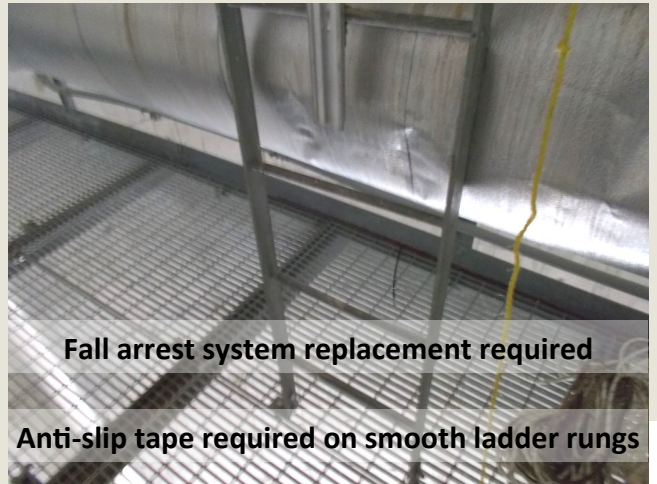
68

Fall arrest system replacement required
Anti-slip tape required on smooth ladder rungs

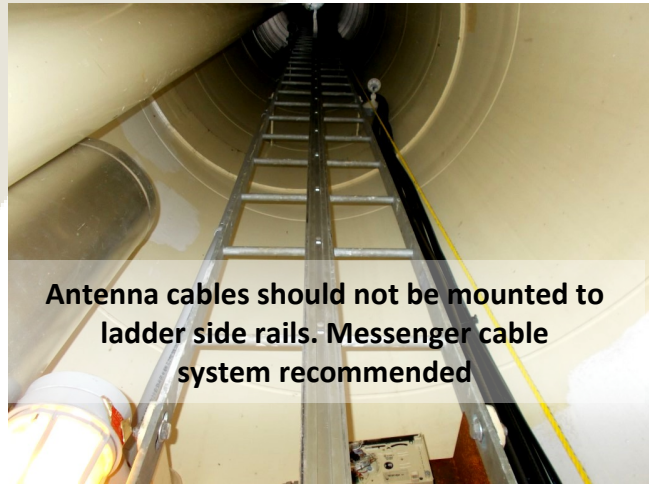
* Manufacturer	Corrosion Services Ltd.	7
ANTENNAE	* Anchorage / Mounting	Fair	78 - 79, 91
	* Cable Routing	Poor - Antenna cables mounted to ladder siderails in pedestal and access tube. Cable tray system required	70

Antenna cables should not be mounted to ladder side rails. Messenger cable system recommended

Relocate antenna cables to proposed cable tray system

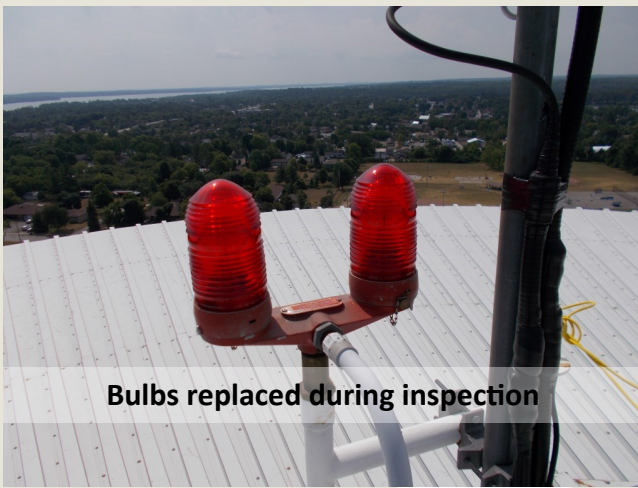
81

Bulbs replaced during inspection

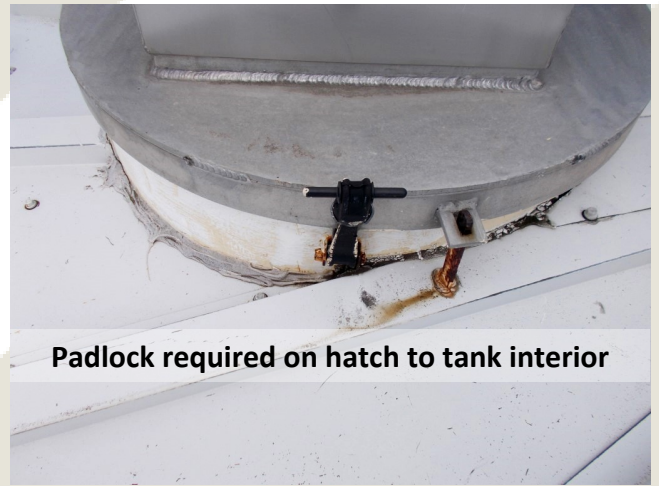
98

Padlock required on hatch to tank interior

2pc padlocks required on hatch to tank interior

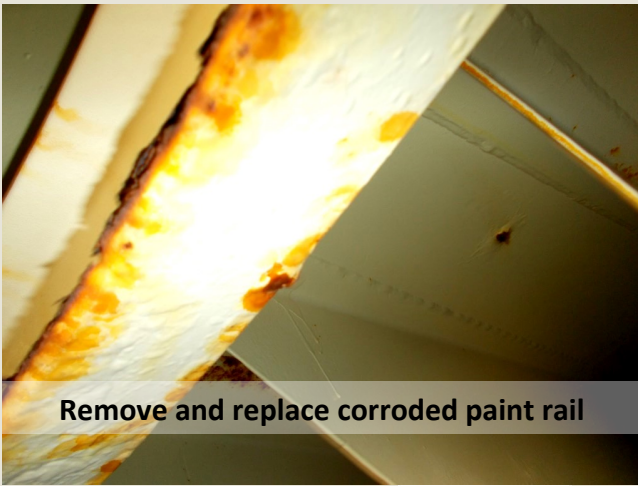
105

Remove and replace corroded paint rail

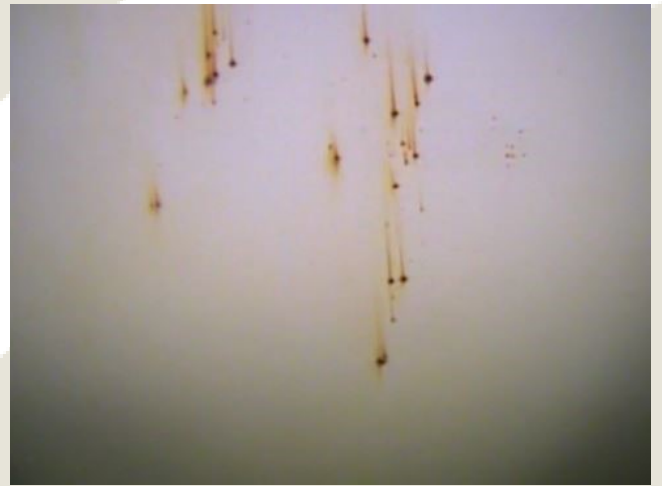
155

At time of inspection cathodic protection system was disconnected
