**BARRY BRYAN
ASSOCIATES**

September 10, 2018

Re: **Structural Condition Review of the Existing Two Storey Building Located at 2 River Street, Coboconk, Ontario
Project No. 18214**

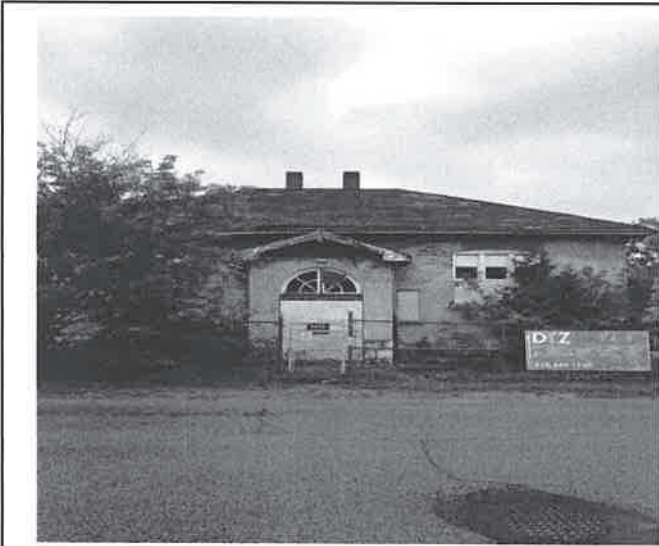
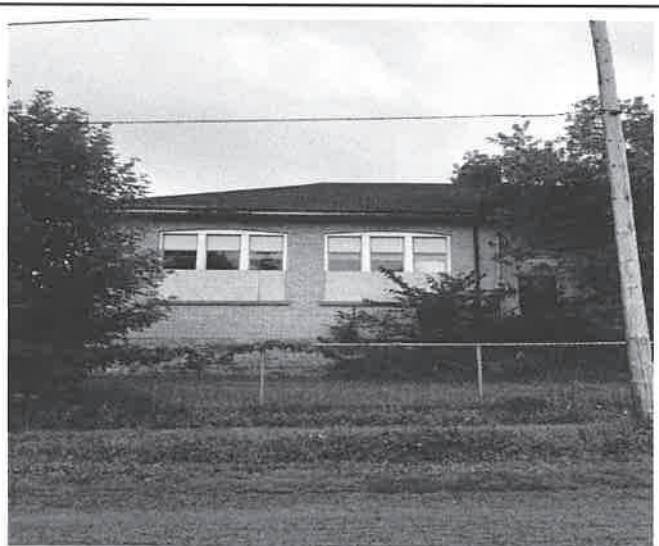
The hip roof consists of wood sheathing which is supported on wood trusses and/or rafters (Photos 001 and 002). We could not verify the spans of the trusses and rafters, however noted that the exterior brick masonry walls are load bearing and support the trusses.

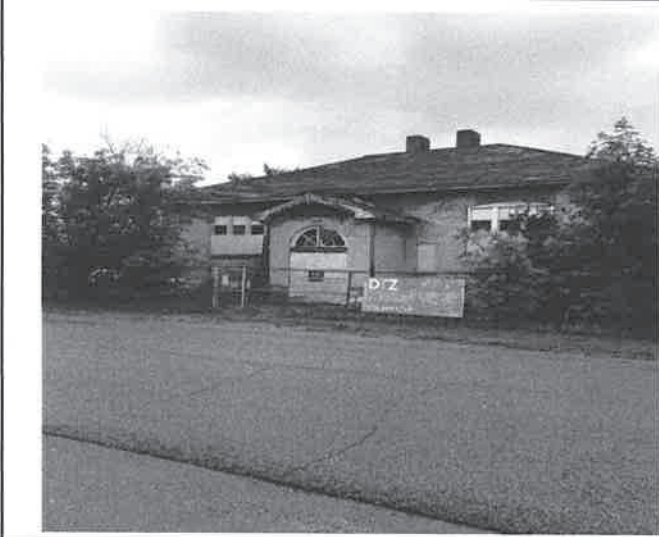
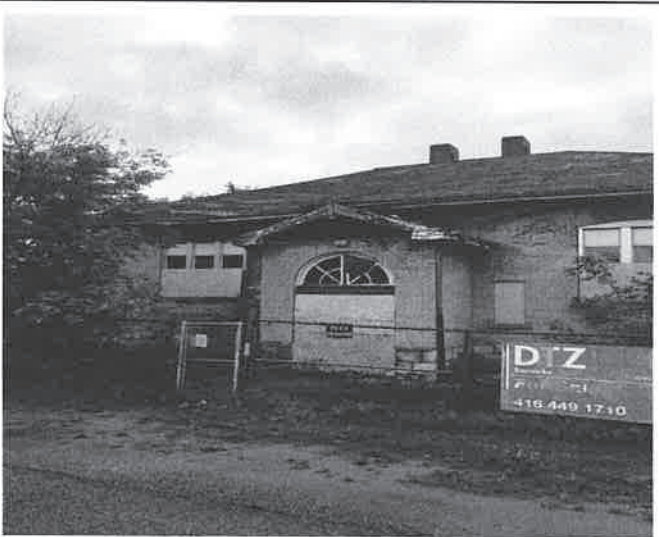
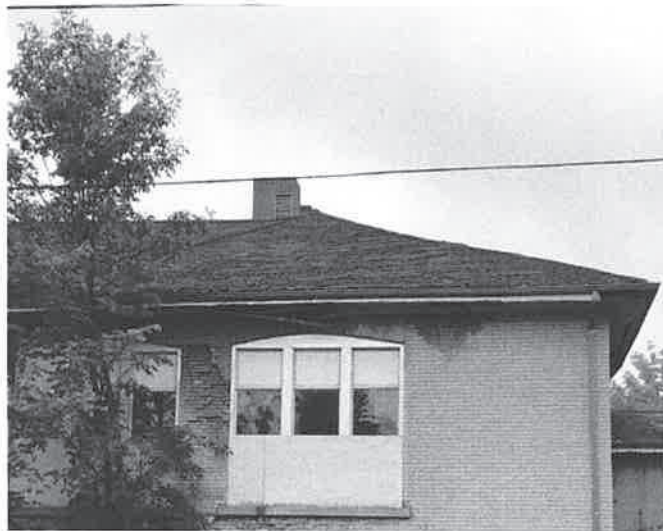
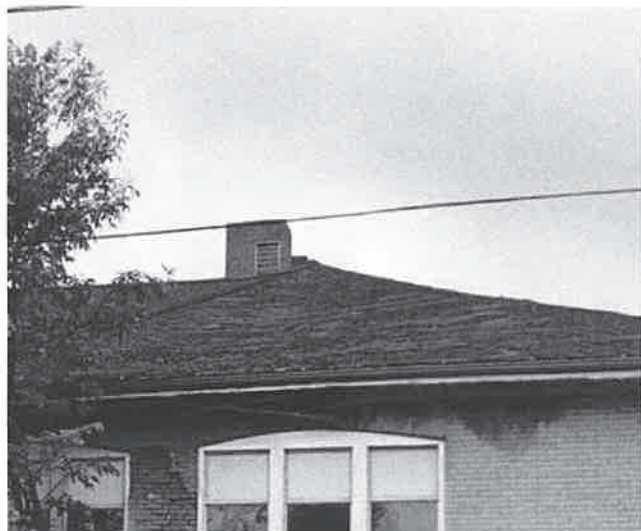
There was evidence of severe deterioration and localized complete failures of the roof structure especially along the north and north / east end of the roof. There was approximately a 24" deep valley observed across the north roof slope. The valley appears to have been caused by the localized failure of the load bearing brick masonry wall below (Photo 003, 004). Additionally, a valley approximately 12" deep had formed along both the east and west roof slope also due to the localized failure of the roof structure above excessively deteriorated sections of brick masonry walls (Photo 005, 006). The roof deck and wood soffit and fascia boards in these areas had fully delaminated from the supporting roof structure and were open to the exterior elements (Photo 007, 008, 009).

5. Repair the failed roof structure. This will involve locally removal of the roof deck and potential installation of new rafters or trusses. Extensive reinforcing of all existing wood framing to remain can be expected due to the amount of moisture infiltration through the roof envelope due to the current condition of the asphalt shingles.

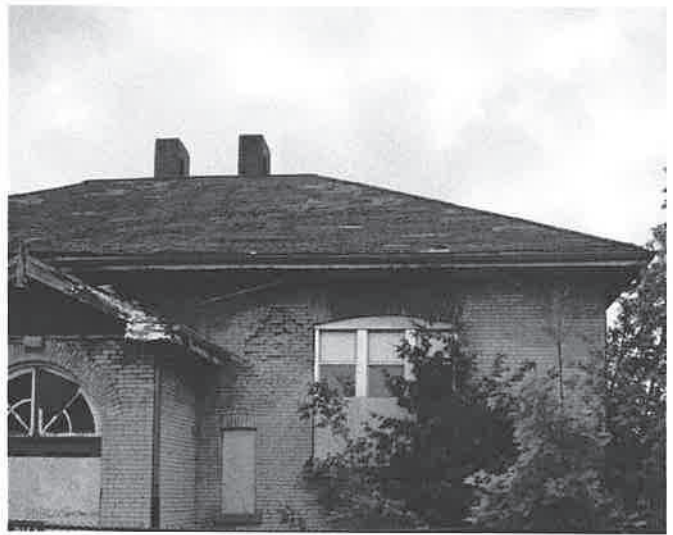
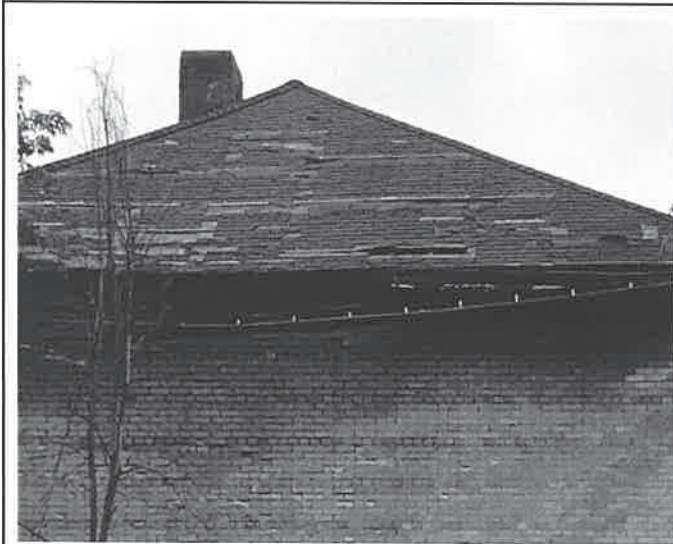
The roof consists of asphalt shingles which in many locations had lifted or were stripped from the roof allowing moisture infiltration into the roof envelope (Photo 010, 011). There were three (3) brick masonry chimney's observed during the site visit which projected approximately 8'-0" above the roof line. We were unable to verify the framing supporting the chimneys.

6. Install a new roof system.
7. Replace broken windows and doors to make the structure weather tight.
8. Cut back all overgrown vegetation to allow the exterior brick masonry walls to dry out and not be under a fully shaded condition.

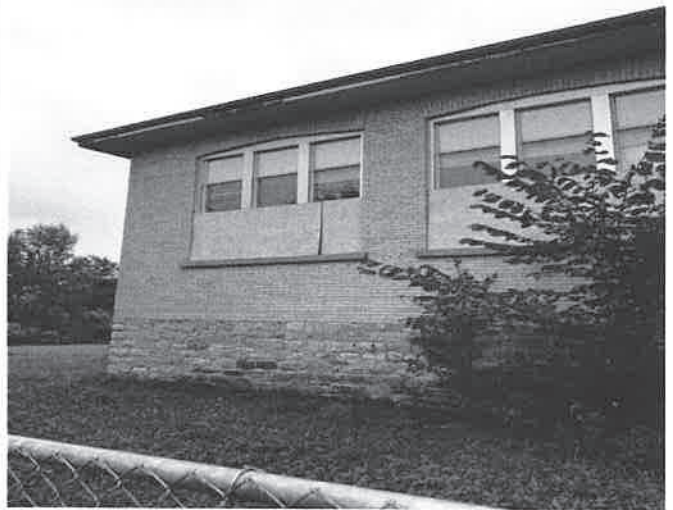
Photo 012

The exterior walls of the building were constructed with load bearing brick masonry units. The brick masonry walls are supported on the top of the exterior limestone foundation walls and extend to the underside of the wood trusses and rafters (Photo 012). There are window and door penetrations located around the perimeter of the building. The openings have been framed with arched soldier coursed headers approximately two (2) brick units deep and precast concrete sills (Photo 013, 014).

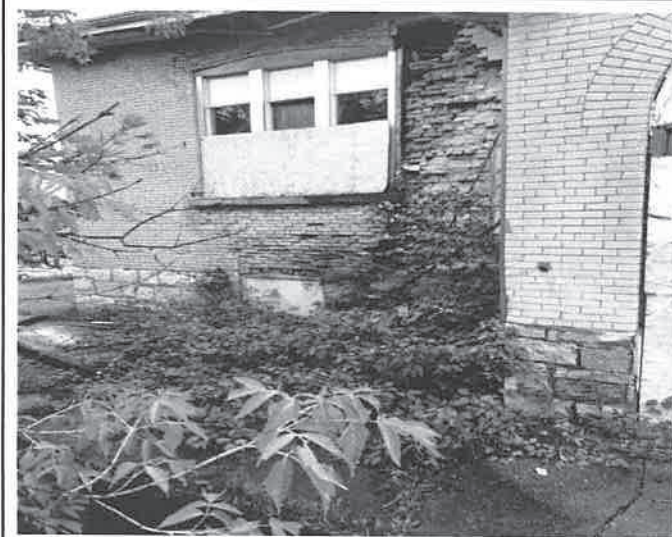
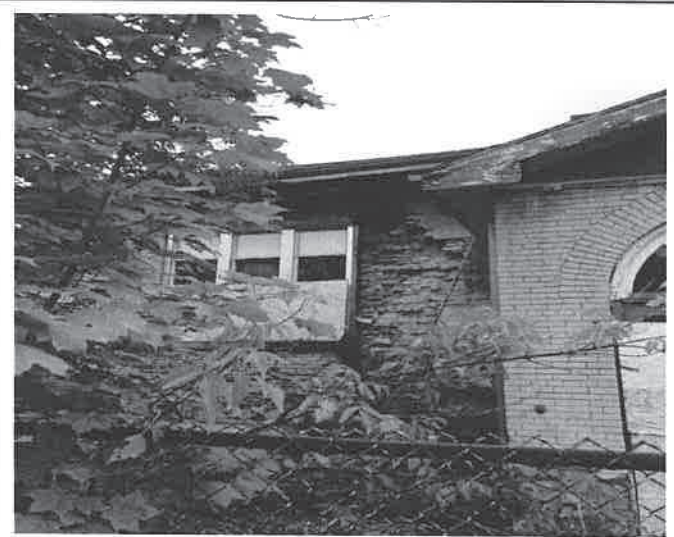
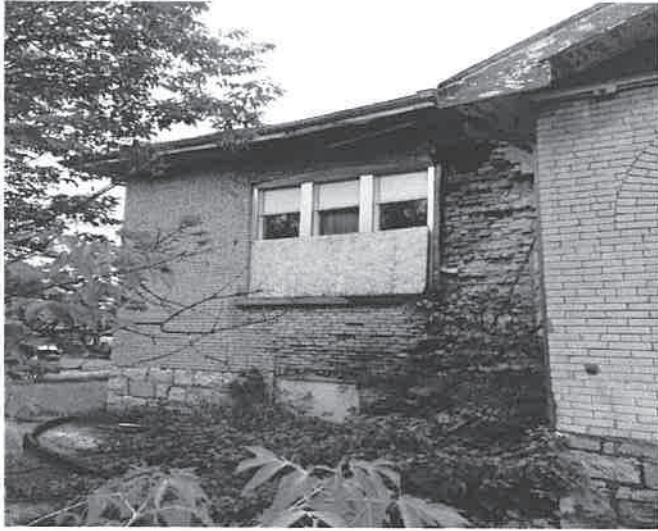
The brick masonry units consist of beige bricks which are stacked approximately three (3) wythes thick where visually accessible. The brick wall had fully failed around the north west corner of the building where the roof framing had deflected and created valleys referenced above (Photo 015, 016, 017).

3. Complete additional shoring as necessary to accommodate further identified areas of structure distress inside the building.
4. Repair the perimeter load bearing brick masonry walls. This work will involve extensive reconstruction of the original three (3) wythe brick masonry walls. We estimate that 30% of the existing walls will need to be reconstructed.

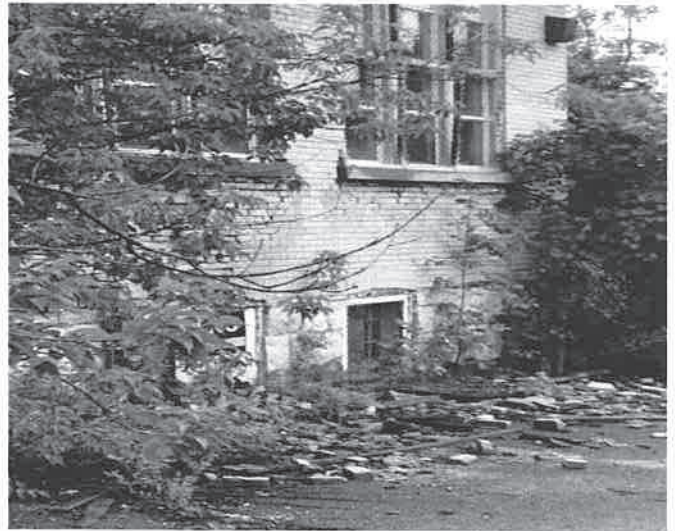
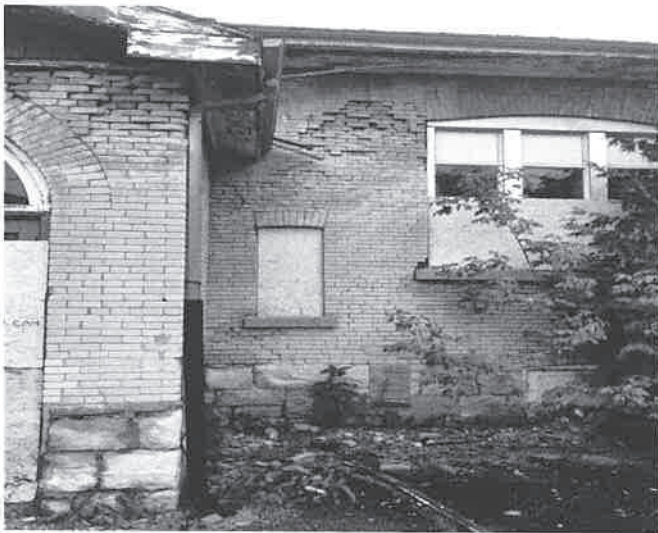
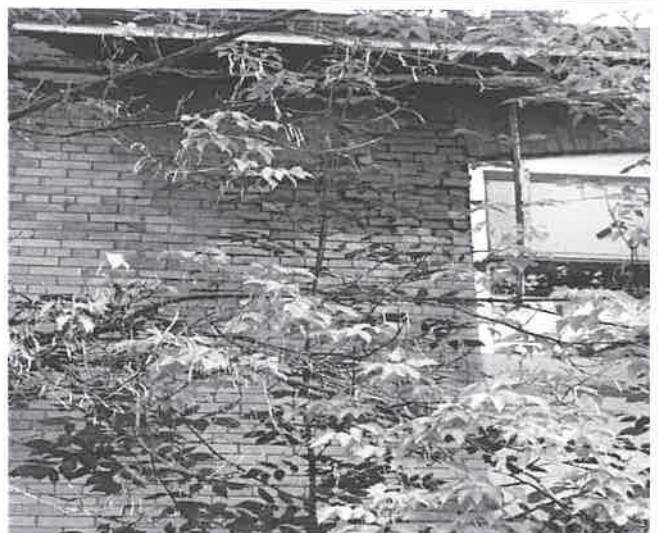
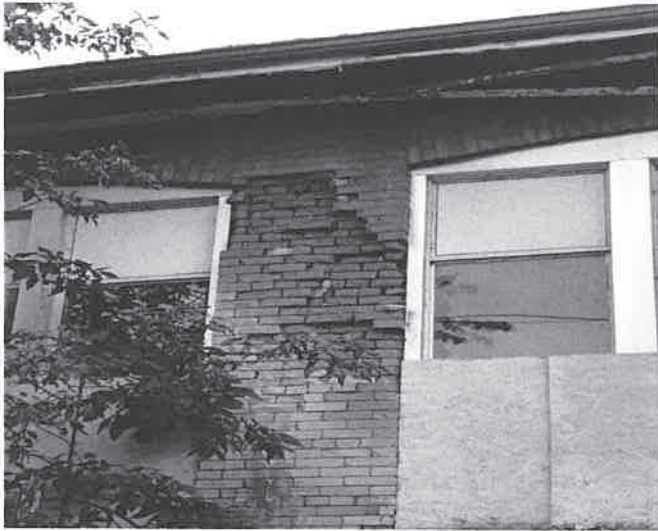
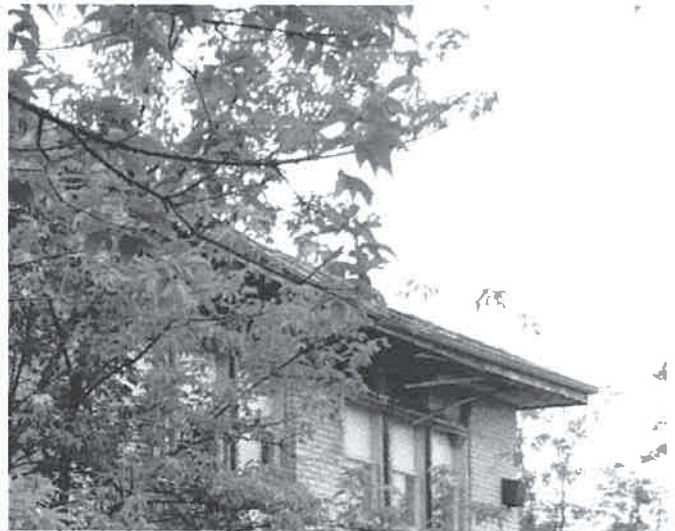
There were localized pockets along the exterior wall where the entire outside wythe of brick had no mortar between the joints and the wall had locally failed or excessively deflected. The remaining bricks in these areas were loose along the exterior facade and had started falling to the ground in many locations (Photo 018, 019, 020, 021, and 022). These pockets of deteriorated brick appeared common at areas where the walls are likely subject to prolonged moisture due to adjacent valleys in the roof profiles and concentrated lateral loading from applied wind pressures on window lintels or sills.

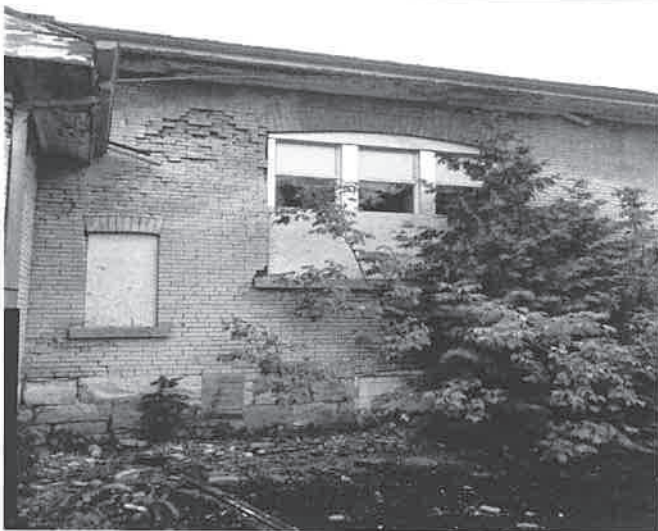
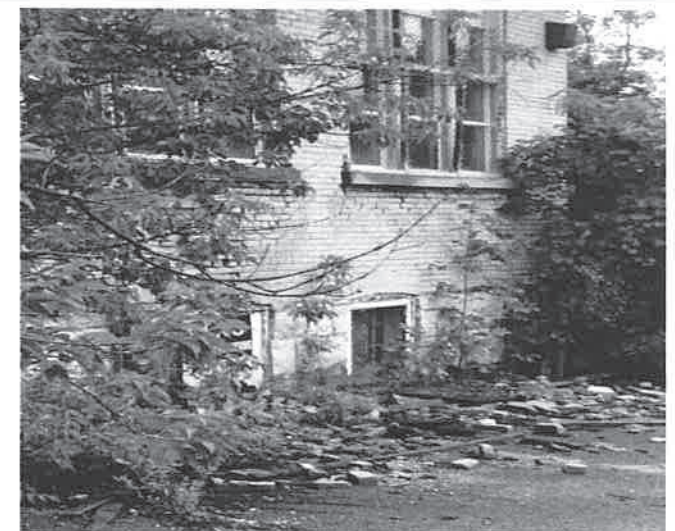
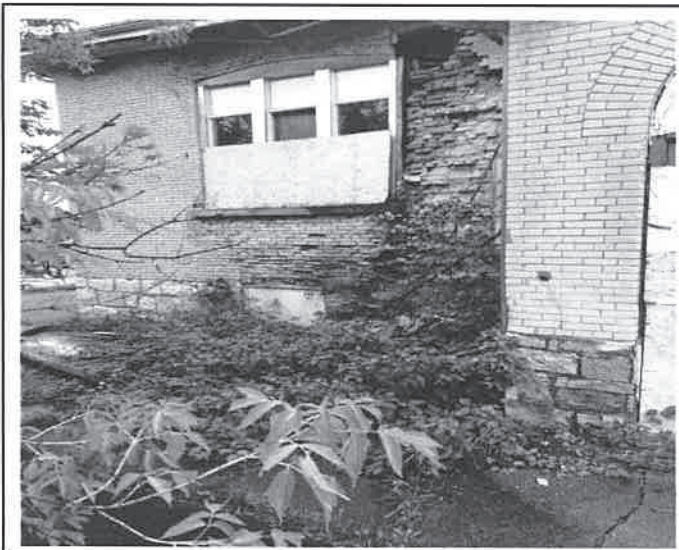
Where the brick was in poor condition, the interior of the building was fully exposed to the exterior elements and likely accessible to local wildlife. There was an accumulation of rubble on the ground indicating that the walls are actively deteriorating (Photos 023, 024, 025).

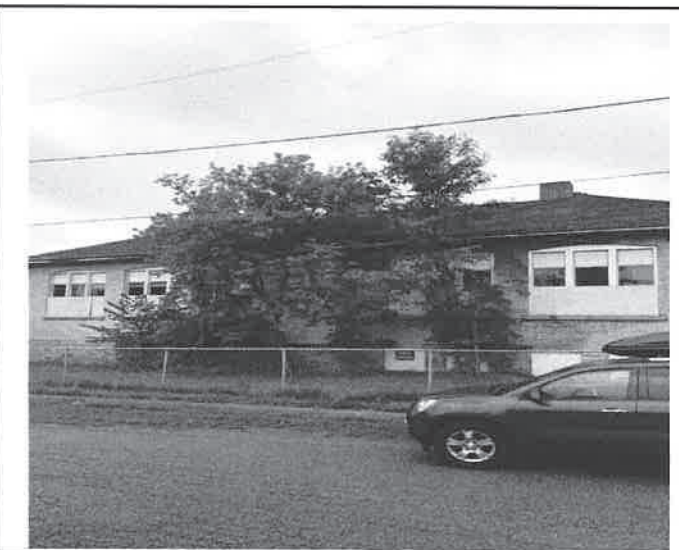
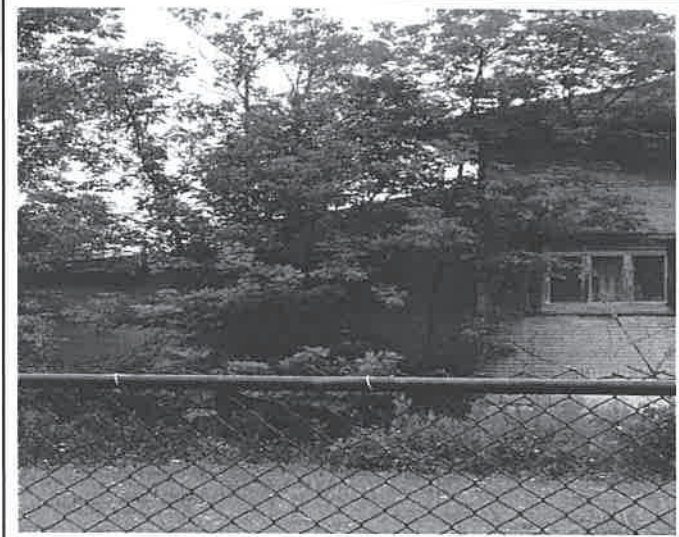
There was excessive overgrown vegetation around the exterior of the building (Photo 026, 027).
