Bobcaygeon Composite Elevated Tank
Remotely Operated Vehicle Inspection and Report
July 16, 2018

Remote Inspection & Report - Bobcaygeon Composite Elevated Tank

# COMPOSITE ELEVATED TANK INSPECTION REPORT

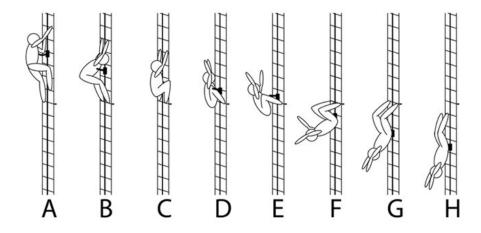
Figure 1: How the water tower worker fell

- A. The worker is descending properly using the fall protection system.
- B. The worker bends at the waist.
- C. The worker's legs fold into a squat position while the worker's hands catch the next rung. The squat position allows the trolley to travel below the height of the worker's knees.

- D. As the worker begins to roll backward their hands release from rung, and the tension in the trolley connection increases enough to remove all the slack out of the full body harness and slide the chest D-ring towards the waist.

- E. This tension in the connection to the trolley forces the worker into a tight squatting position while rotating around the rung that the worker's feet are on

- F. The trolley connection remains in tension as the trolley travels below the rung that the worker's feet are on.
- G. The connection to the trolley, now in tension between the worker's legs prevents the engagement of the braking mechanism that would stop the workers motion

- H. The worker, with back to the ladder, continues to fall head first while still attached to the fall protection system.
