**FACILITY CONDITION ASSESSMENT
MARIPOSA COMMUNITY HALL
1010 ELDON ROAD, OAKWOOD, ONTARIO
Job No: 20130. 101037.000**

Prepared for:
THE CITY OF KAWARTHA LAKES

Prepared by:
ALTUS GROUP LIMITED

Issued: **April 19, 2016**

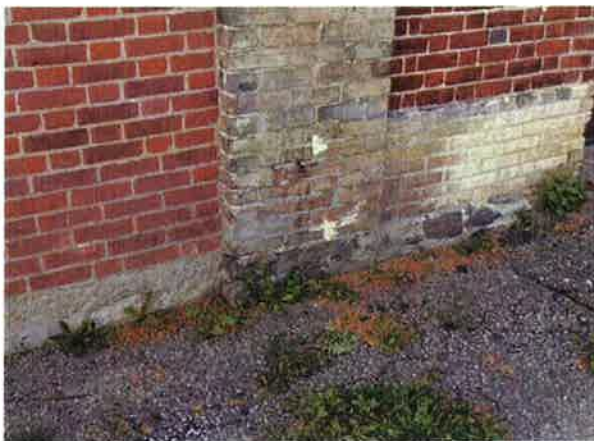
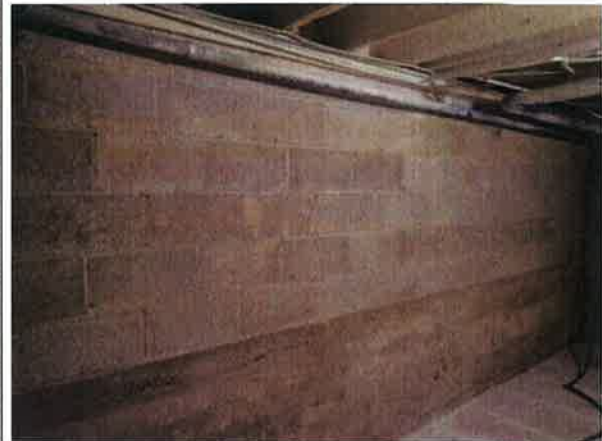
The foundation walls consist of concrete masonry and are visible at a few locations at grade level and in the basement around the building perimeter. The footings are not visible as they are concealed below grade level. As is typical, a number of minor shrinkage cracks (less than 1/16th of an inch) were noted in the poured concrete foundations at various locations. The footings are not visible as they are concealed below grade level. No significant signs of deterioration were present. No issues were reported by the Site Representative. Based on a normal life span for this component replacement is not anticipated during the study period. Minor repairs in the interim are considered under operations and maintenance.

<p>Poured concrete foundation walls</p>	<p>Poured concrete foundation walls</p>

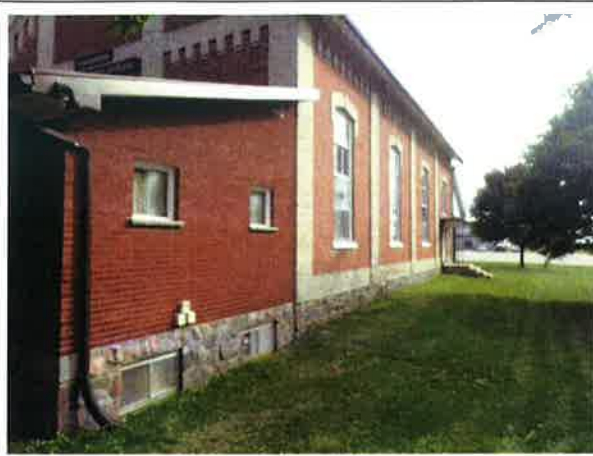
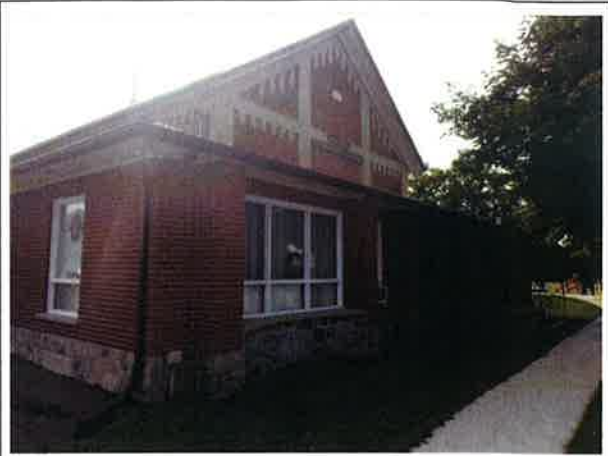
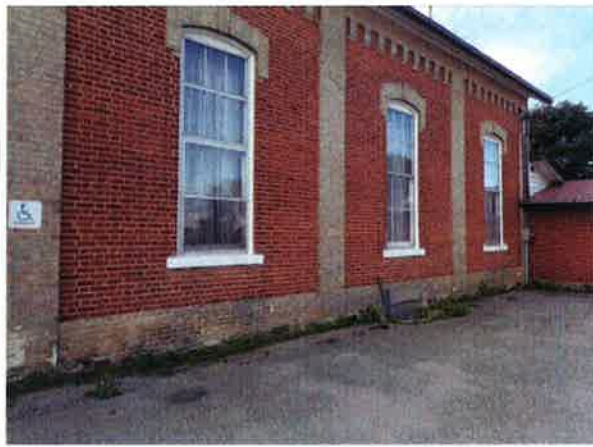
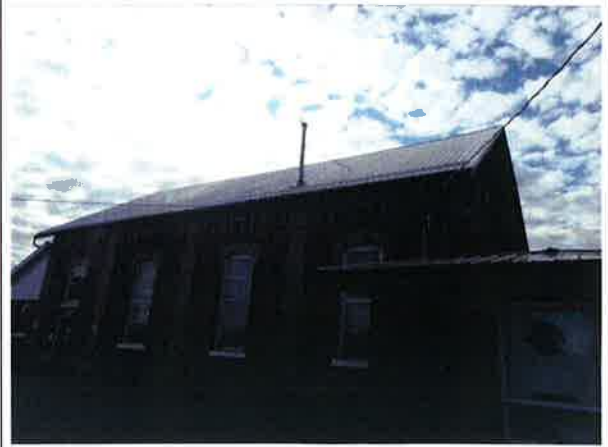
The exterior walls are brick masonry cladding. Overall, the component is in good condition. Based on the normal life span of this component, repairs are anticipated during the study period. This can be completed under normal operation and maintenance.

Exterior cladding

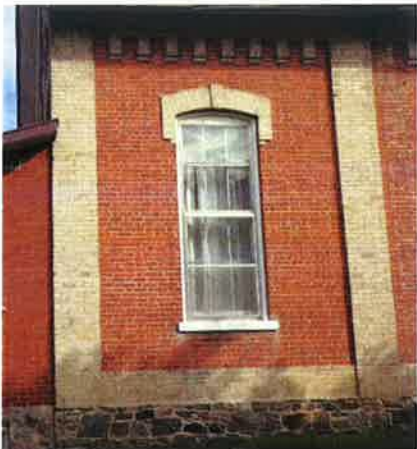
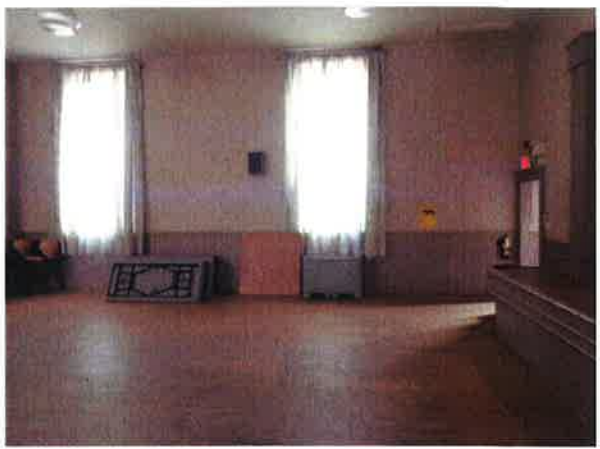
The building features double-glazed anodized aluminum insulated glass units (IGU) in fixed refurbished wooden frames. The windows are in good condition. Based on the normal life span of this component, replacement is not anticipated during the study period. Minor repairs, if any, are considered under normal operation and maintenance.

Typical window unit	Typical window unit

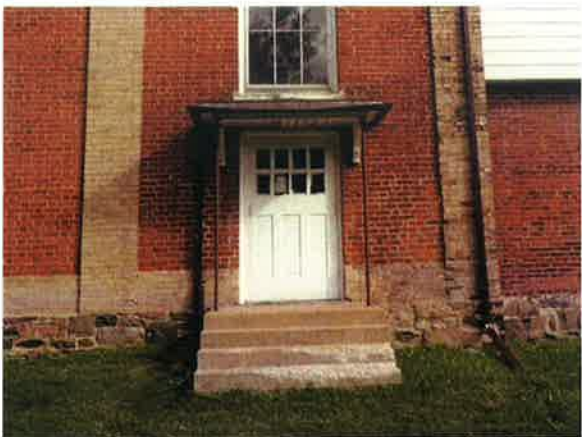
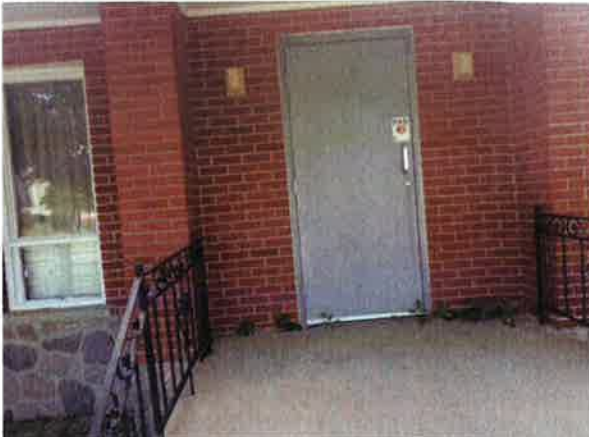
Exterior doors at the facility are a combination of wood with glass inserts in wooden frames and metal service doors in metal frames. No significant signs of deterioration were present during the site visit. No issues were reported by the Site Representative. Doors can be replaced on an as needed basis at a cost below the threshold limit.

Exterior door	Exterior door

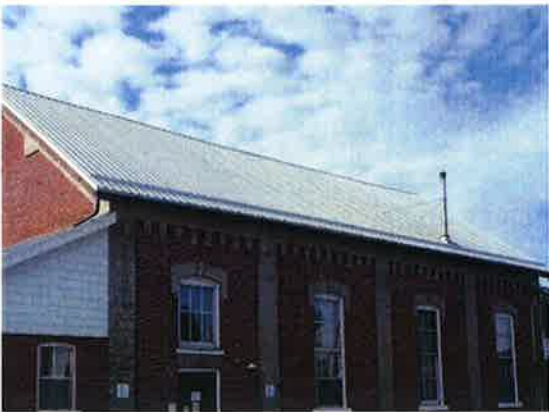
The roof is sloped with a corrugated sheet metal finish. The roof is in good condition and according to the Site Representative the roof has been replaced in the last five years. No significant signs of deterioration were present during the site visit. No issues were reported by the Site Representative. Based on the normal life span of this component, replacement is not anticipated during the study period. Minor repairs, if any, are considered under normal operation and maintenance.

Overview of sloped roof	Overview of sloped roof

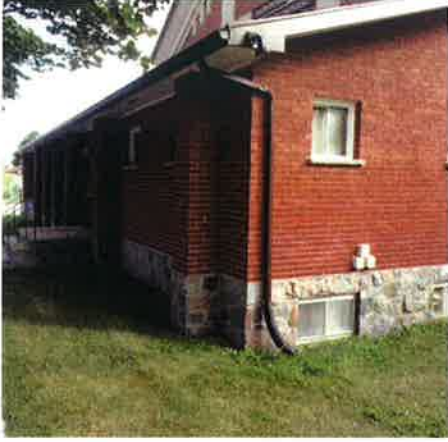
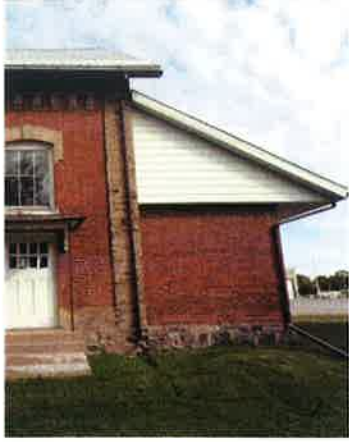
The roofs drain into prefinished aluminum eavestroughs and downspouts which discharge on grade. There were no reported problems with the drainage system. No significant signs of deterioration were present during the site visits. No issues were reported by the Site Representative. Based on the normal life span of this component, repair and replacement is anticipated during the study period. This is considered under normal operation and maintenance.

Prefinished aluminum eavestroughs and downspouts	Prefinished aluminum eavestroughs and downspouts

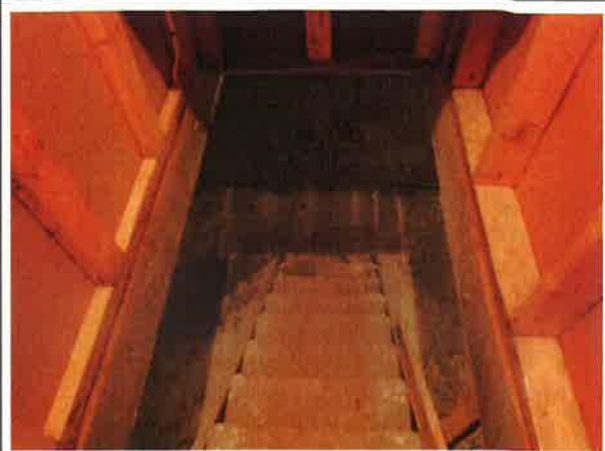
There is a wood staircase leading to the basement. No significant signs of deterioration were present during the site visit. No issues were reported by the Site Representative. Based on the normal life span of the component, replacement is not anticipated during the study period. Minor repairs, if any, can be completed under normal operation and maintenance.

Wood stairs

There are no handrails or guardrails at the stairs leading to the basement. We recommend installing handrails at the stairs. Installation of the handrails can be completed at a cost below the threshold limit.

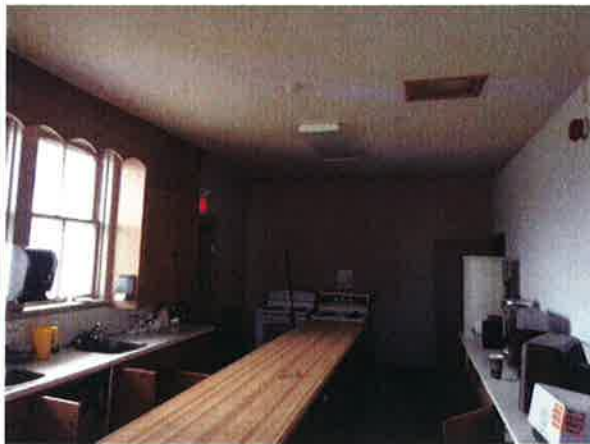
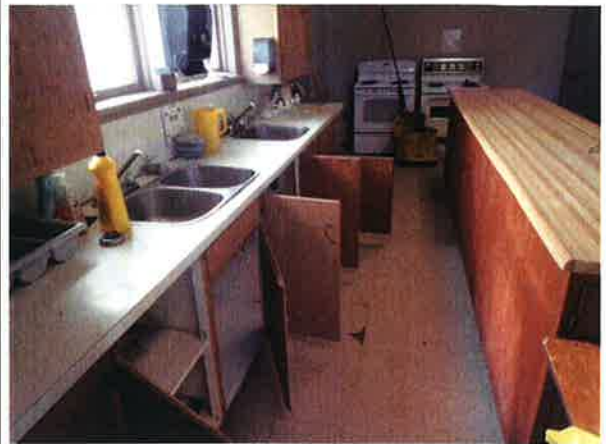
The kitchen has laminated countertops, pressboard cupboards and stainless steel sinks. No significant signs of deterioration were present during the site visit. No issues were reported by the Site Representative. Based on the normal life span of the component, replacement is anticipated during the study period. We have included an allowance to refurbish the kitchen.

Kitchen finishes

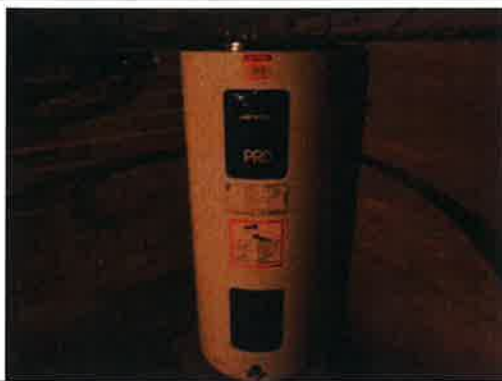
There is an electrical “John Wood” hot water storage tank in the basement with a storage capacity of 184 Litres. According to the technical data tag, the equipment was manufactured in 2005. Based on the normal life span of the component, replacement is anticipated during the study period. We have included an allowance to replace the hot water storage tank.

Hot water storage tank

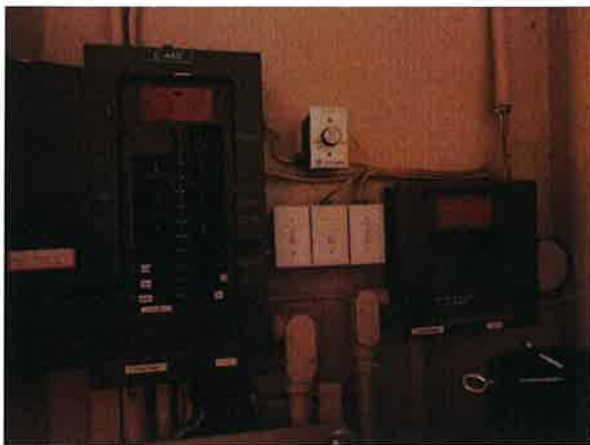
The incoming electrical service enters the building at basement where the electrical equipment is located. There are four (4) "Taylor Electric" and "Federal Pioneer" electrical panels of various age and condition. There are two disconnects and two splitters rated at 600 Volts. No significant signs of deterioration were present during the site visit. No issues were reported by the Site Represented. Based on the normal life span of this component, replacement is anticipated during the study period. We have included an allowance for replacement.

General housekeeping issues were noted including the removal of storage items near electrical systems, removal of abandoned equipment and/or the provision of general labeling/identification. This is considered under normal operations and maintenance as below the threshold limit.

Electrical service

It is recommended that infrared thermography or arc flash studies be performed to look for "hot spots" and other deficiencies in the electrical equipment. Surveying of electrical equipment should be carried out regularly on an annual basis. This is considered under normal operations and maintenance and is below the threshold limit.
