Committee of the Whole Report

Report Number: ENG2024-006
Meeting Date: March 5, 2024
Title: Drainage Near 149 Fenelon Drive
Description: Drainage review
Author and Title: Juan Rojas, Director of Engineering and Corporate Assets

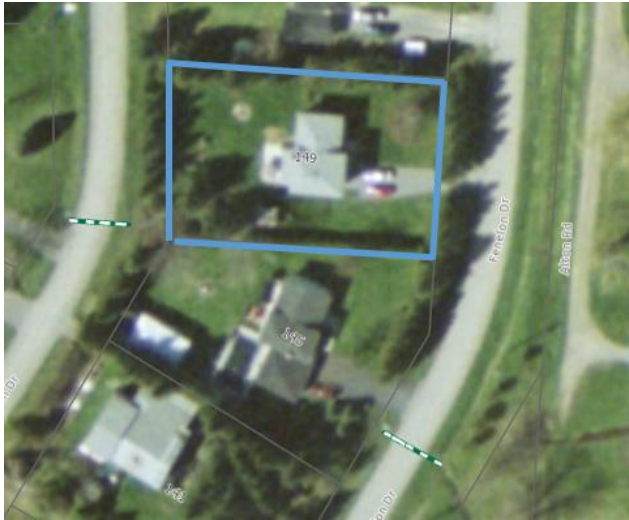
149 Fenelon Dr. – Aerial 2004

The exact construction date of the garage is unknown, however the record aerial photos below from 2004 shows no garage and the 2018 aerial photo shows a constructed garage with a widened driveway.

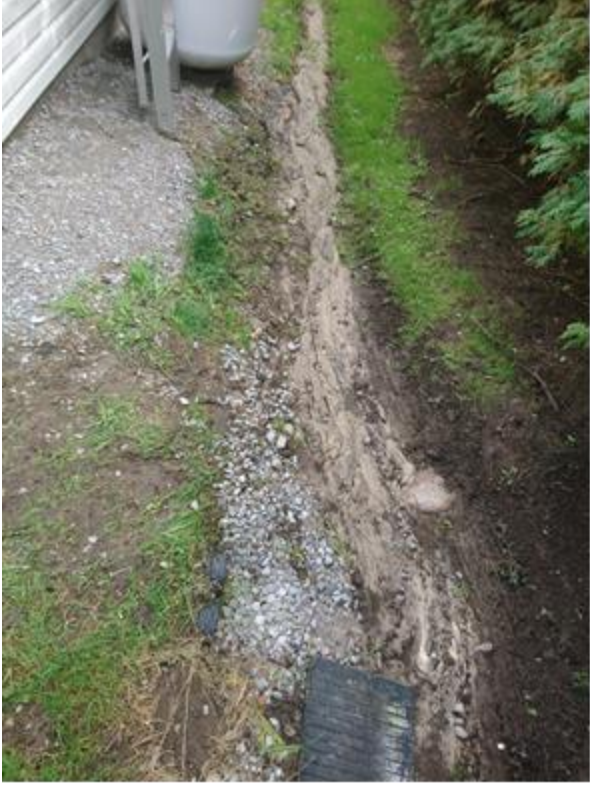
The Drainage system is working, as designed, with no staff concerns and no flooding issues. The existing cross culverts are located at the low point of the municipal roads.

Swale on 149 Fenelon Drive

It is recommended to continue with the existing drainage pattern as designed and approved.

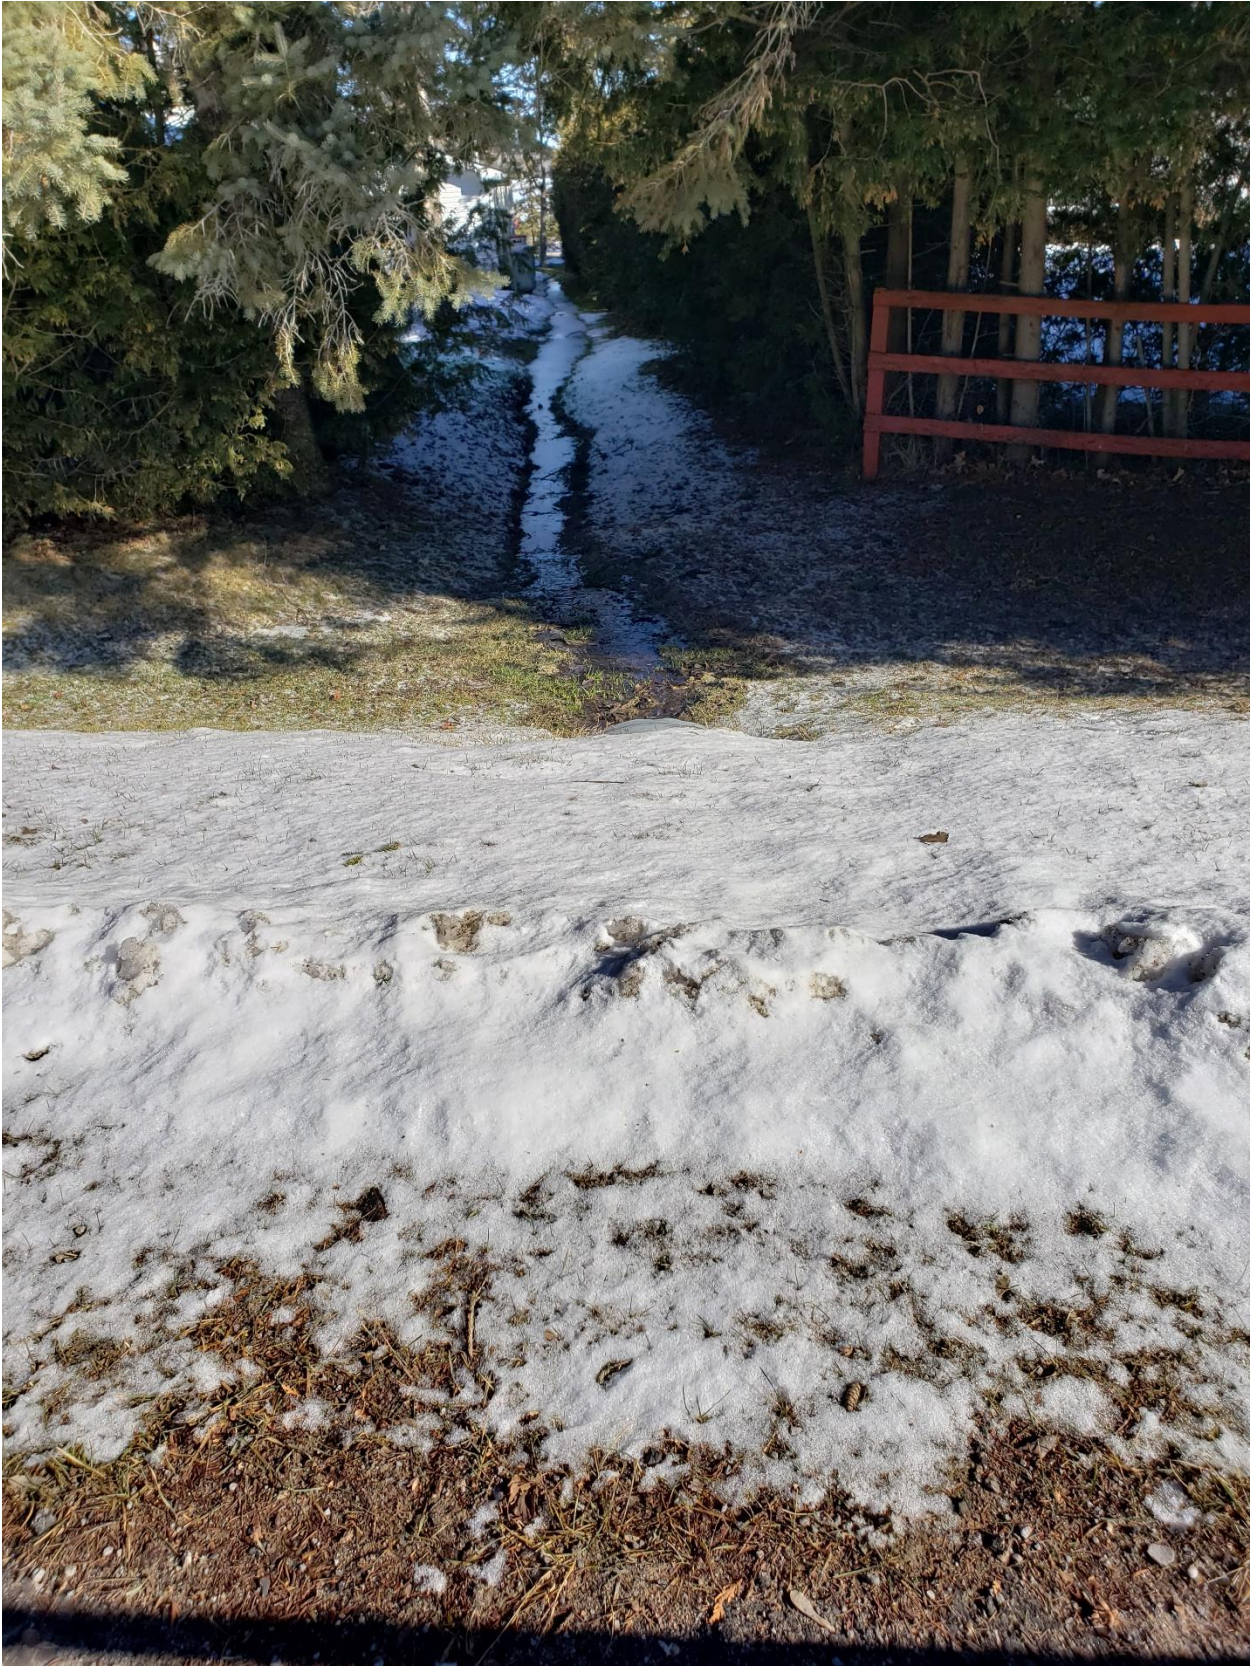
Another view of swale on 149 Fenelon Dr.

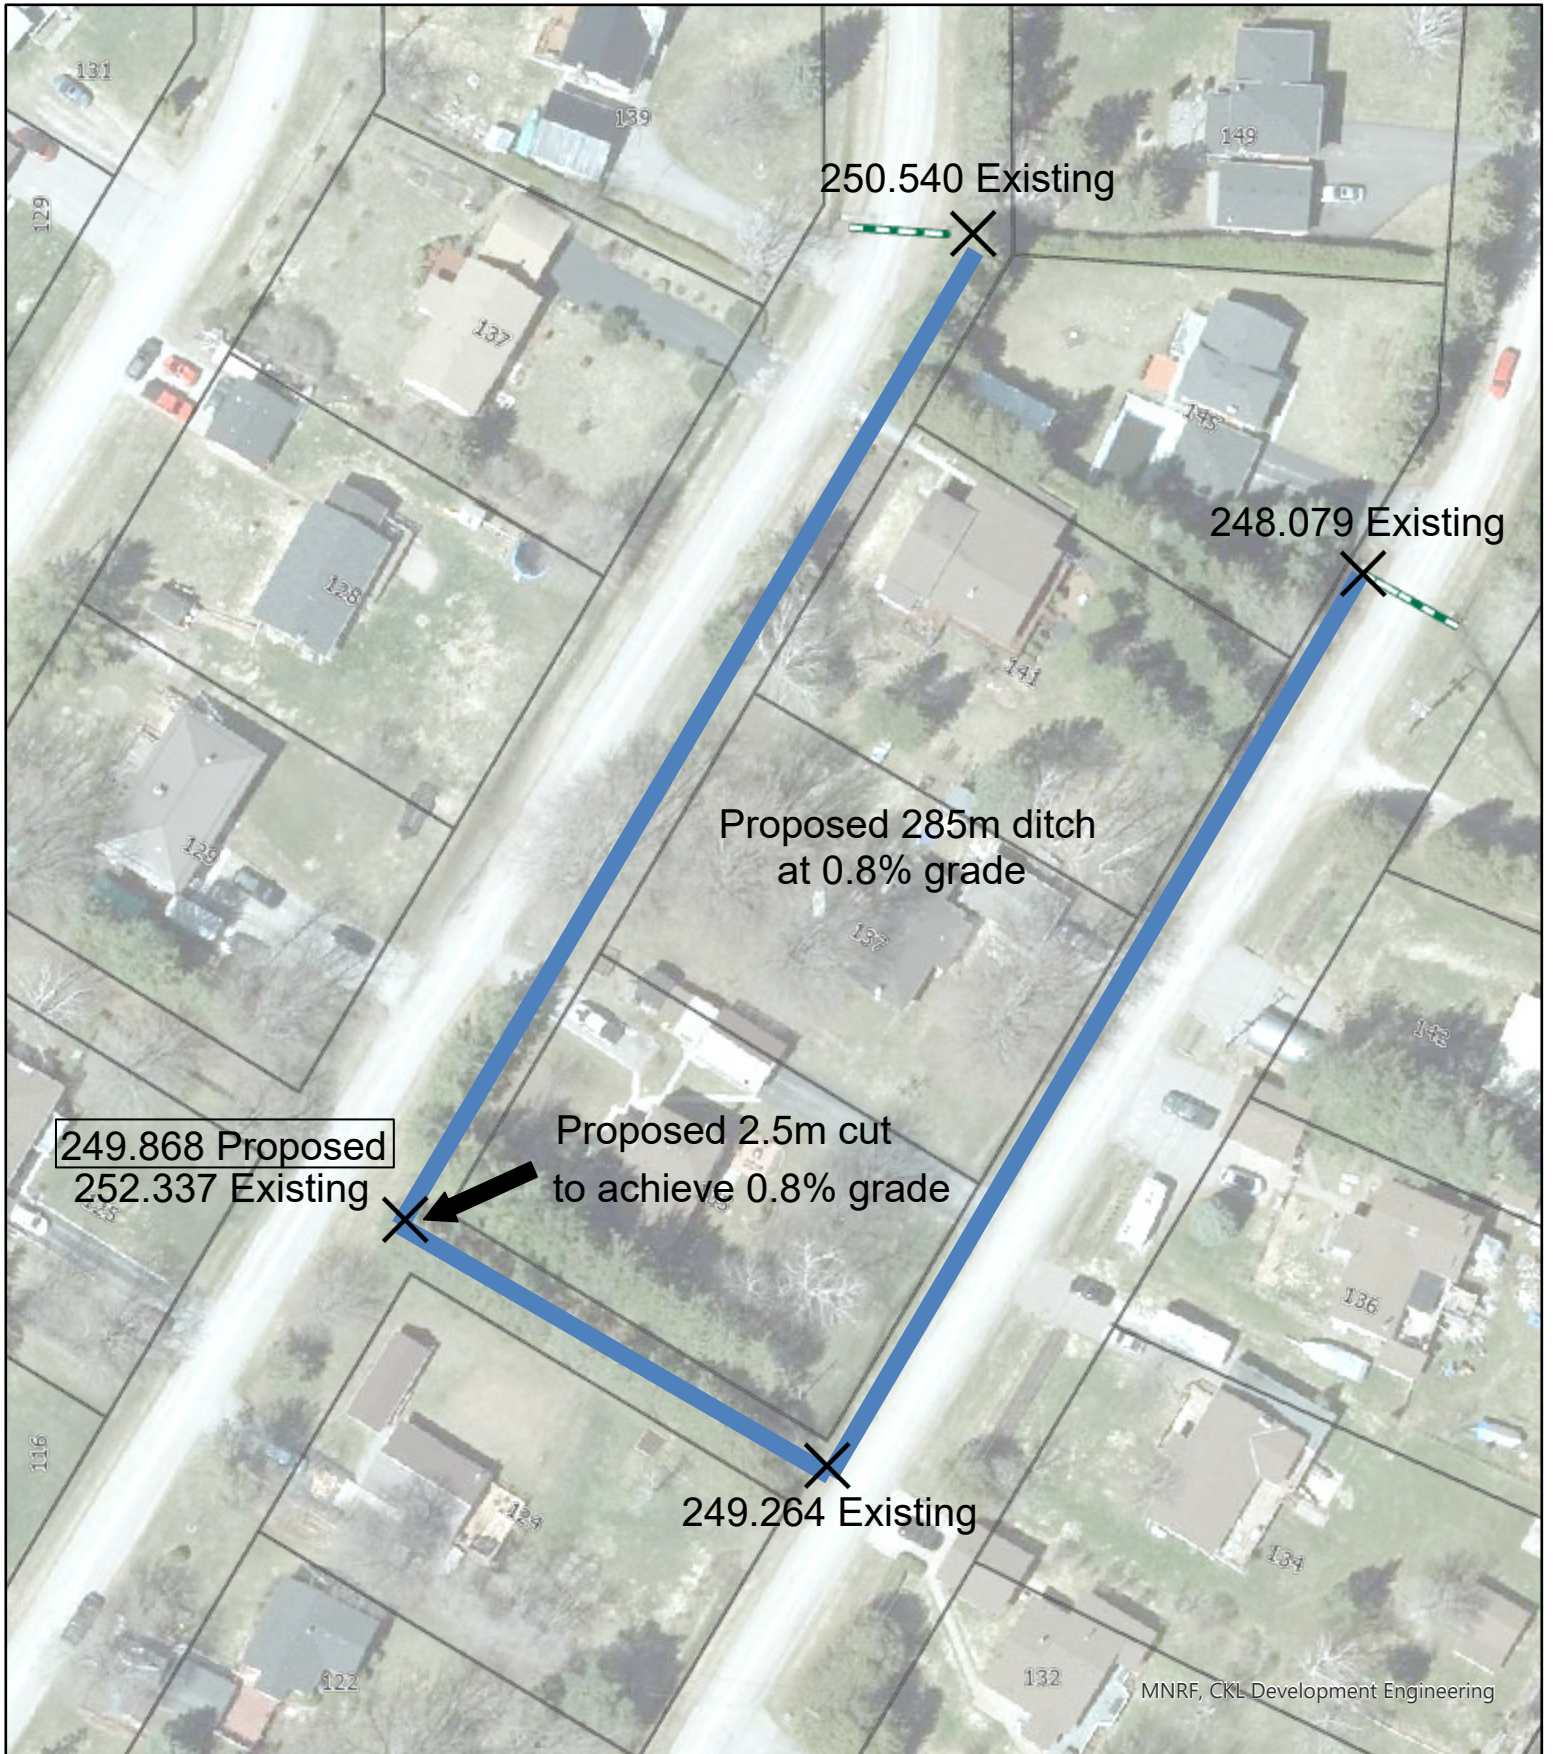
Southview Estates - Scenario 1

In order to re-ditch from the outlet of the cross culvert at Cameron Drive and drain to the south to the walkway at an 0.8% grade, a 2.5m cut would be required at the start of the walkway block.

Existing grade at walkway block is 252.337, required grade to provide positive drainage would be 249.868, thus a difference of 2.469m

This is not practical, as it would adversely impact the municipal road right of way, the existing homes along the road section and the pedestrian walkway.

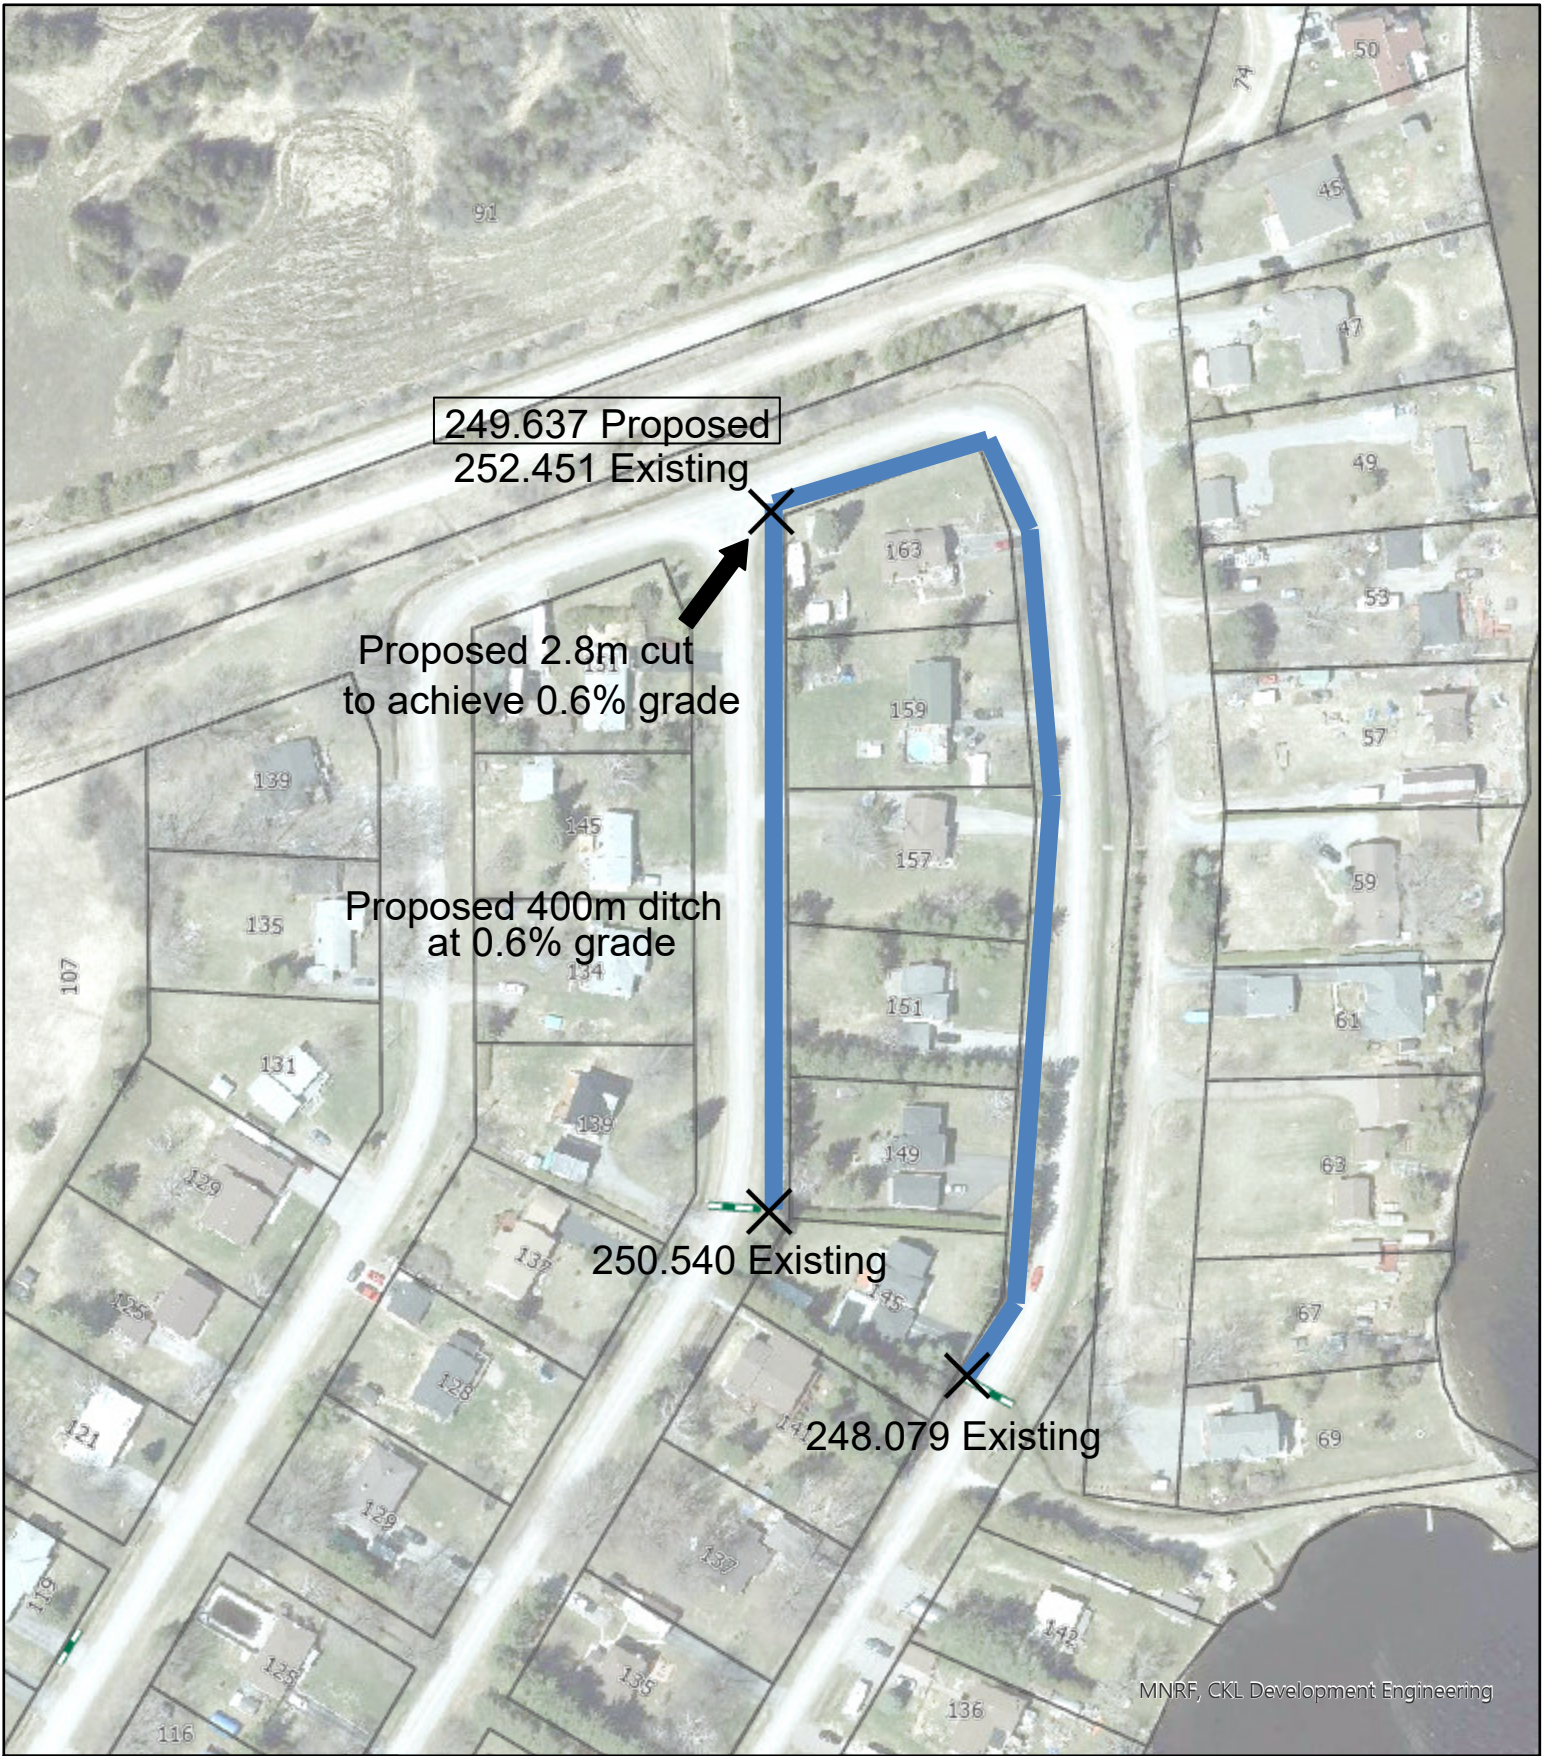
Southview Estates - Scenario 2

In order to re-ditch from the outlet of the cross culvert at Cameron Drive and drain to the north to the intersection of Cameron Drive and Fenelon Drive at an 0.6% grade, a 2.8m cut would be required at the intersection.

Existing grade at southeast corner of intersection is 252.451, required grade to provide positive drainage would be 249.637, thus a difference of 2.814m

This is not practical, as it would adversely impact the municipal road right of way and the existing homes along the road section.
