Committee of the Whole Report

Committee of the Whole Report	
Report Number:	ENG2024-006
Meeting Date:	March 5, 2024
Title:	Drainage Near 149 Fenelon Drive
Description:	Drainage review
Author and Title:	Juan Rojas, Director of Engineering and Corporate Assets
Recommendation	n(s):
That Report ENG2024	-006, Drainage Near 149 Fenelon Drive , be received; and
That this recommendate Regular Council Meeting	ation be brought forward to Council for consideration at the nex ng.
Department Head: _	
Financial/Legal/HR	/Other:
Chief Administrative	e Officer:

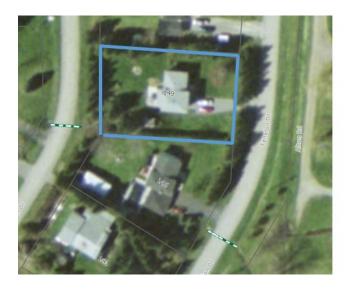
149 Fenelon Dr. - Aerial 2004

The exact construction date of the garage is unknown, however the record aerial photos below from 2004 shows no garage and the 2018 aerial photo shows a constructed garage with a widened driveway.

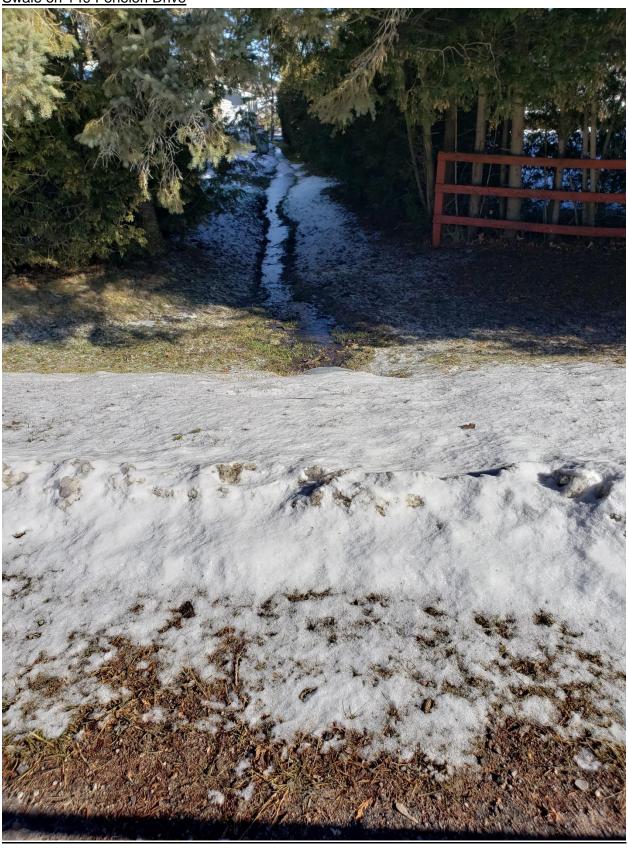
The Drainage system is working, as designed, with no staff concerns and no flooding issues. The existing cross culverts are located at the low point of the municipal roads.

Swale on 149 Fenelon Drive

It is recommended to continue with the existing drainage pattern as designed and approved.

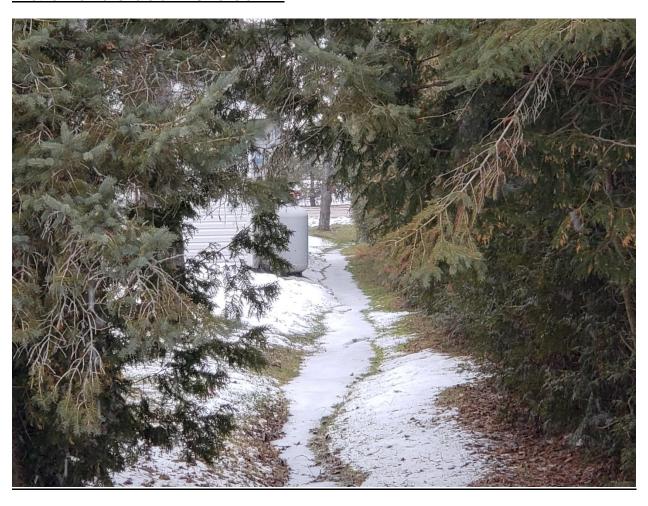
Another view of swale on 149 Fenelon Dr.

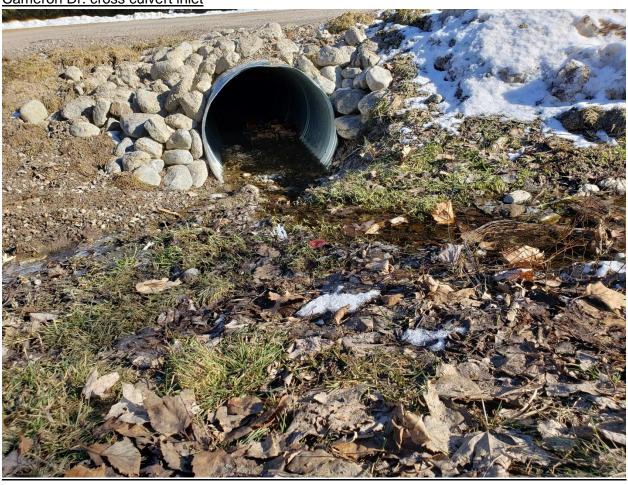
In late 2023, Public Works department placed Rip-Rap at the inlet (upstream) of the Cross Culvert. Picture of the culvert and rip-rap can be seen in Appendix C, 3rd picture.

Cameron Dr. cross culvert inlet

It is recommended to also Rip-Rap the outlet of the culvert from end of culvert to property line along the invert of the ditch, within the road right of way. This will help in maximizing the energy displacement during large storm events.

Engineering will coordinate with Public Works to have this implemented in the Spring/Summer of 2024.

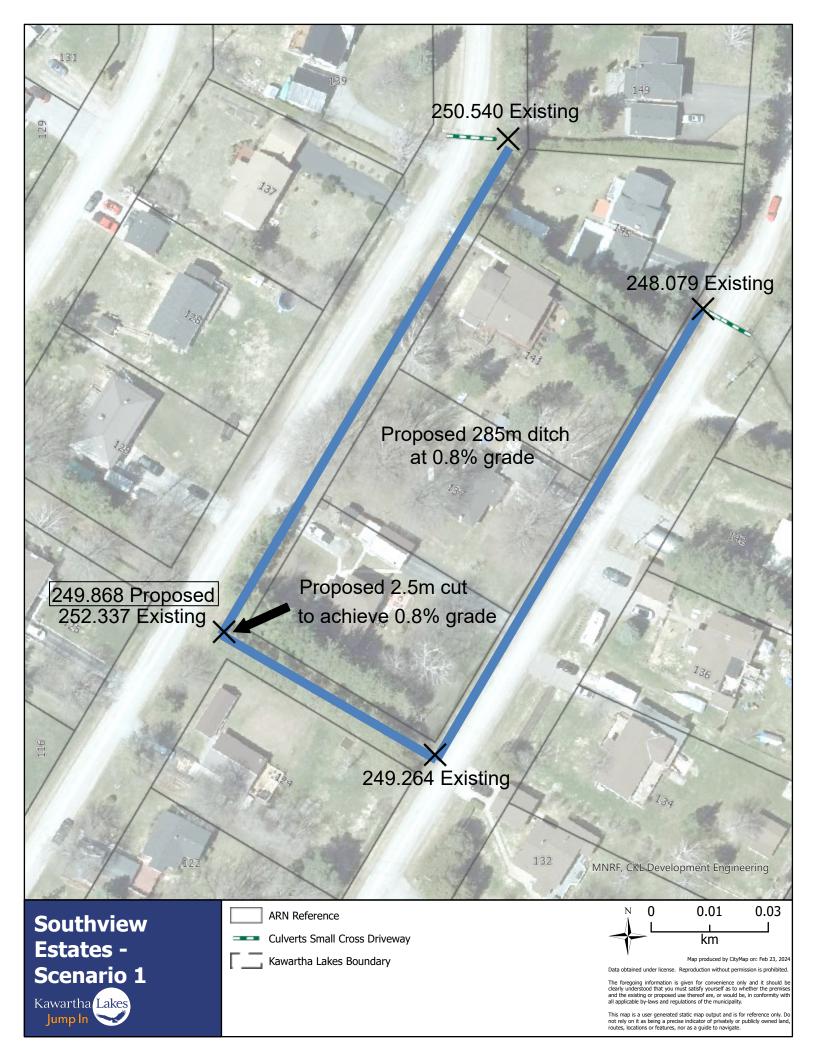
Scenario 1 – re-ditching to the south

In order to re-ditch from the outlet of the cross culvert at Cameron Drive and drain to the south to the walkway at an 0.8% grade, a 2.5m cut would be required at the start of the walkway block.

Existing grade at walkway block is 252.337, required grade to provide positive drainage would be 249.868, thus a difference of 2.469m

This is not practical, as it would adversely impact the municipal road right of way, the existing homes along the road section and the pedestrian walkway.

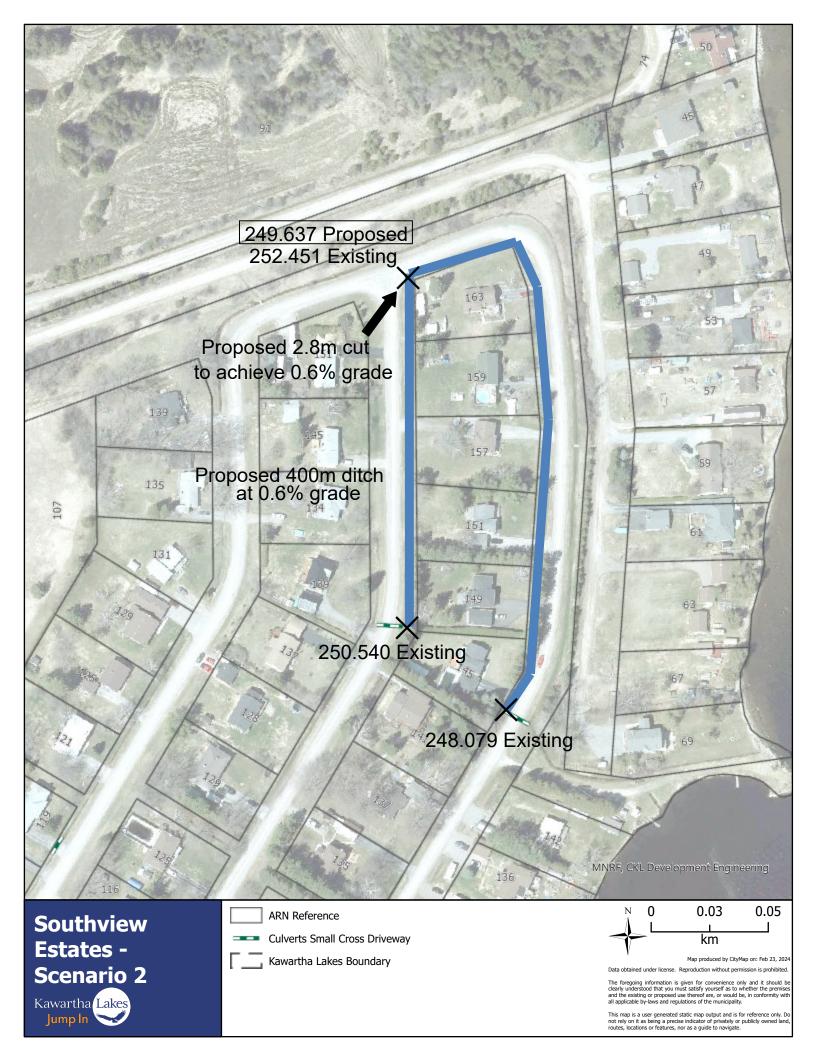
Scenario 2 – re-ditching to the north

In order to re-ditch from the outlet of the cross culvert at Cameron Drive and drain to the north to the intersection of Cameron Drive and Fenelon Drive at an 0.6% grade, a 2.8m cut would be required at the intersection.

Existing grade at southeast corner of intersection is 252.451, required grade to provide positive drainage would be 249.637, thus a difference of 2.814m

This is not practical, as it would adversely impact the municipal road right of way and the existing homes along the road section.
