**FACILITY CONDITION ASSESSMENT
HARTLEY ROAD OPERATIONS DEPOT
574 HARTLEY ROAD, WOODVILLE, ONTARIO
Job No: 20130.101037.000**

Prepared for:
THE CITY OF KAWARTHA LAKES

Prepared by:
ALTUS GROUP LIMITED

Issued: **January 22, 2016**

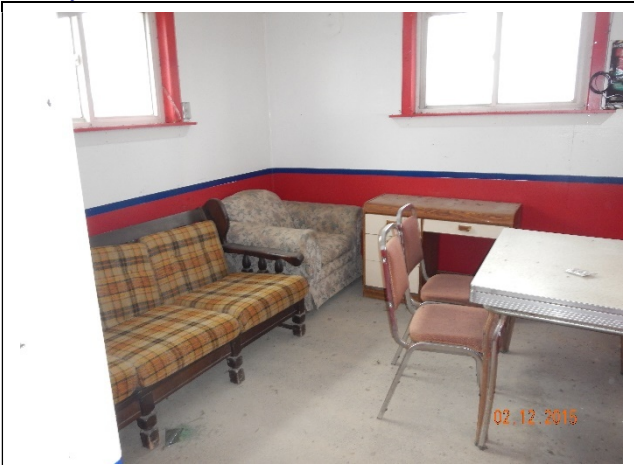
The visible areas of the slab on grade foundation were found to be in fair condition with only minimal shrinkage cracks. Cracking in slab on grade may be due to long-term dry shrinkage over the early life of the building, the nature of the granular base, the type of soils or loading conditions, the manner in which it was installed or reinforced if at all or the location of the control joint grid pattern. The component is not anticipated for repair or replacement during the study period.

View of slab on grade floor

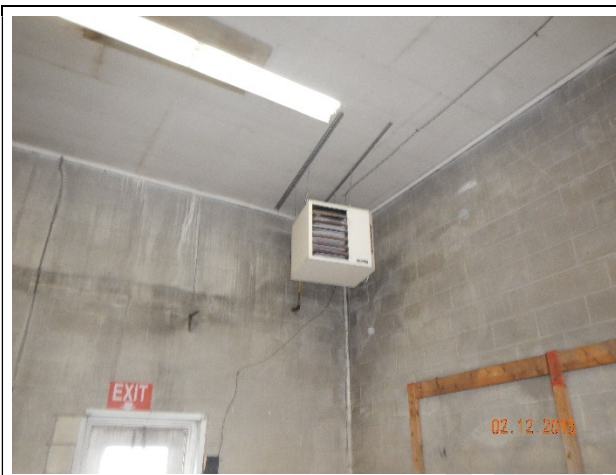
Interior concrete block walls

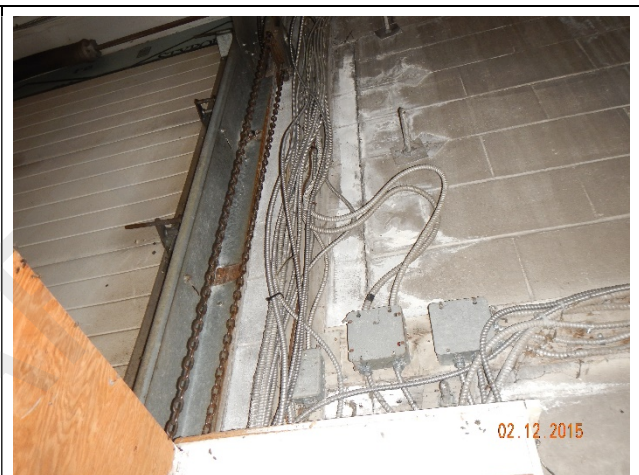
Interior concrete block wall

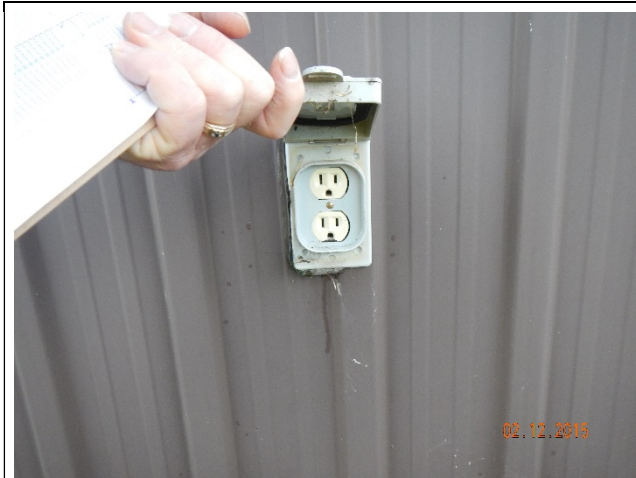
The exterior cladding is prefinished sheet-metal cladding. The prefinished metal cladding is generally in good condition. No significant signs of deterioration were present. No issues were reported by the site representative. This item is not anticipated for repairs or replacement during the study period. Minor repairs if any are considered under normal operations and maintenance.

Exterior vertical prefinished metal cladding

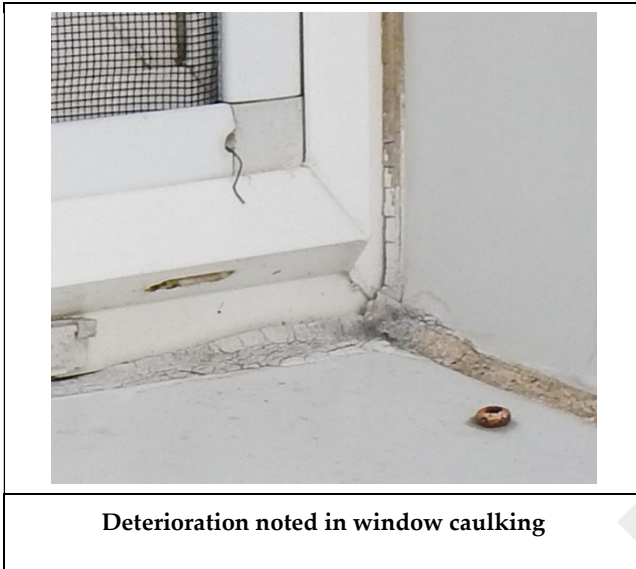
The sealants at the building joints and around the perimeter of the doors are generally in fair condition. Some small signs of deterioration were present. This item is not anticipated for repairs or replacement during the study period. Minor repairs if any are considered under normal operations and maintenance.

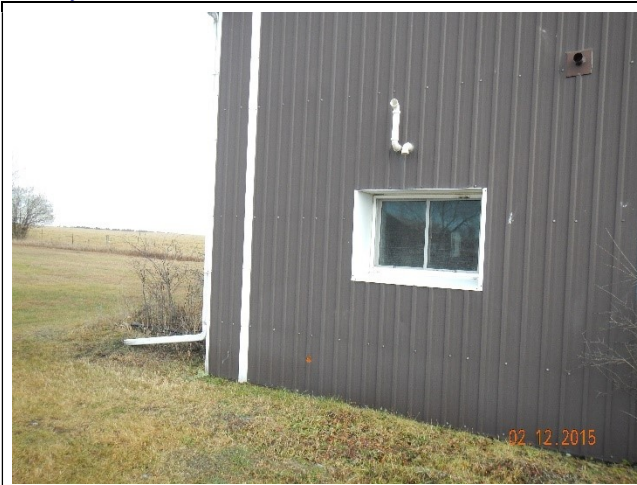
The windows consist of double glazed vinyl frame insulated glass units. The Windows are set up in a horizontal slider configuration. The Windows appeared to be in good condition with no issues or water leakage at the perimeters. Due to the small quantities of Windows at this property we assume the Windows can be replaced on an as needed at a cost below the threshold of this report.

Typical window

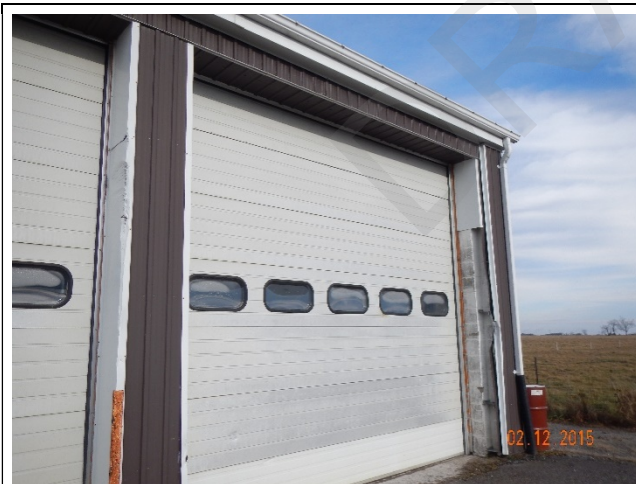
The exterior doors consist of three overhead roller doors at the front of the building with two metal service doors both having a glass panel insert. The overhead doors are manually operated. No significant signs of deterioration were present. No issues were reported by the site representative. This item is not anticipated for replacement during the study period.

Overhead roller doors

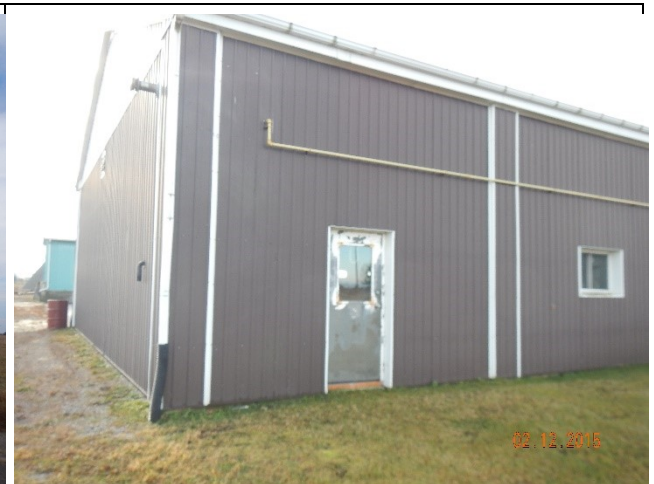
Service door

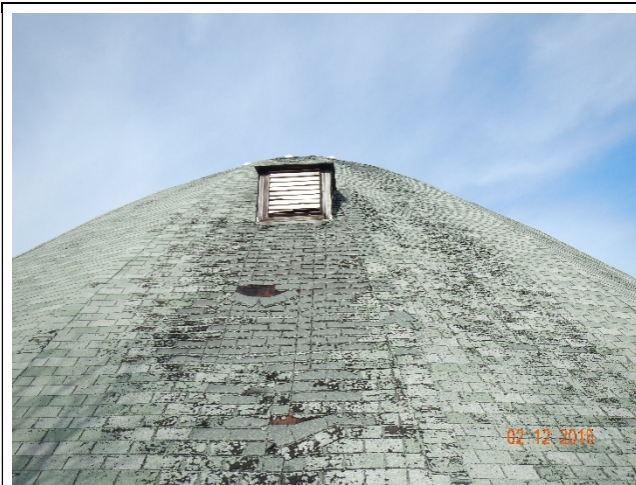
The roof on the salt dome is an asphalt multi-tab shingle type roof. This roof is in extremely poor condition and needs to be replaced immediately. This component is anticipated for repair or replacement during the study period. An allowance is carried.

Salt dome shingle damage

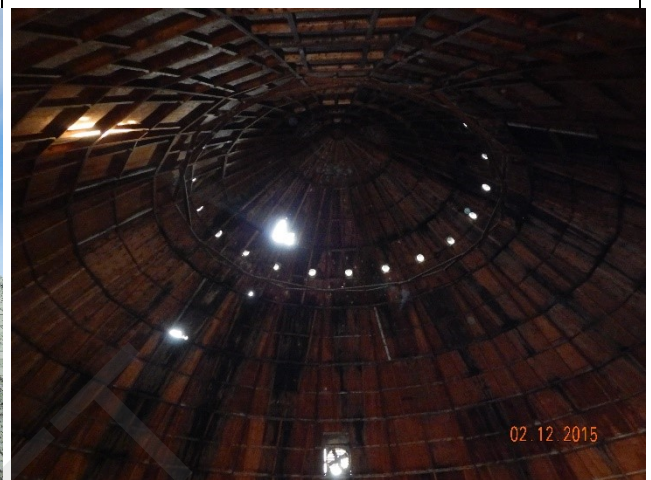
Damage inside of salt dome

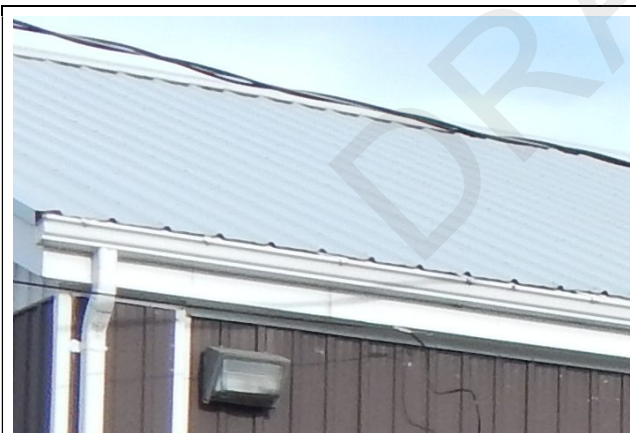
The roof is a corrugated sheet metal roof. The roof was inspected from grade level and appears to be in good condition with no issues reported by the site representative. Due to the age of the roof replacement

as it is anticipated within the term of this report. We have included a budget to replace the roof within the term of this report. An allowance is carried.

Overview of main roof

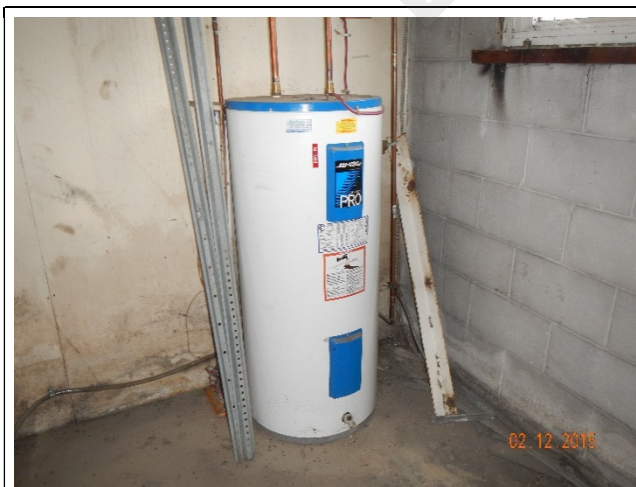
The domestic hot water for the building is generated by one "JOHN WOOD" 184L electric hot water tank. (At the time of our inspection the system was winterized). Based on our assessment and discussion with building representative, the system is working satisfactorily and no issue identified. We anticipate the system can be upgraded on an as needed basis at a cost below the threshold of this report. No allowance is carried.

Electric hot water tank

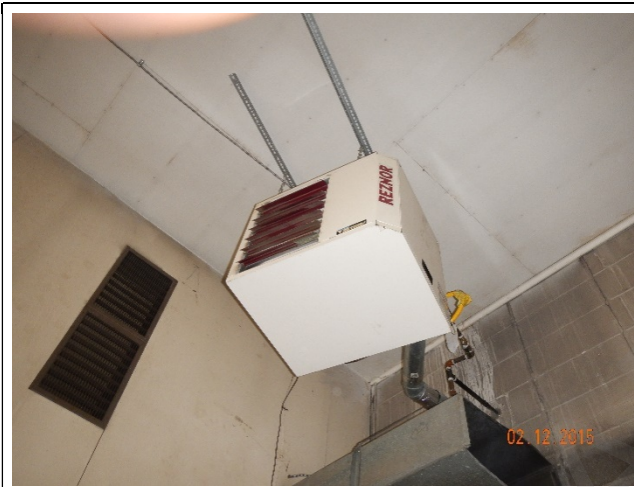
Heating for the depot area is provided by two ceiling mounted propane unit heaters. Heating for the office washroom and lunchroom area is provided by a high-efficiency propane forced air furnace. The heaters appear to be in good condition. We have included a budget to replace the unit heaters and the furnace within the term of this report. An allowance is carried.

Ceiling mounted propane heating unit

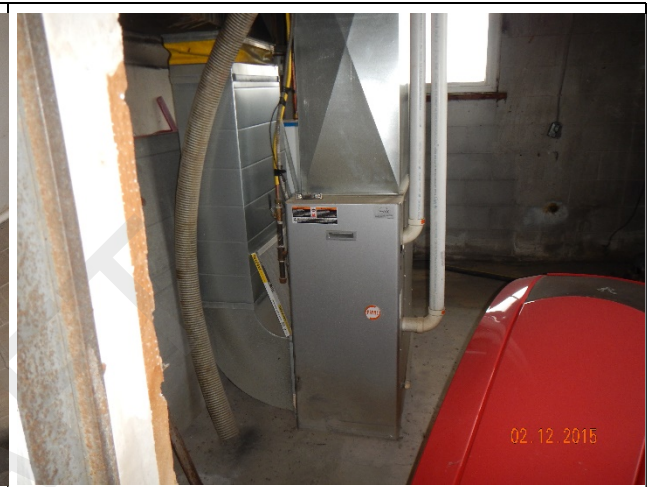
High-efficiency forced air propane furnace

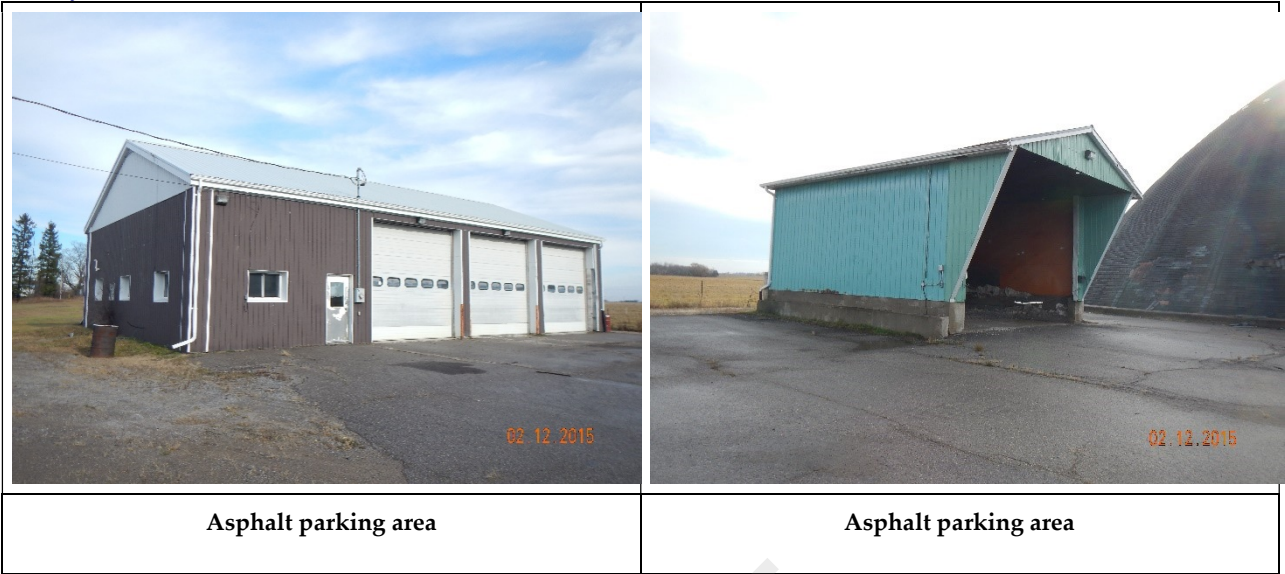
There is an asphalt driveway a with an asphalt parking lot area. The asphalt surfaces are in fair condition with alligator cracks everywhere due to natural age.

Based on a normal life span for this component, repairs and/or replacements are anticipated during the study period. Appropriate costs are carried.

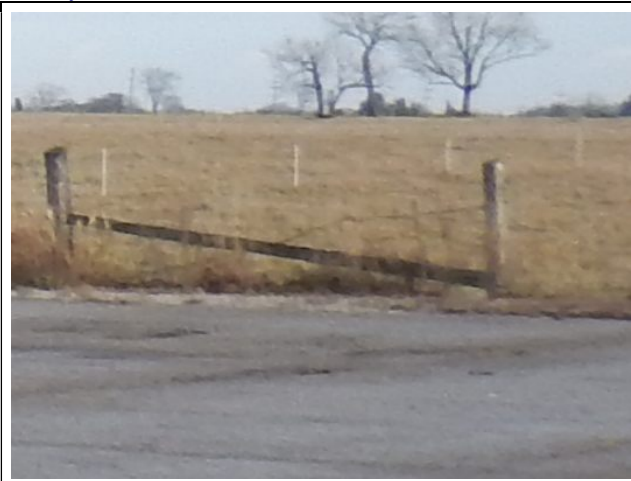
There is a 3-foot farm fence surrounding the complex with a gate at the entrance. The fence and the gate appear to be in good condition.

3-foot farm fence surrounding the complex
