Re: Quonset Hut Review, City of Kawartha Lakes (Revision 1)
603 Sandringham Road
Project No.: 300058345.0000

R.J. Burnside & Associates Limited (Burnside) was requested to complete a structural review of the existing Works Department utility building at the above address. The building has a semi-circular-shaped corrugated roof with cast-in-place foundations and is commonly known as a "Quonset Hut". The purpose of this review and report is to visually review the structure, advise on its condition, and provide some general recommendations for further consideration. On March 26, 2024, Burnside attended the site to undertake the review and met with some of the City of Kawartha Lakes staff who also came out to the site.

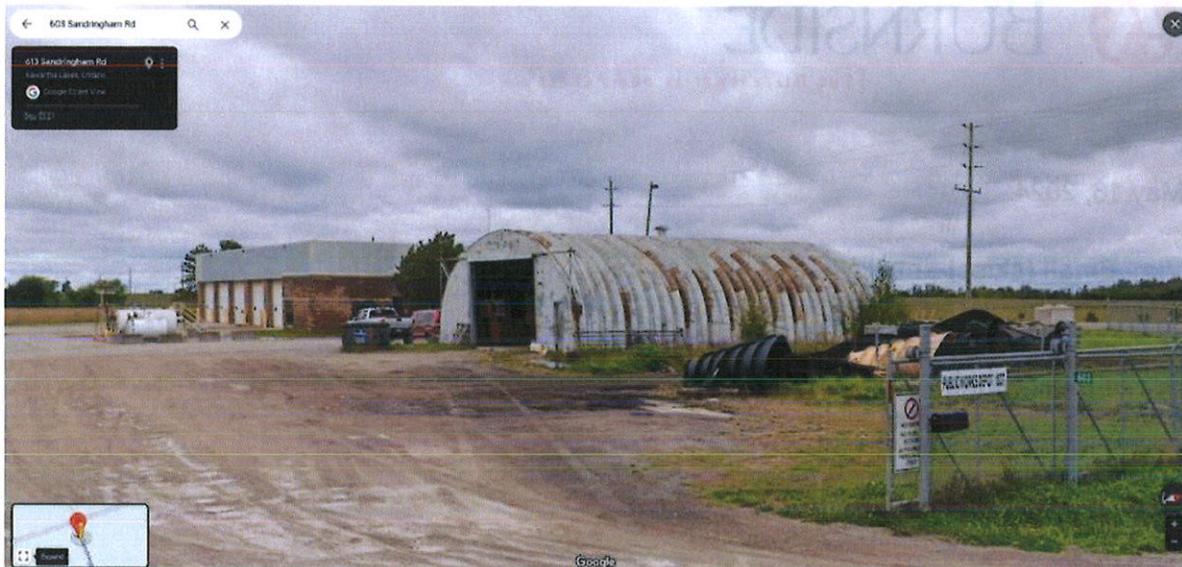
The picture below provides a general view of the southeast corner side of the utility building.

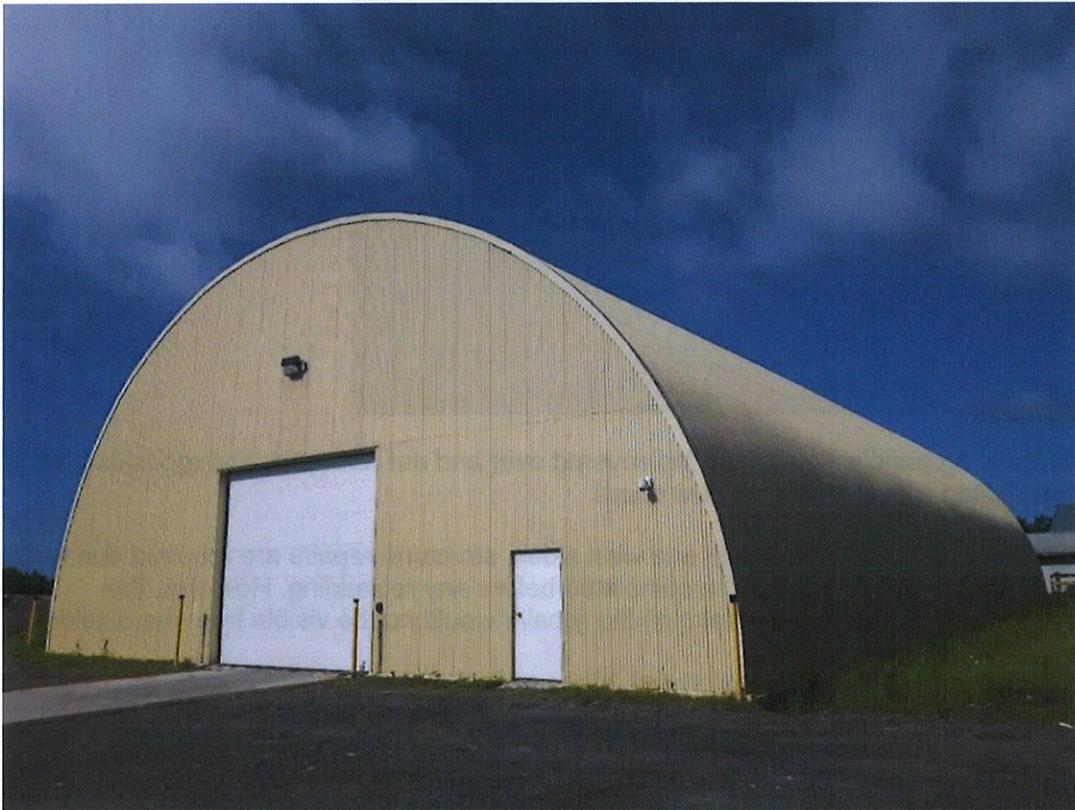
The picture below shows a re-cladded similar structure completed by Agway Metals.

Cladding the roof with a prefinished light gauge metal product would provide the added benefits of improved aesthetics and would protect the existing structural steel panels without repainting them. The exterior could have insulation added, but this increased cost would not be worthwhile unless there was an intention to heat the building and use it for purposes other than storage. The recladding could be done with a light gauge prefinished metal panel such as Agway Metals 7/8" corrugated profile. If the panels were applied with the ribs running horizontally, there would be problems with water accumulation in the ribs and possible leaks through the fastener locations. Running the corrugation of the new cladding in the same direction as the current steel ribs is much better for water issues and there is no ponding. Sheets are overlapped by two 22 mm (7/8") cladding ribs with a seal strip placed between the sheets. These panels are fastened to galvanized "Z" shaped girts connected to the existing ribs at about 1200 mm on centre. These new panels are factory-rolled to the curvature of the existing roof. We have verified this concept with Agway Metals and pictures are below for a similar recladding project already completed. Of course, other parts of the building are treated with flashing and trim panels.

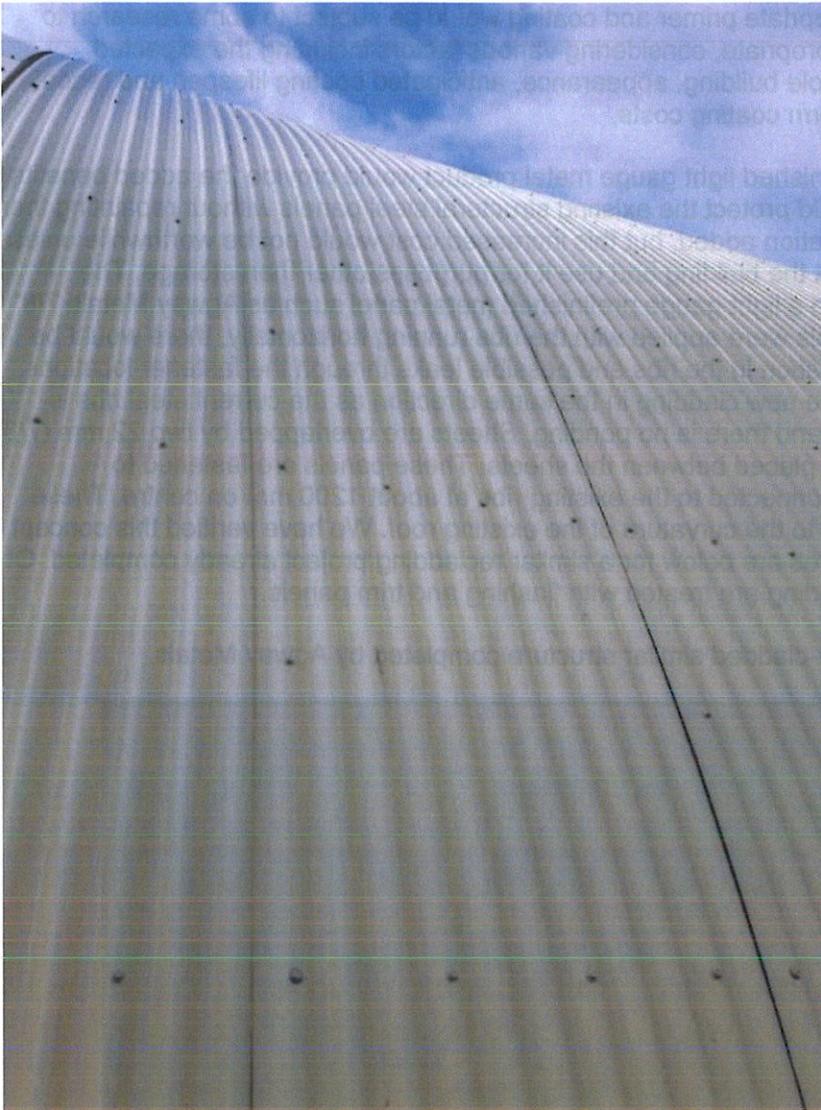
The picture below shows fasteners from the new cladding to the new Z girts.

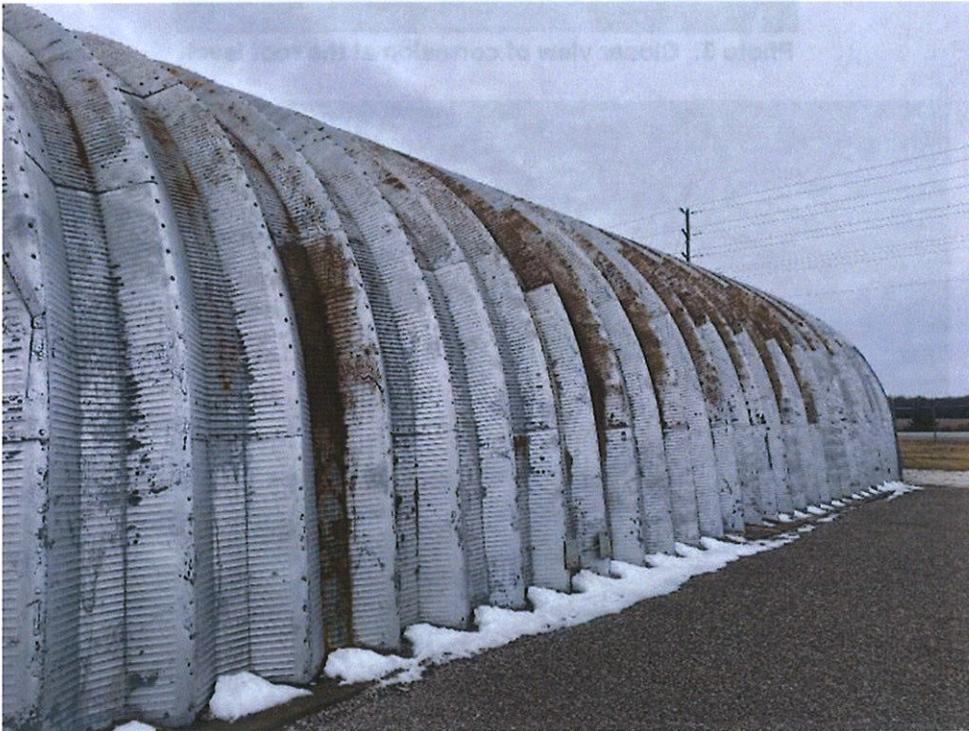
We observed that the corrugated steel panels were as noted and bolted together. Some roof panels have lost their galvanized coating protection and are showing some corrosion. It appears these lightly corroded panels account for 10% to 15% of the roof area.

Photo 2: East elevation showing light corrosion on some panels.

The steel panel corrosion will accelerate in areas where rusting has begun, and the galvanizing is now depleted. Such steel would have to be cleaned and painted to extend the lifespan of the panels. Determining an appropriate primer and coating would be subject to some research to determine what would be appropriate, considering various factors including the expected remaining lifespan for the whole building, appearance, anticipated coating lifespan and recoat time, initial costs, and long-term coating costs.

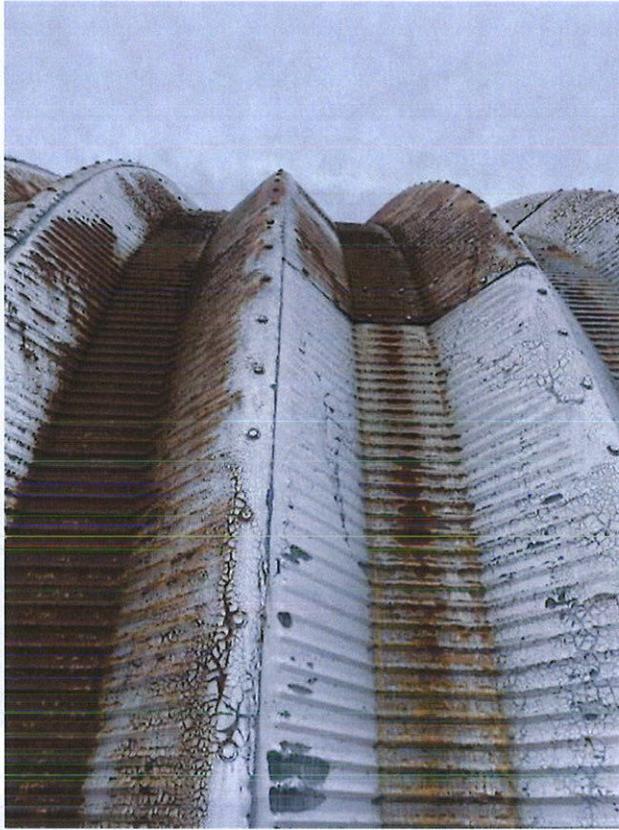
Photo 3: Closer view of corrosion at the roof level.

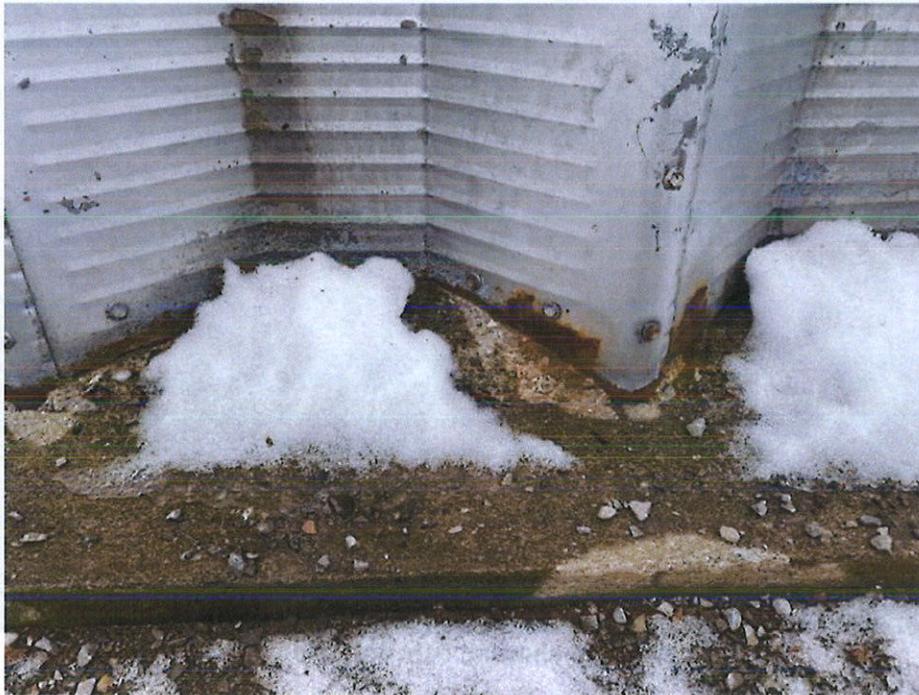
Photo 4: Corrosion near wall base, possibly clean and touch up repairs.

For panels which are not corroding at the base interface with the concrete footing, it may be prudent to add a cold galvanizing coating, or a zinc-rich paint to a strip 200 mm high above the concrete. This would be done after all the repairs are completed.

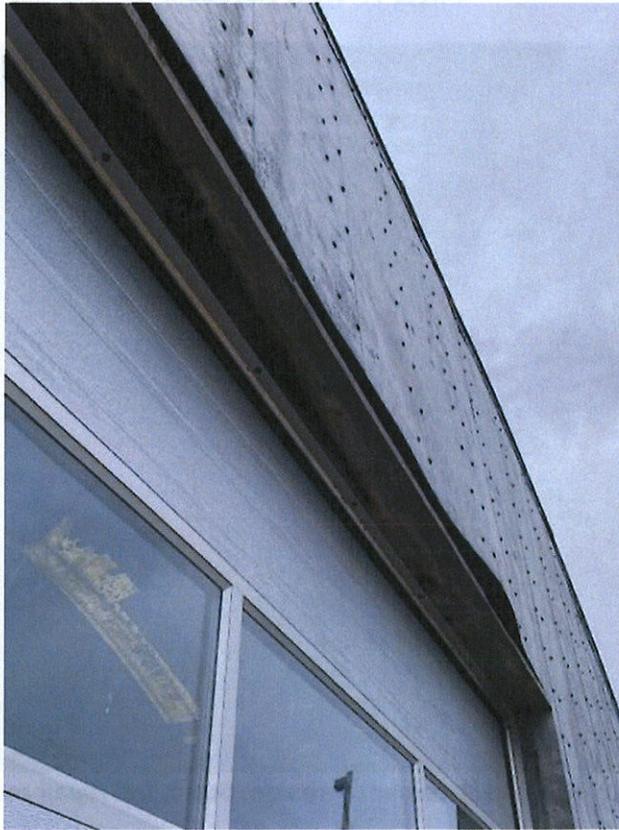
The local staff can best advise regarding the current performance of the doors and if they can be salvaged. We noticed that the cladding is loose over the north overhead doors and there may be missing flashing over door headers, thus, regardless of the door replacement question, some rework at doors is expected.

Photo 6: Cladding loose above the north door.

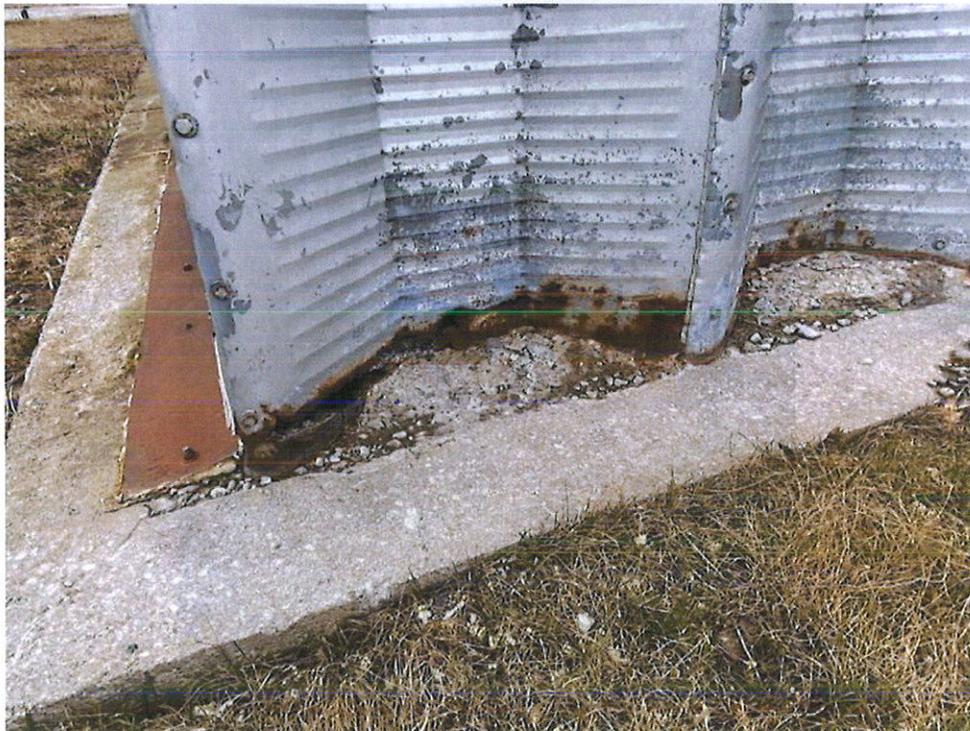
There are more heavily corroded panels along the base of the Quonset Hut walls, where the panels are set in the grout bed. The most significant corrosion is along the west side, where some panels have completely corroded through at the interface between the concrete and the wall. There are similar panels on the east side. There are corroded panels on the north side and at the base of the man door, but these are not as structurally significant. These north and south end walls must only resist wind loading and do not carry roof snow load to any significance.

Photo 8: Northwest corner corrosion. Structural repair required.

Along the base of the walls on the east and west sides, structural repairs are required due to the level of corrosion and would have to be completed before any recladding. However, the recladding would nicely cover the repairs so the repairs would not be visible from the outside.

The final design of the repairs may need further study, but we initially anticipate removal of the grout in areas where the panels are failing. This should be done in a checkerboard pattern of one

panel being repaired, and the adjacent panel left as is, then once the first panel is repaired and grouted the adjacent panel can be repaired, so as not to disengage too many structural panels at once. Completing a test section for practicality may be required to see how difficult grout removal will be. An alternate galvanized steel plate anchored to the top of the footing and fastened to the steel panels may be an alternative to fully removing existing grout, but some engineering would be required to determine sizes and anchorage. If existing panels cannot be supplied from a current manufacturer to match the existing in terms of profile, we believe galvanized sheets in the order of 3 mm thick can be bent and spliced with the existing panels.

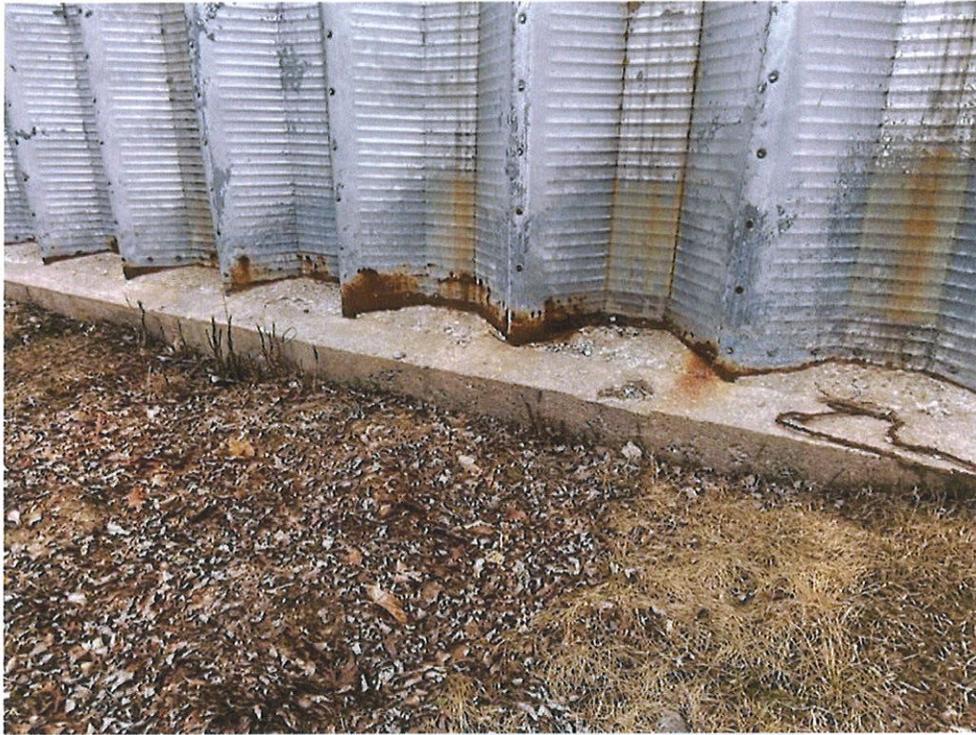
Photo 9: West side structural repair at base of panel required.

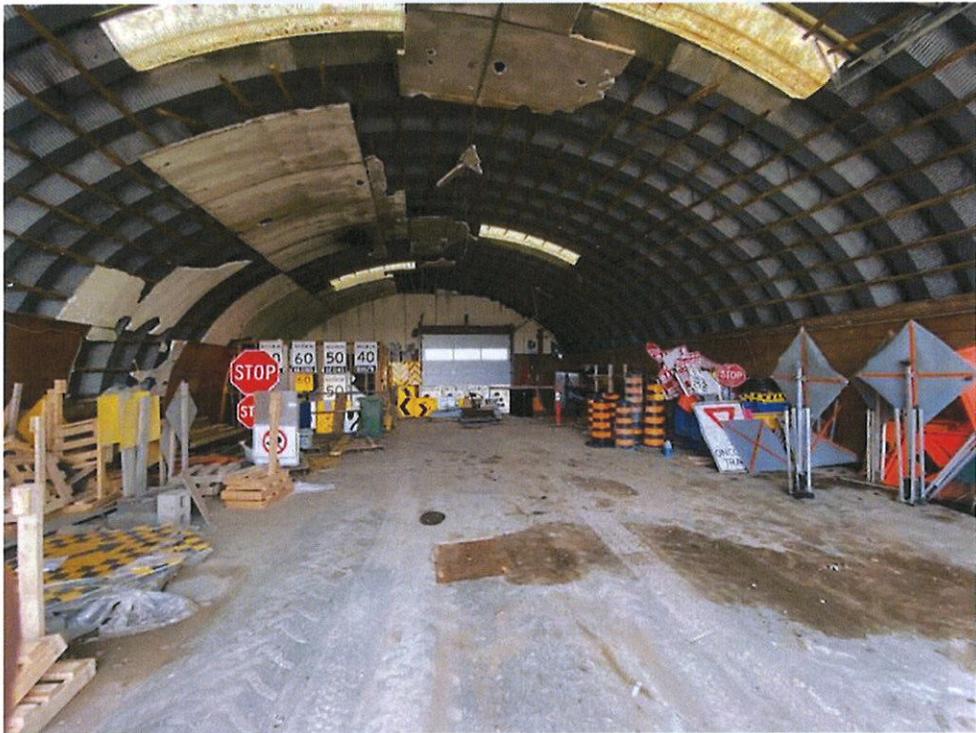
Photo 10: General interior view. Most insulation is missing.

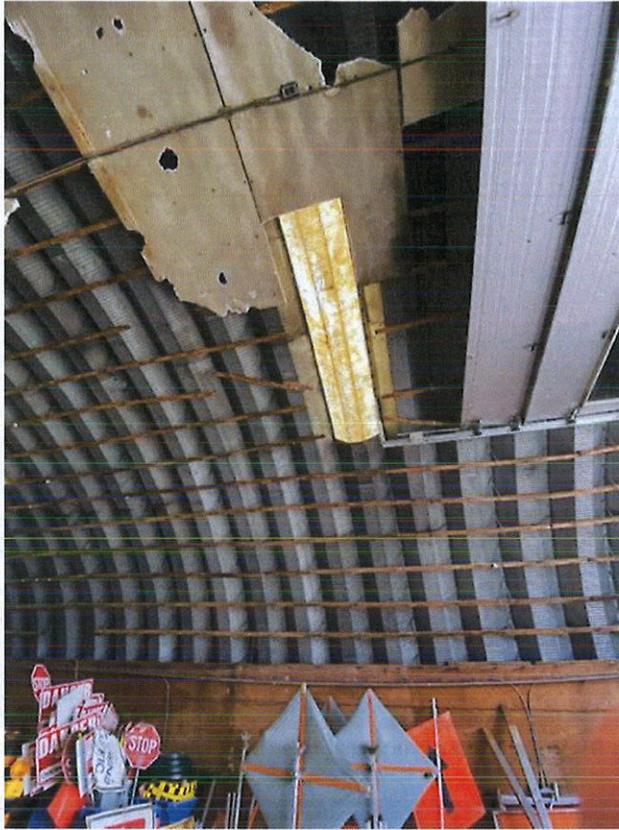
Photo 11: Translucent roof panels, wood furring strips and plywood panels.

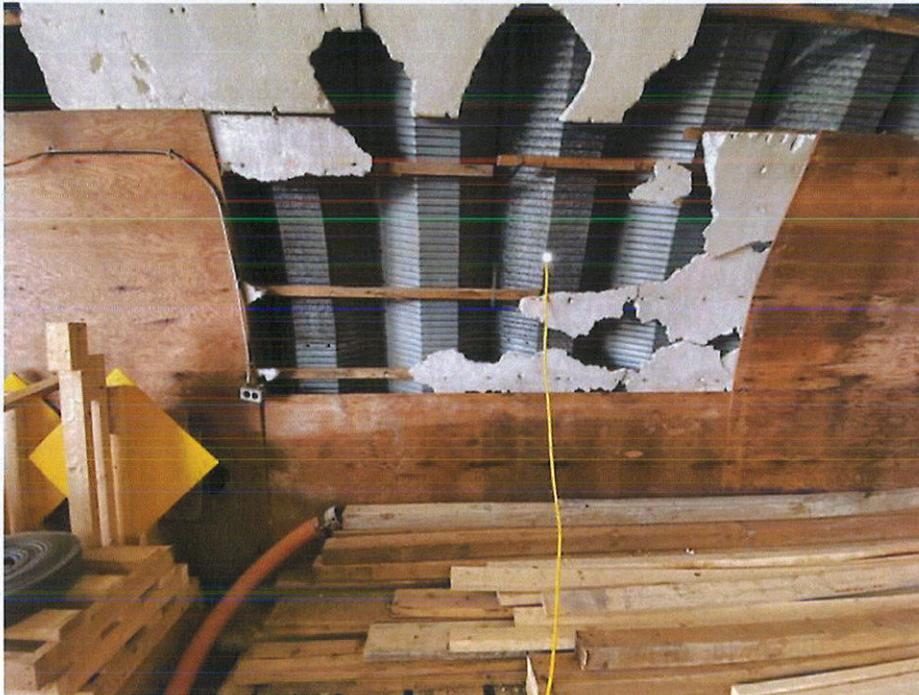
Photo 12: Similar to Photo 11. Note that plywood covers insulation.

We would suggest removal, and possibly the re-use of the interior plywood panels, as we believe there may be debris between the plywood and the steel panels which may hold moisture and accelerate the steel corrosion. Access to the base of the walls is required for repairs.
