WINDOW UPGRADES - 21 FRANCIS STREET, LINDSAY

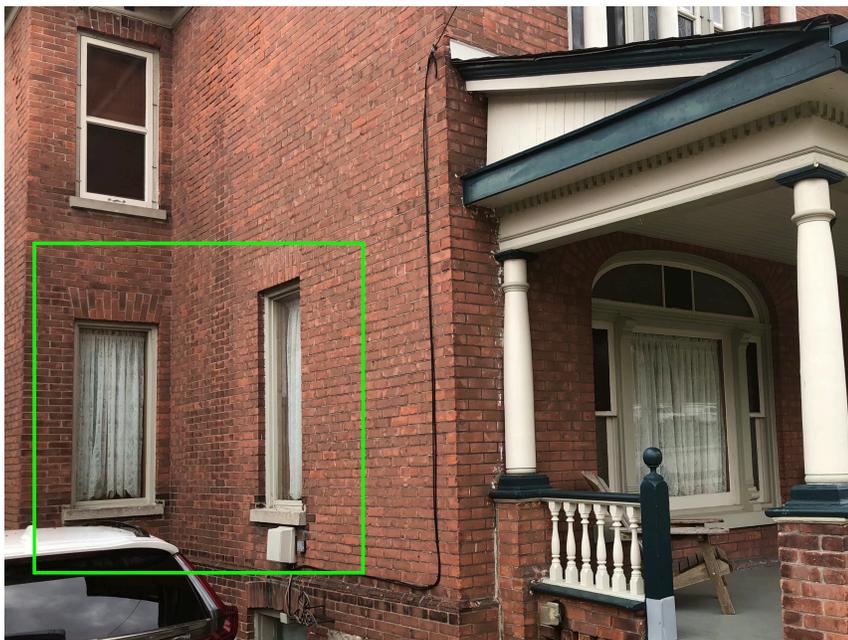
North and east facing

There are seven double-paned windows on the main floor that require replacement glass due to compromised seals; two of them also have cracked glass, and all of them have fog and/or mold between the panes.

We would like to replace these windows with thermal (Energy Star certified) awning windows that would look virtually the same from the outside but could open (slightly at bottom) to accommodate airflow.

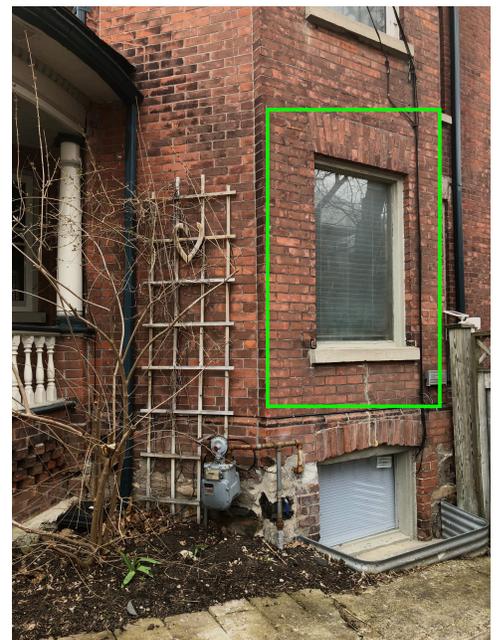
West facing

Each window is a single double-pane window that does not open (glass is held in place via a wood surround).

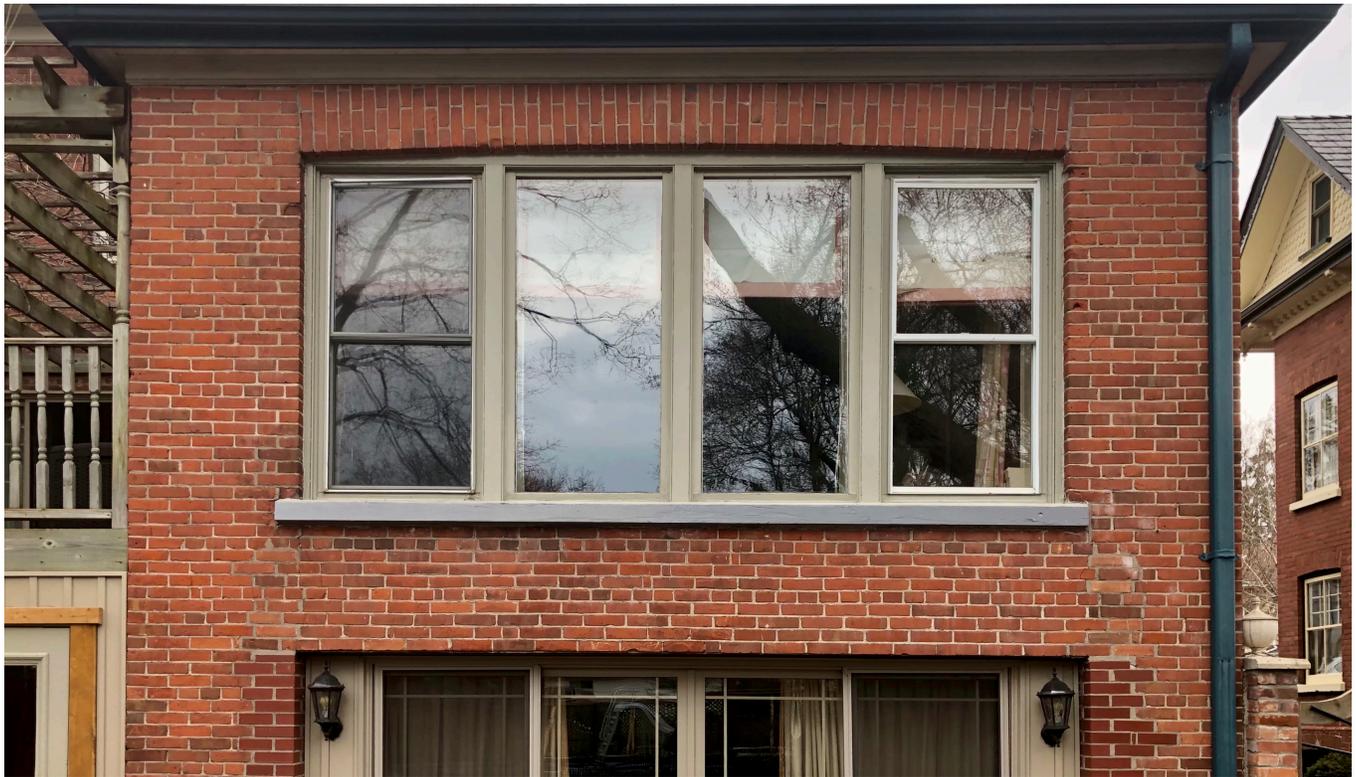
These are the four windows at the back of the house:

There are two double-hung windows. Between them are two single double-pane windows that do not open.

We would like to replace these four windows with thermal (Energy Star certified) windows (two awning and two fixed). The outside colour of the new windows will be in alignment with the current colour scheme of the house.
