## MEMO REPORT

**TO:** Juan Rojas  
**FROM:** Joseph Kelly – Senior Engineering Tech, Technical Services  
**RE:** Farmer's Road and Glamorgan Road Intersection  
**DATE:** January 16, 2017

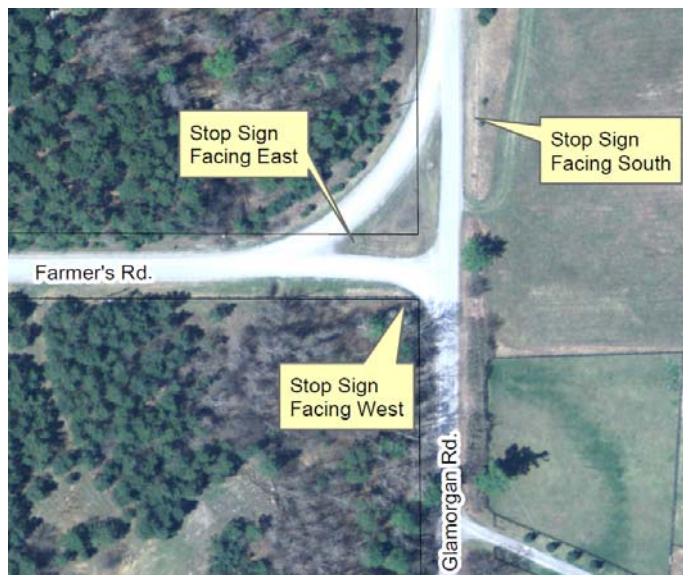
Staff reviewed the sign inventory (with on-site confirmation) and found there is a stop control located on Farmer's Road at the T-intersection approach at Glamorgan Rd (the right angle of the island). There are also stop controls on both legs of the islands (where the legs meet the curved hypotenuse); one on Glamorgan Road north of the T-intersection, and a recently installed stop control on Farmer's Road west of the T-intersection. Both controls grant the right of way to vehicles traveling the curve through Mr. Ogborne's property (Figure 1).

**Figure 1.** Aerial Image showing stop sign placement granting right of way to traffic on curve.

The current sign placement indicate that the curve through the property is intended for use by both southbound traffic turning west, and westbound traffic turning north.

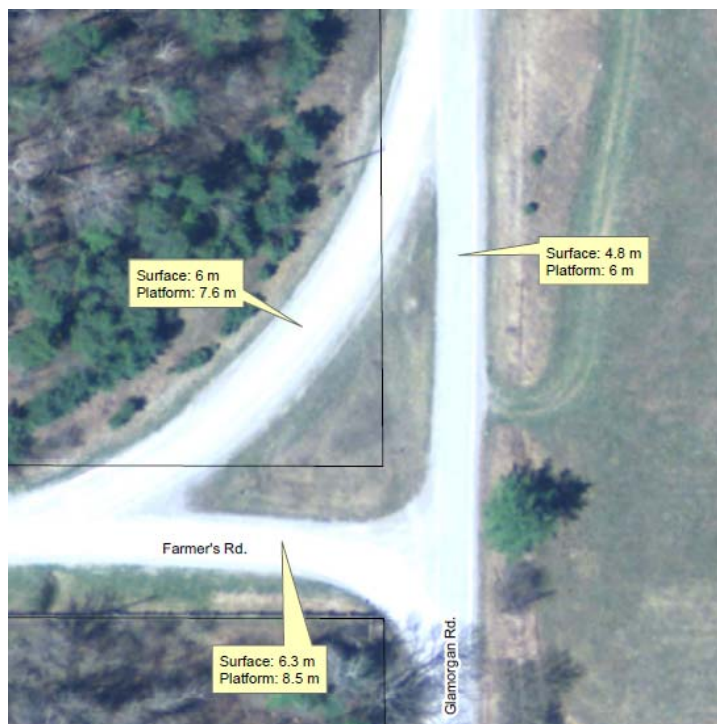
It was found that although the Glamorgan leg is used by two way traffic, the surface width of 4.8 m is deficient (Figure 2). Vehicles must use the shoulder when passing as the platform width of 6m would accommodate two vehicles.

There is also a misalignment on Glamorgan Road for southbound traffic. Vehicles travelling south would not only have to be aware to northbound cross traffic intersecting their lane from the curve, they would also have to veer left into a narrowing choke point. Here, northbound vehicles travelling through the intersection on Glamorgan could be stopped at the stop control, or approaching it. It should be noted that 50% of the vehicles observed during the site visit ignored this stop sign.

**Figure 2.** Measurements showing narrow Glamorgan leg.

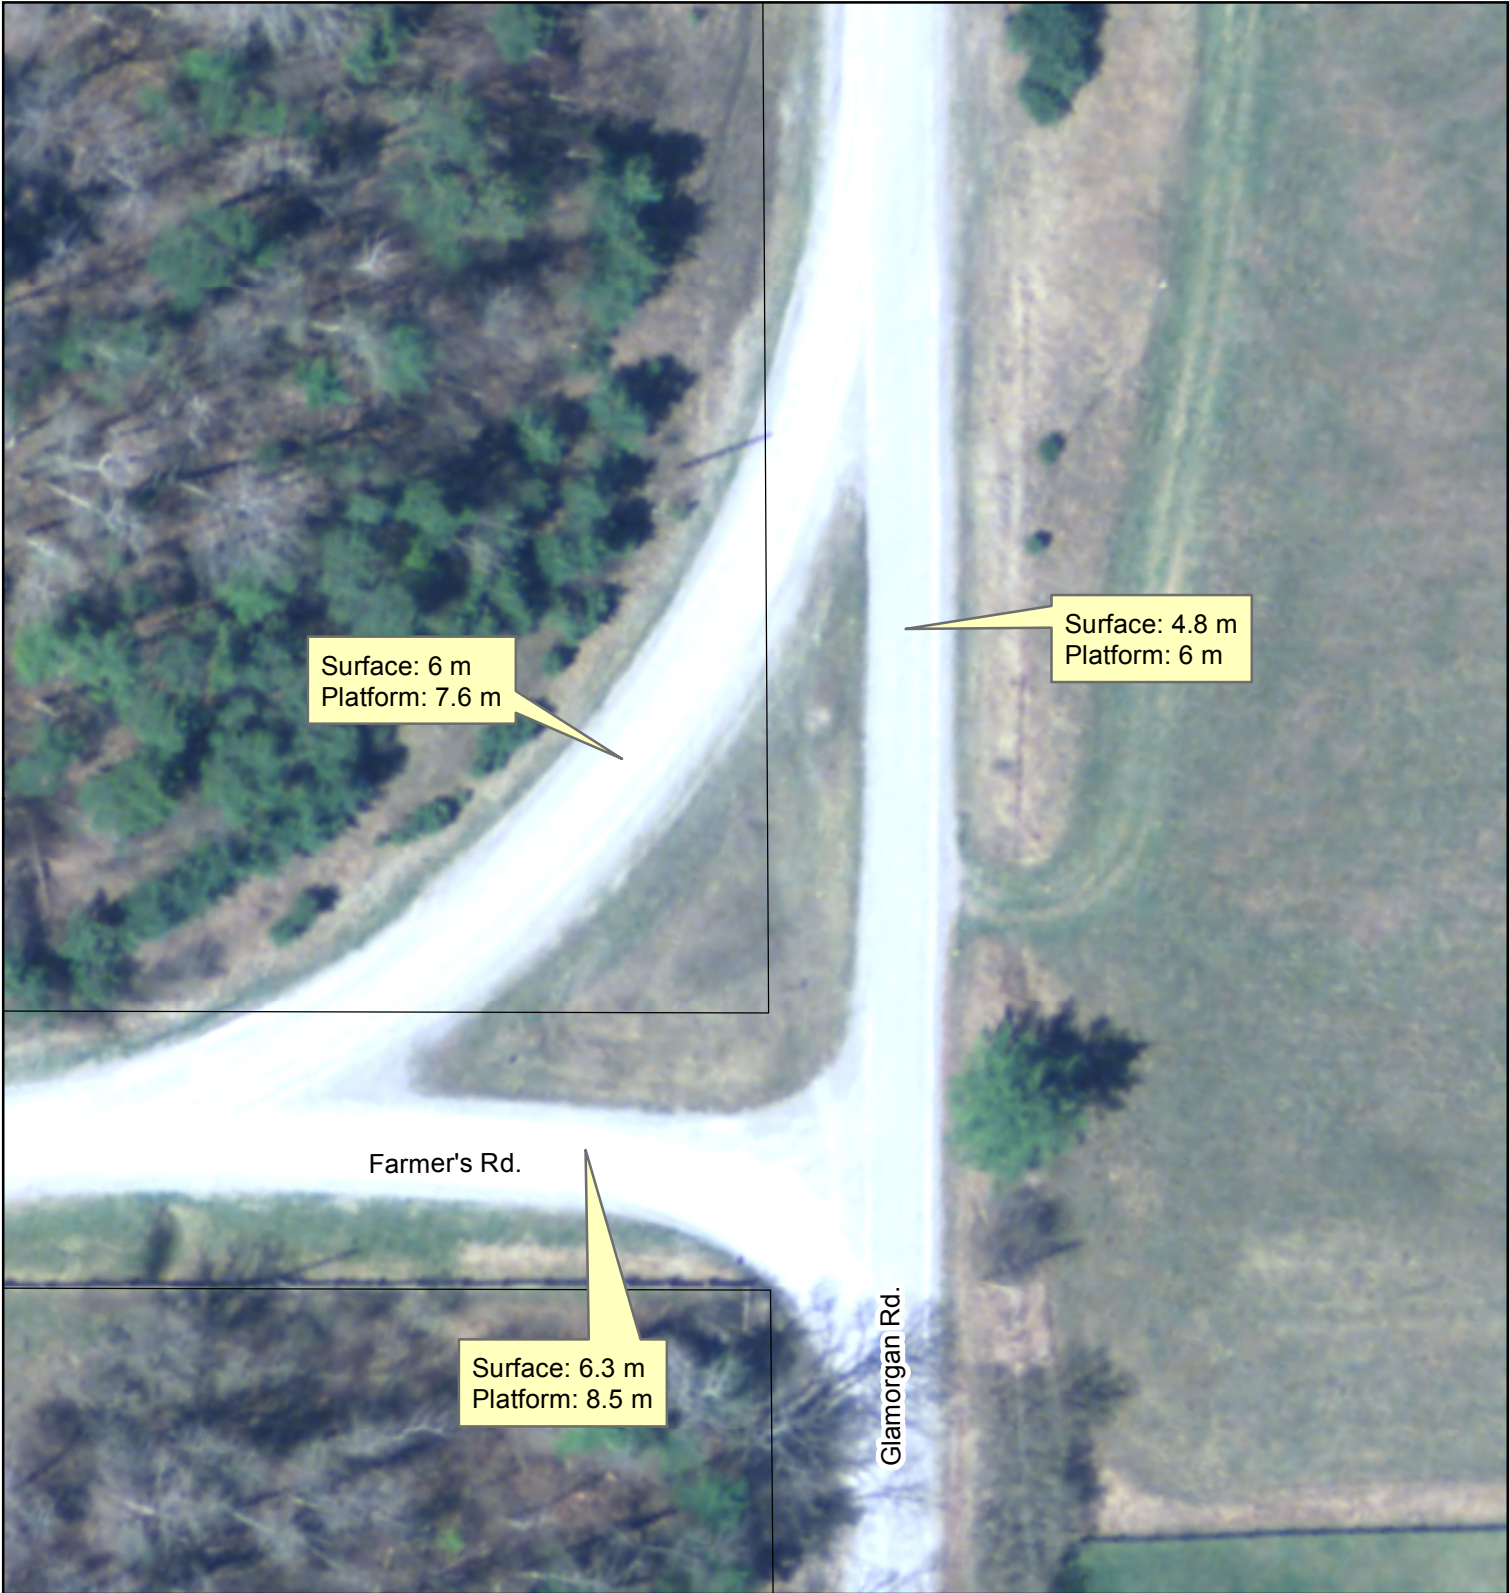
Appendix B  
Field Measurements

The curve had a surface width measurement of 6m and a platform width of 7.6 m. Appendix B shows a map listing the width measurements.

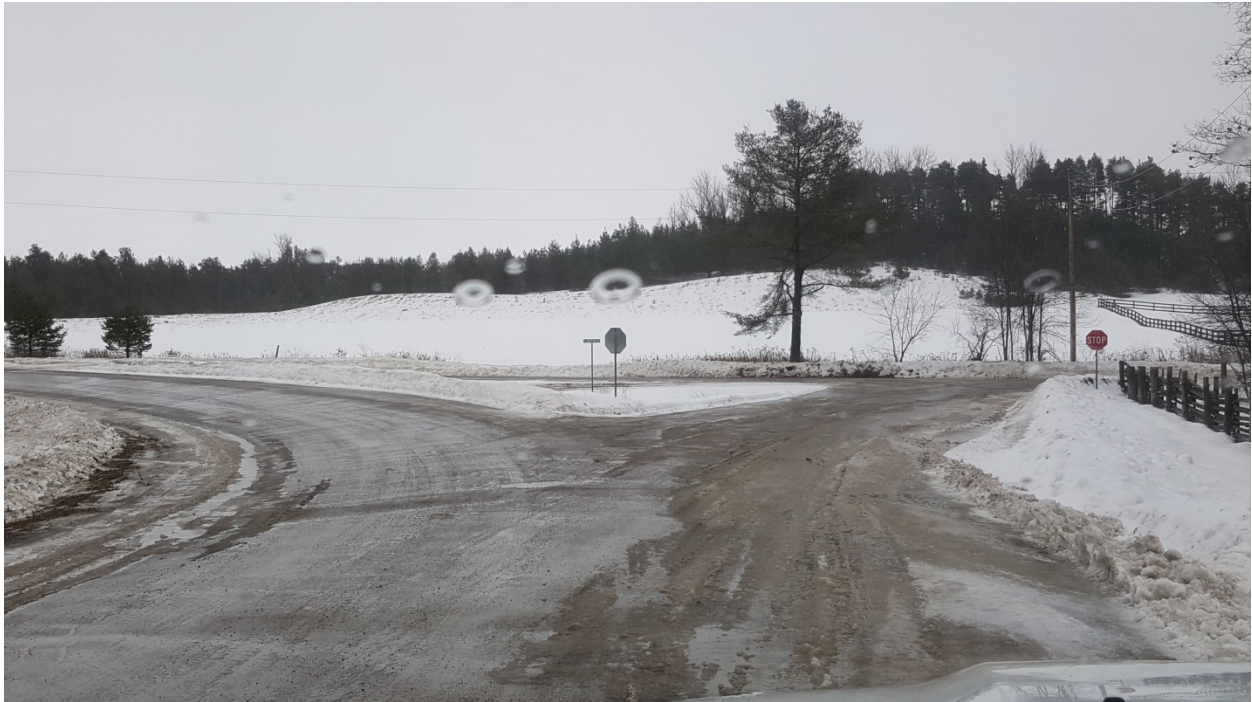
Farmer's Rd facing Glamorgan Rd

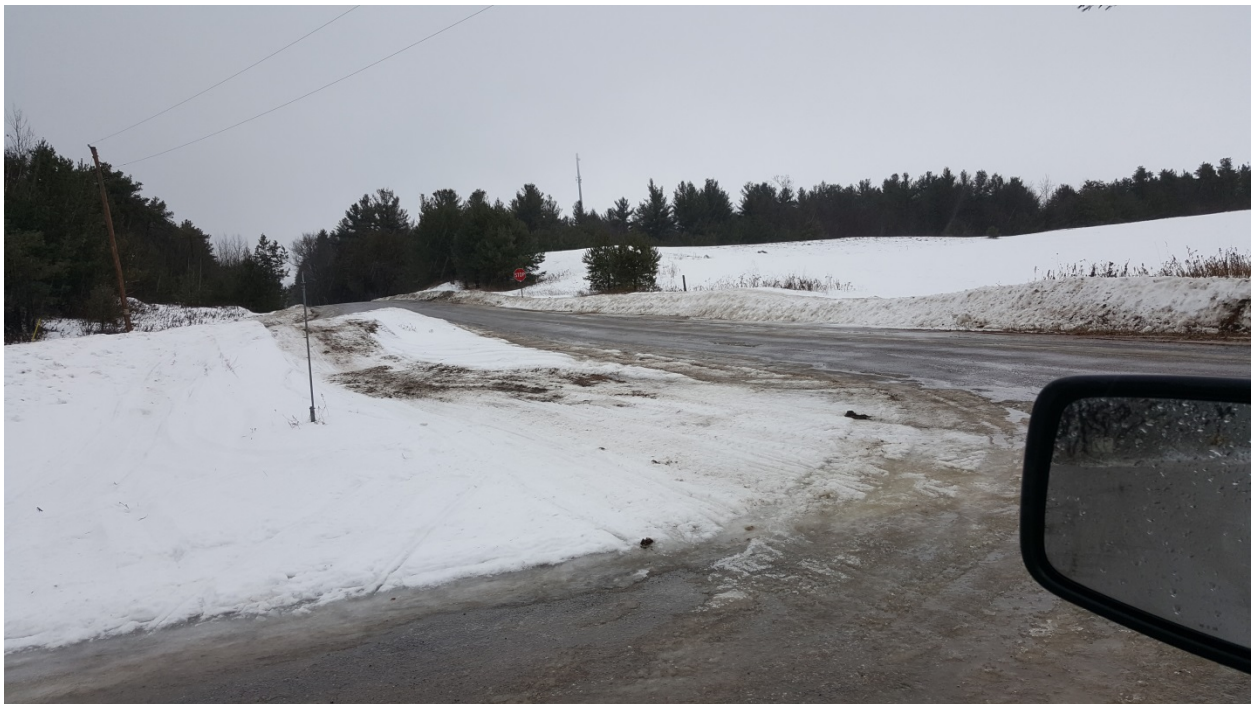
Departure sight distances were measured from the stop location on Farmer's Road at the T-intersection. TAC recommends a departure sight distance of 250m on roads with a design speed of 80 km/h. Due to a vertical curve north of the intersection, the measured sight distance is 180m. South of the intersection is straight and flat with a sight distance greater than 250m.

At Farmer's Rd approach T-stop control checking north sight lines

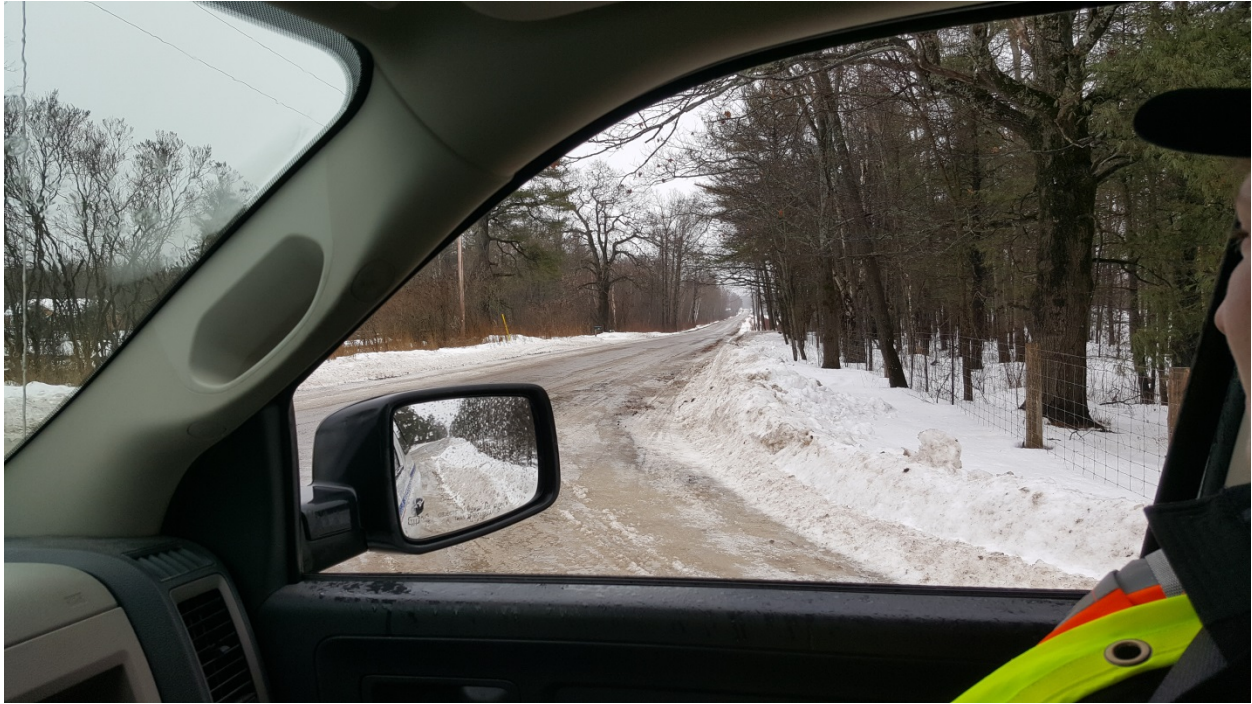
At Farmer's Rd approach T-stop control checking south sight lines

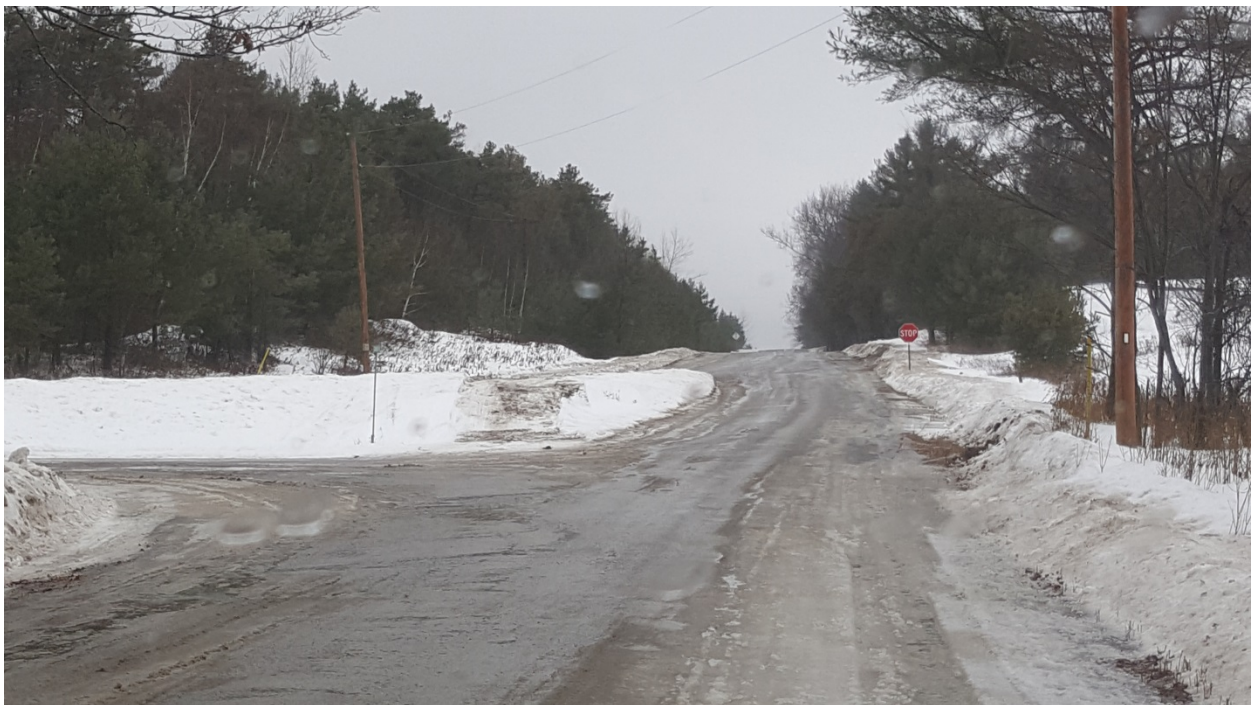
Glamorgan Rd approaching Farmer's Rd facing north

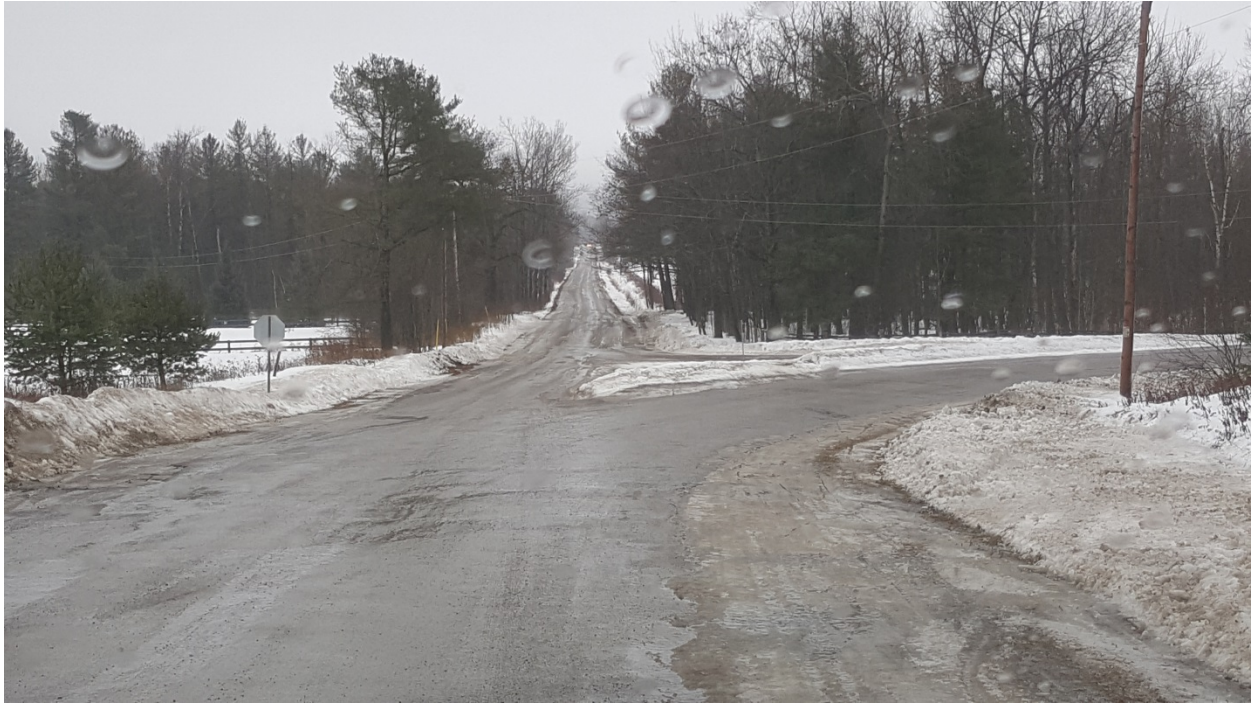
Glamorgan Rd approaching Farmer's Rd facing south

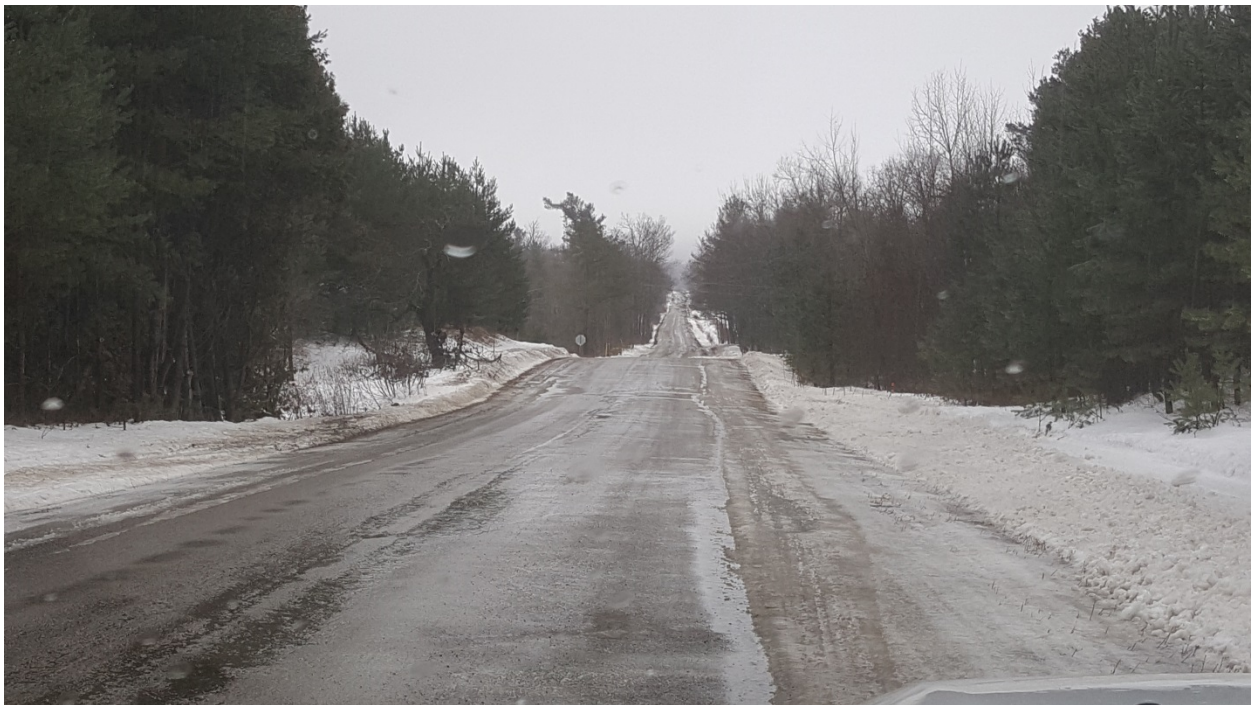
Glamorgan Rd 180m north of intersection facing south

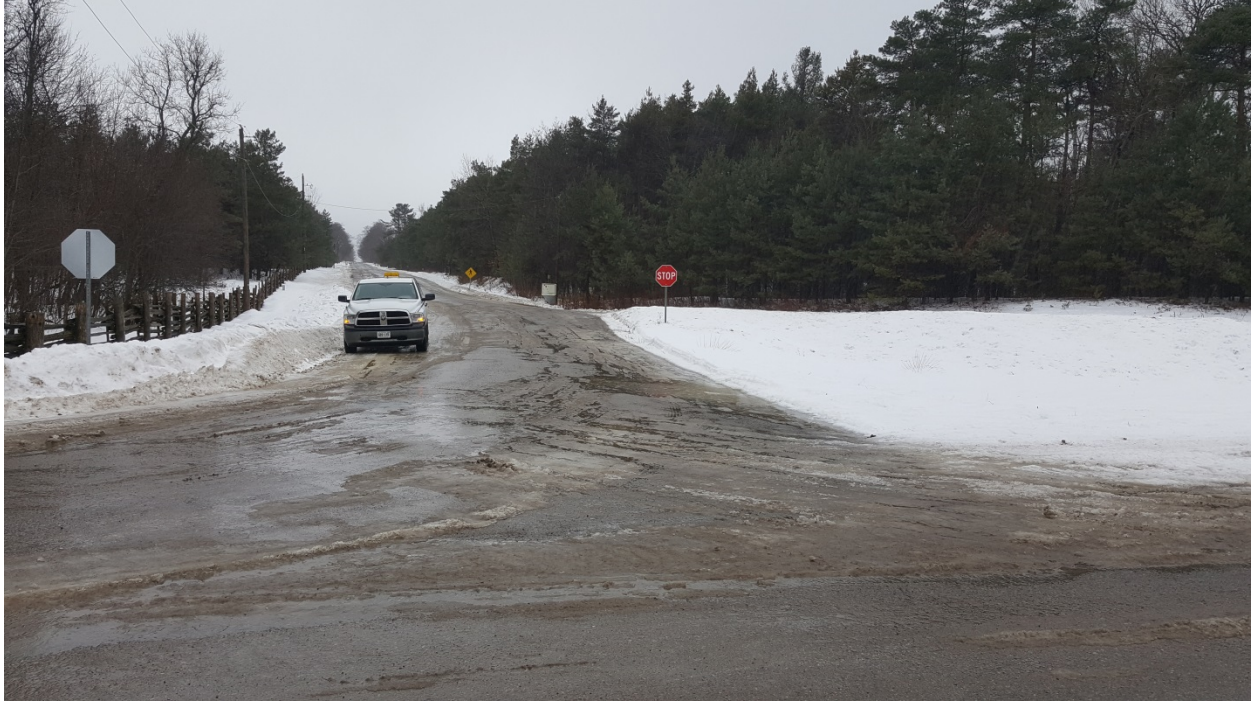
On Glamorgan Rd facing west (showing south leg of island)

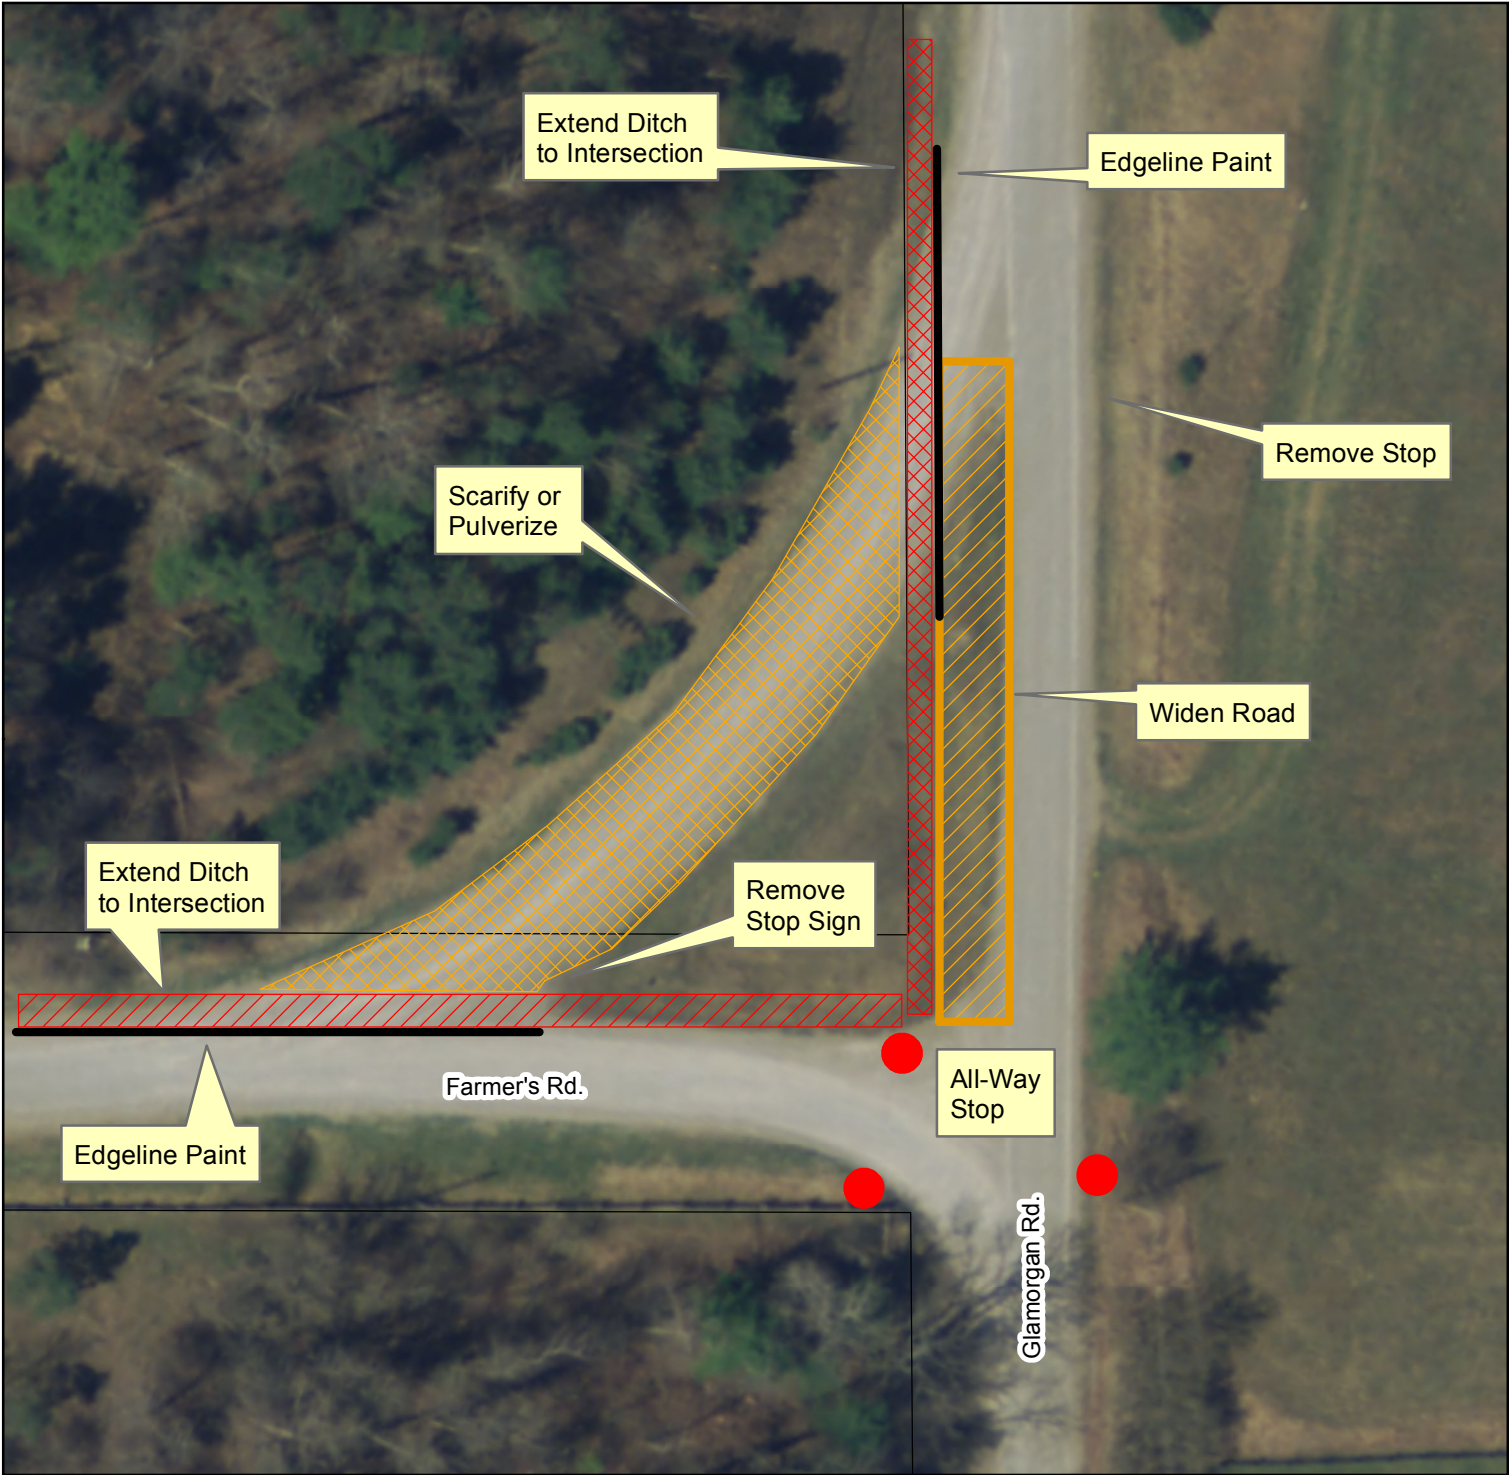
# Appendix E Closure Option

A key map can be seen in Appendix E.
