**Environmental Assessment  
Project File**

**Mary Street East, Omemee, ON**

**Mill Pond Bridge #100018  
Rehabilitation / Replacement –  
Environmental Assessment**

**D.M. Wills Project Number 9213**

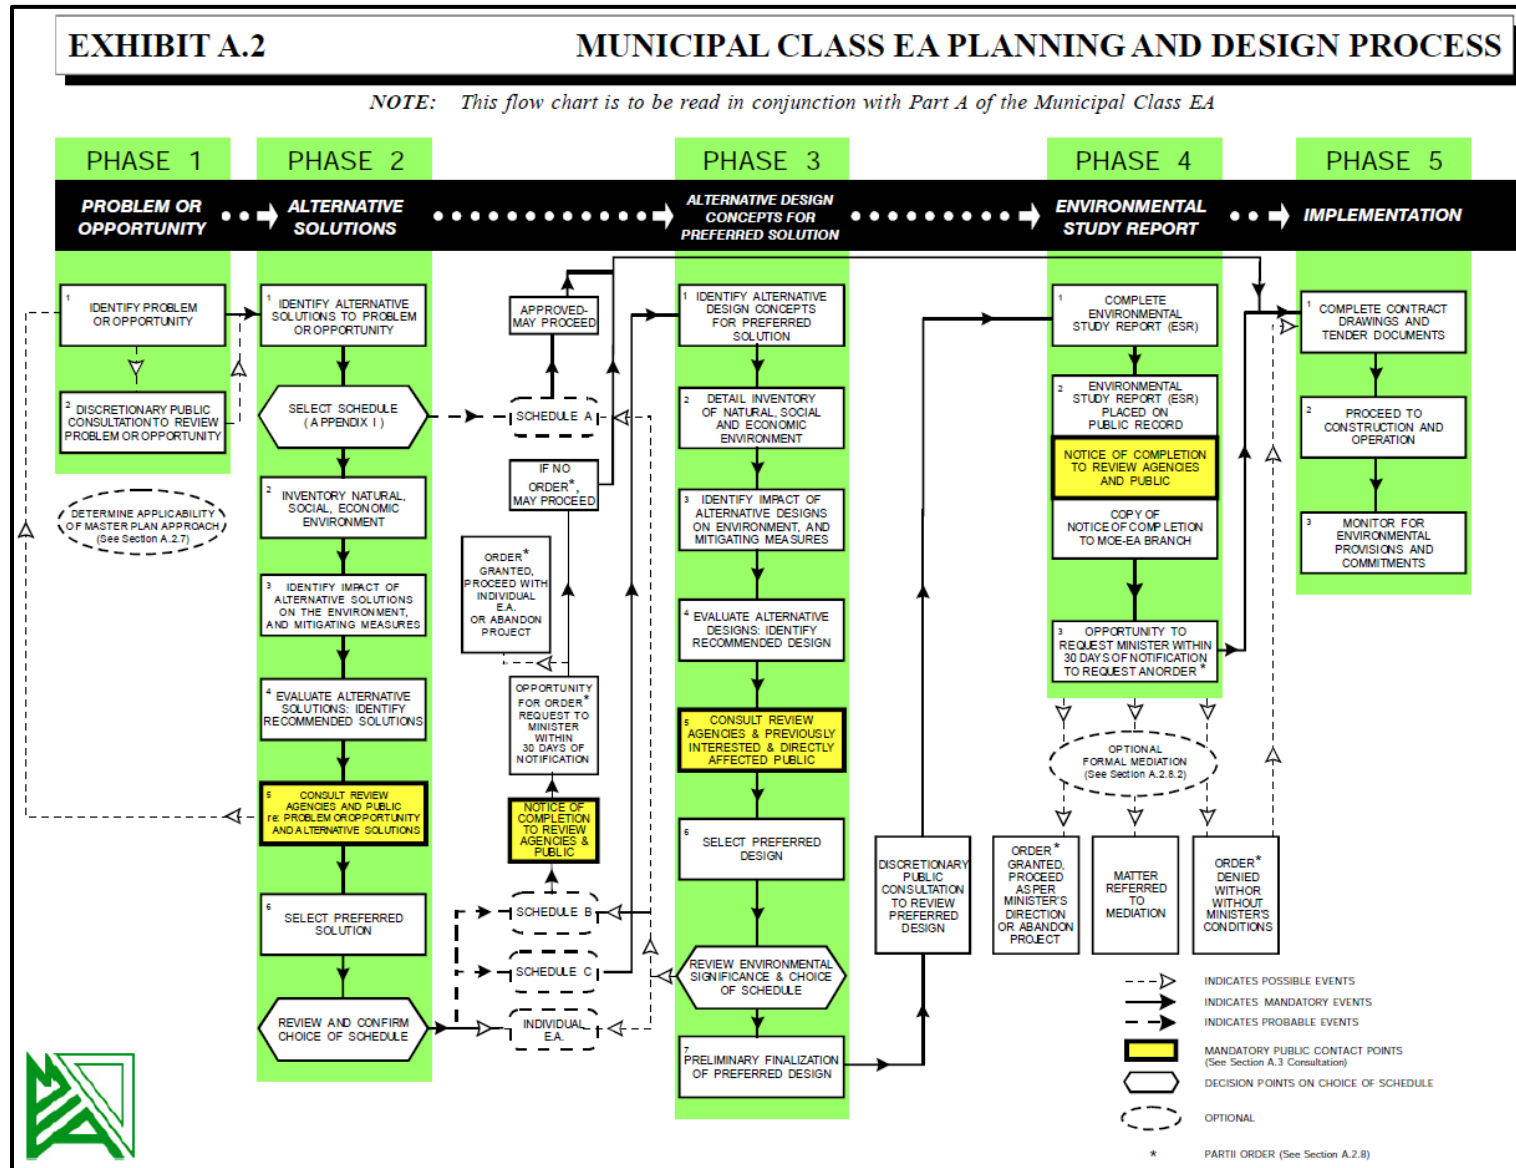
Figure 2 - MCEA Five-Phase Planning and Design Process.

The primary elements of the MCEA have been categorized into five (5) phases. One or all of the phases apply to a given project, depending on the Schedule identified during Phase 2. **Figure 2** depicts the five-phase flowchart. Regardless of the project and at the initiation of an environmental assessment, a Notice of Study Commencement, outlining the project and proponent contact information, must be advertised and issued to applicable review agencies and the public. The MCEA document provides guidance with regard to which review agencies should be contacted for a given EA.

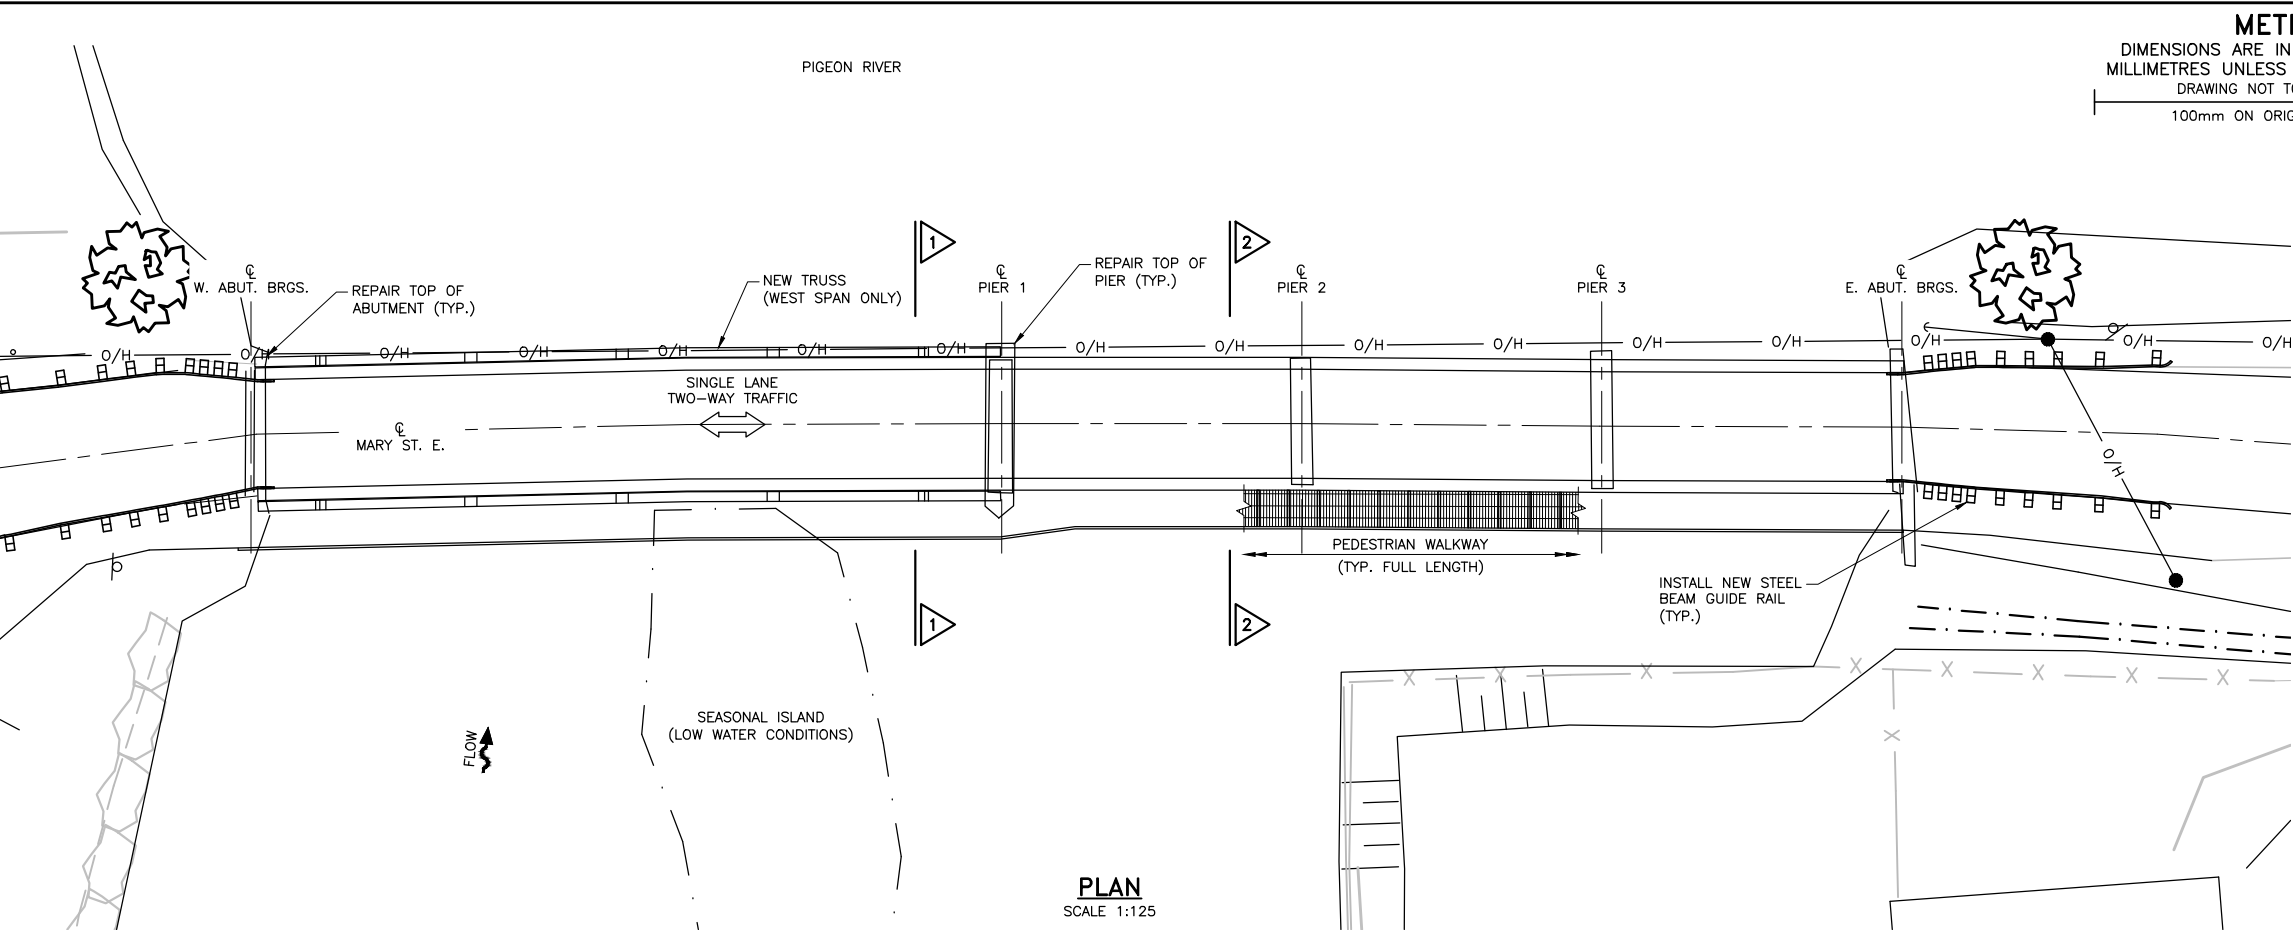
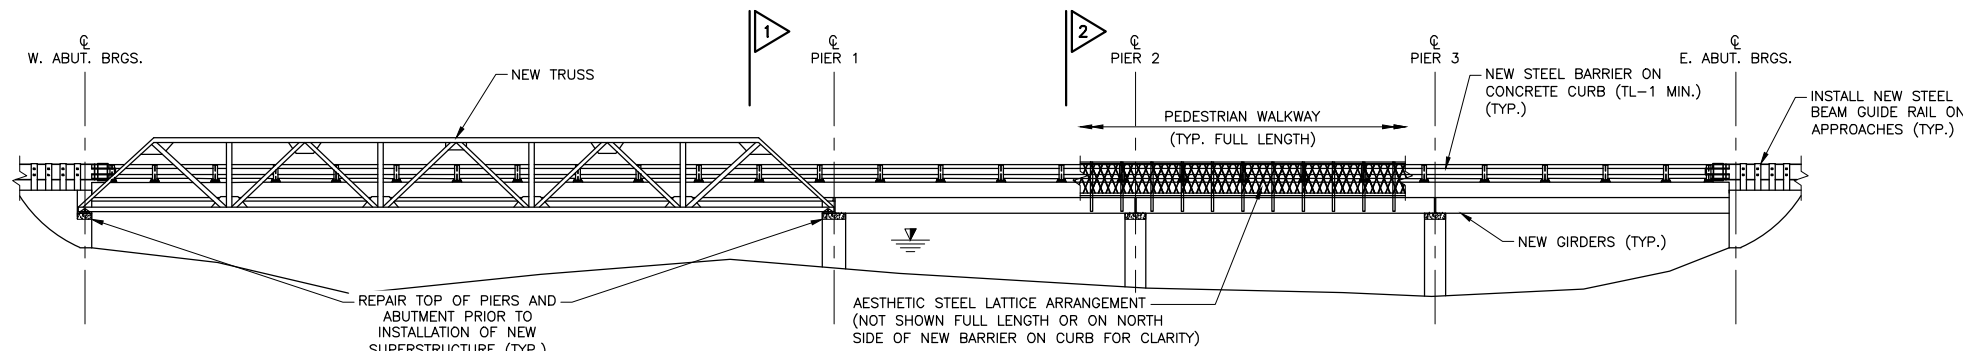
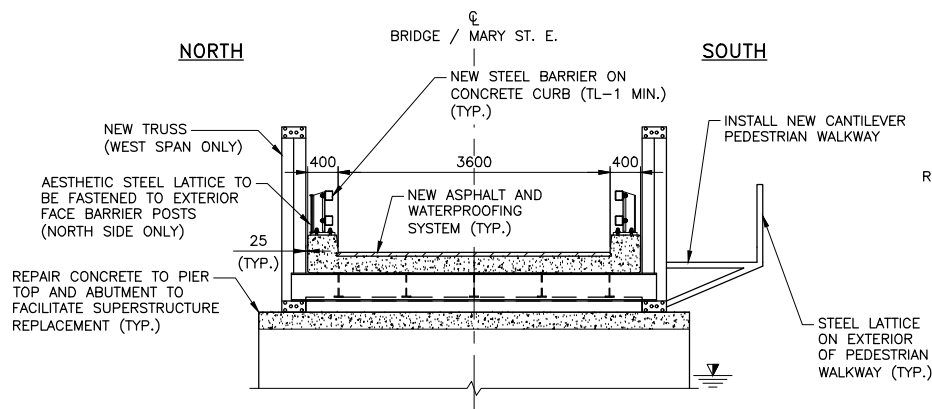
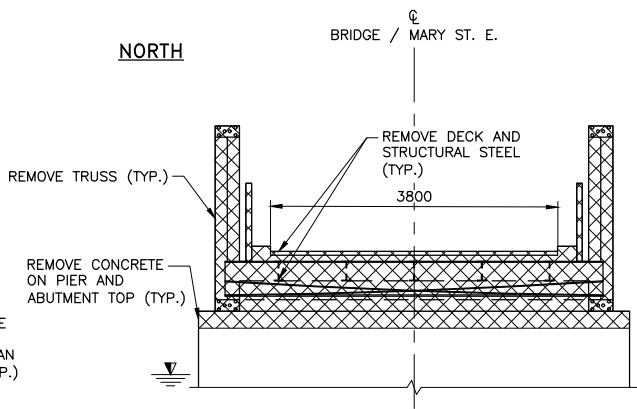
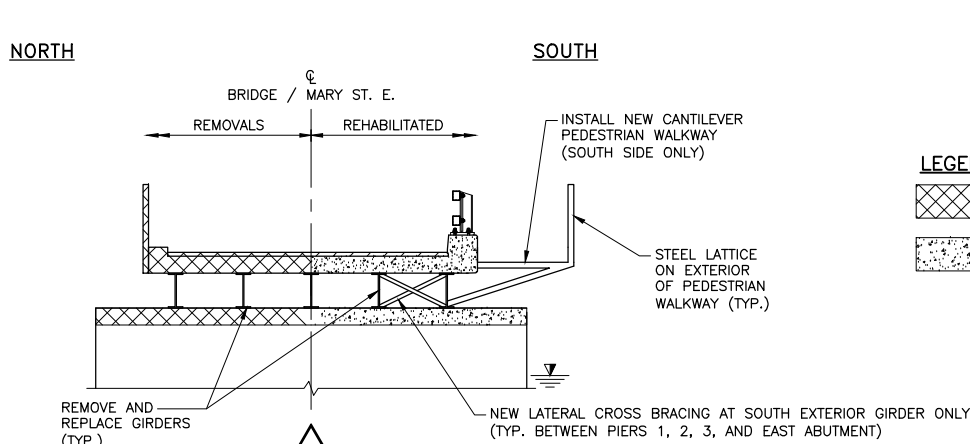
A General Arrangement drawing (Drawing R01) has been developed to depict the aforementioned scope of work for the Recommended Design Alternative. The drawing is shown below and can be found in **Appendix C**.

This includes the installation of a new deck. This deck will be supported by a new truss over the western span, and new girders over the eastern spans. A code compliant barrier system (minimum TL-1) and cantilevered pedestrian sidewalk with railing on the south side of the bridge will also be installed. To the extent possible, the design of the barrier system and sidewalk railing will be chosen to be sympathetic to the steel 'lattice' design of the existing barrier system. Furthermore, design of the replacement truss structure over the western span shall likewise be sympathetic to the existing truss design so as to maintain the aesthetic appearance of this heritage feature.

Due to the advanced deterioration of the truss structure over the western span, rehabilitation through refurbishment is not considered to be a viable option. Rather, replacement of the truss is the recommended rehabilitation method. In order to retain the heritage features of the structure, a truss of sympathetic design is recommended.

Given the deterioration identified in the most recent bridge inspection, as well as the general condition of the bridge, the following scope of work is anticipated for the rehabilitation of Mill Pond Bridge:

- Complete replacement of superstructure over the entirety of the bridge.
- Design and installation of code compliant barrier system with sympathetic design characteristics to the existing steel 'lattice' barrier system;
