# City of Kawartha Lakes

## Rehabilitation of Mill Pond Bridge – Mary Street East, Omemee

### Schedule “B” Municipal Class Environmental Assessment

Presentation to Council

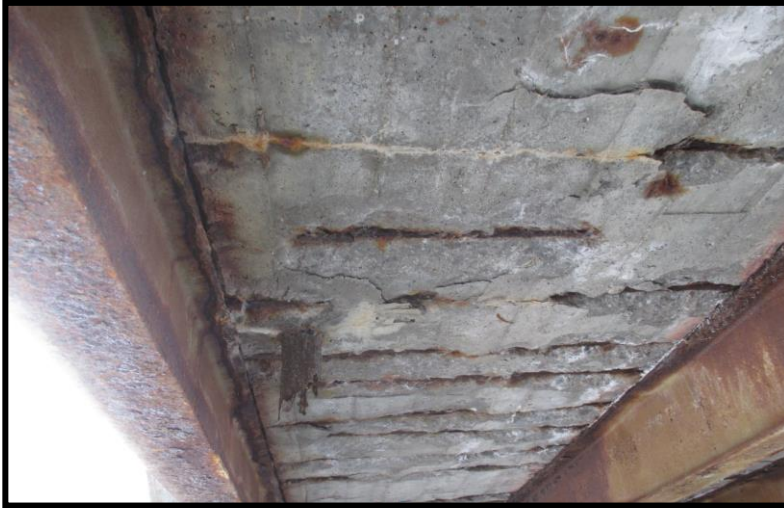
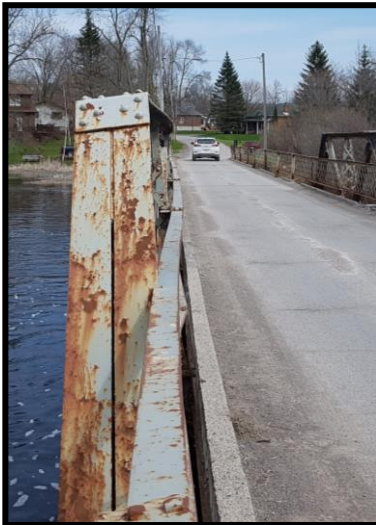
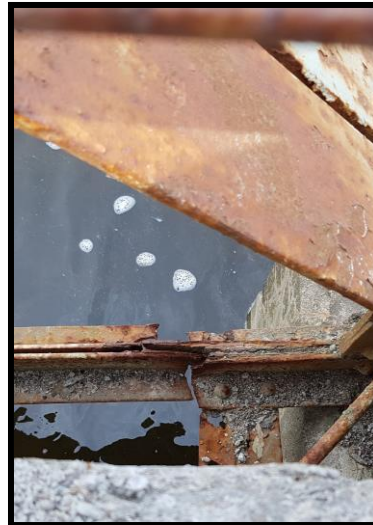
- Mill Pond Bridge serves the Village of Omemee, providing local residents an alternate crossing of the Pigeon River separate from the Trans-Canada Highway (Highway 7) located ~0.1 km to the north.
- 2017 OSIM Inspection indicated that the structure is in need of rehabilitation or replacement.
- Independent investigation conducted in 2019 revealed further structural deterioration.
- Structure was closed to vehicular traffic on May 7, 2019.

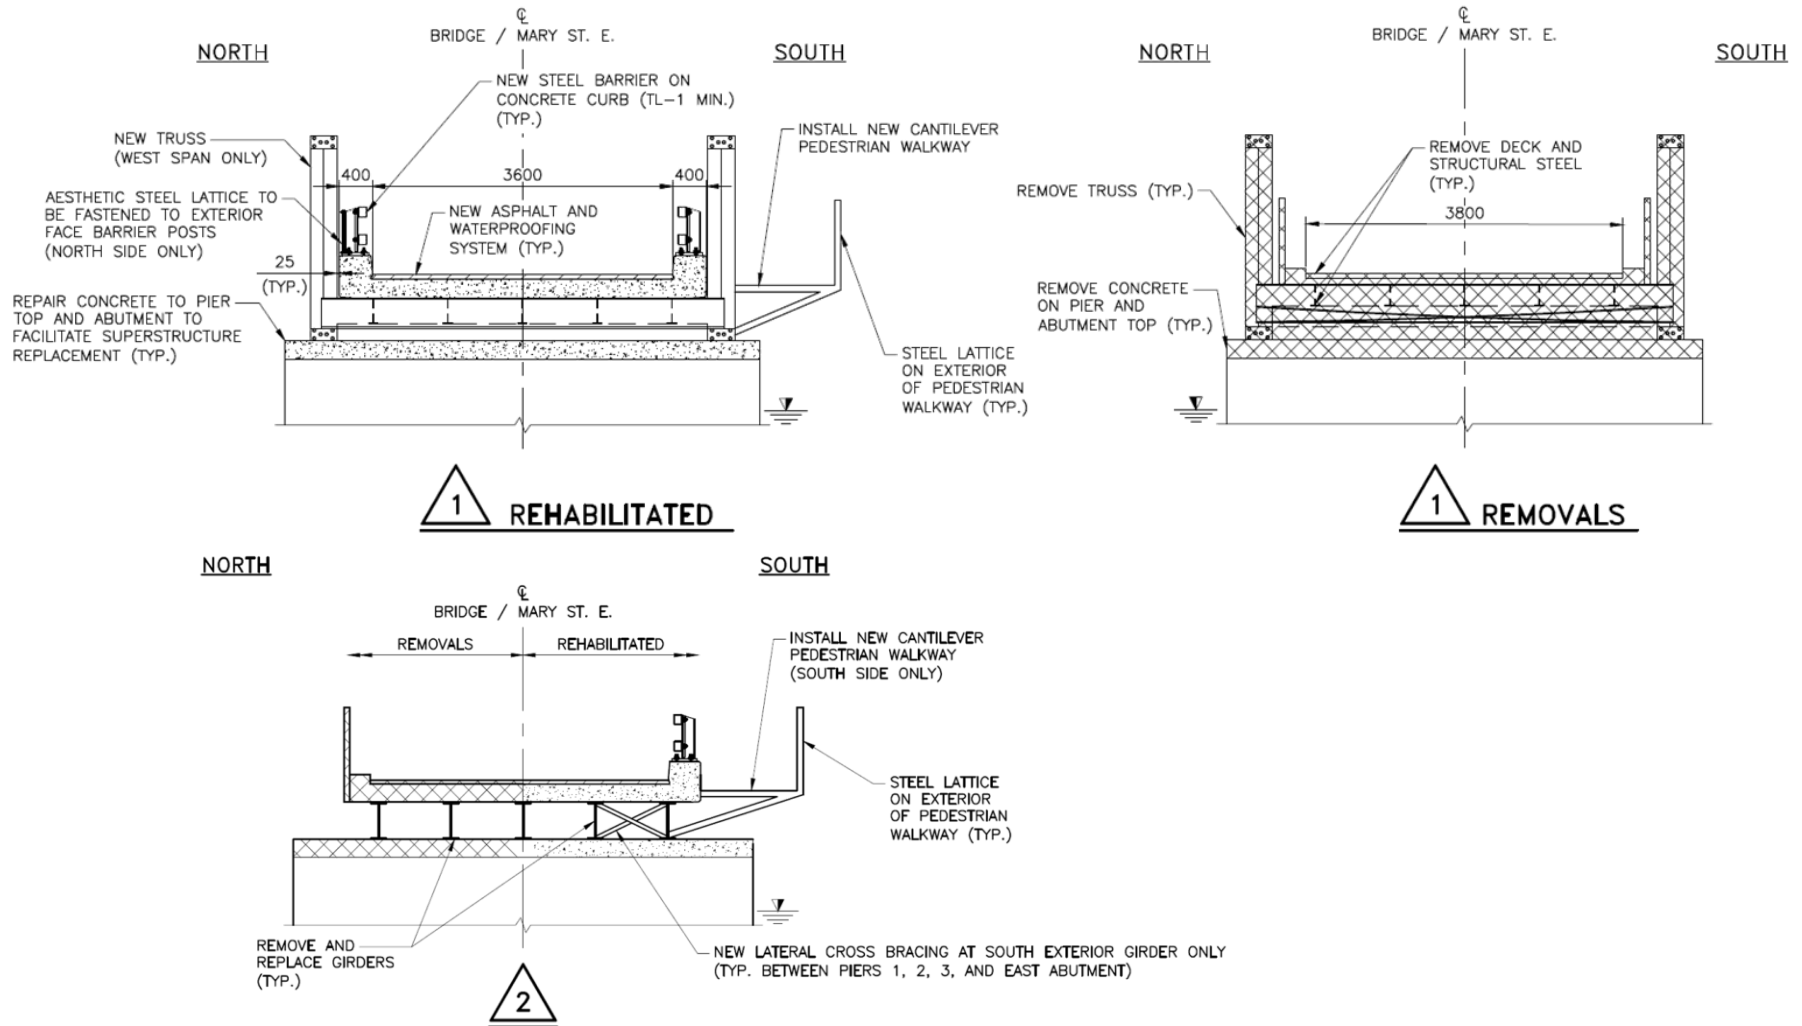
# Conceptual Plan of Preferred Solution (Alternative #1)

- Heritage aspects of existing structure include the truss over the west span.
- Due to the advanced deterioration of the truss, refurbishment is not considered to be a viable option.
- Replacement of the truss with sympathetic design is recommended.
- Recommended rehabilitation method includes complete superstructure replacement with concrete repair to abutments and piers.
- In-water work required for repair of abutments and piers. Continued consultation with MNRF and KRCA to finalize environmental impact mitigation strategies.
- Replacement superstructure includes the installation of code compliant barrier system (minimum TL-1).
- Implementation cost estimated at \$1.49 Million (excluding HST).
