## Edgewood Wall Restoration Project

### Nature of the Proposed Work:

## Architecture of the Edgewood Wall/Fence to be restored as originally built

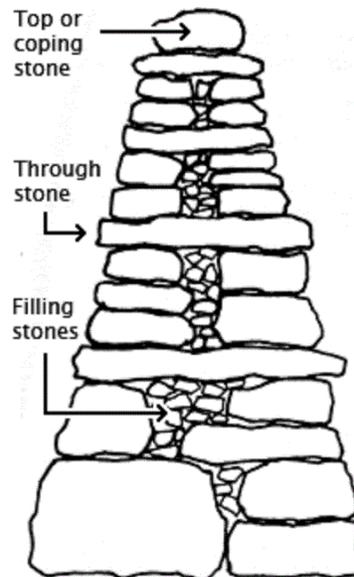
The W.T.C. Boyd Edgewood/Case Manor wall is an example of the double wall fence. The double wall is two rows of stone built along the area to be walled with tie in stones used to bind the two walls together and serving to increase the integrity of the wall. The Edgewood fence is representative of the typical style – foundation stones set in ground and then rows of large flat stones decreasing in size as the courses of stones are added. The interior of the two fences is also typically of its day and filled with smaller stones referred to as “hearting” or “filling”. Dry stack was used so that mortar, both difficult to obtain in large quantities and to transport to these sites, was not required. Lack of mortar also serves to eliminate the problems caused during freeze thaws cycles of our winters. Repairs on these historic fences, if done, are typically done with mortar thus compromising the historic integrity of the wall. The Edgewood Wall will be restored without mortar and in the true dry stack style as noted here to maintain its true heritage.

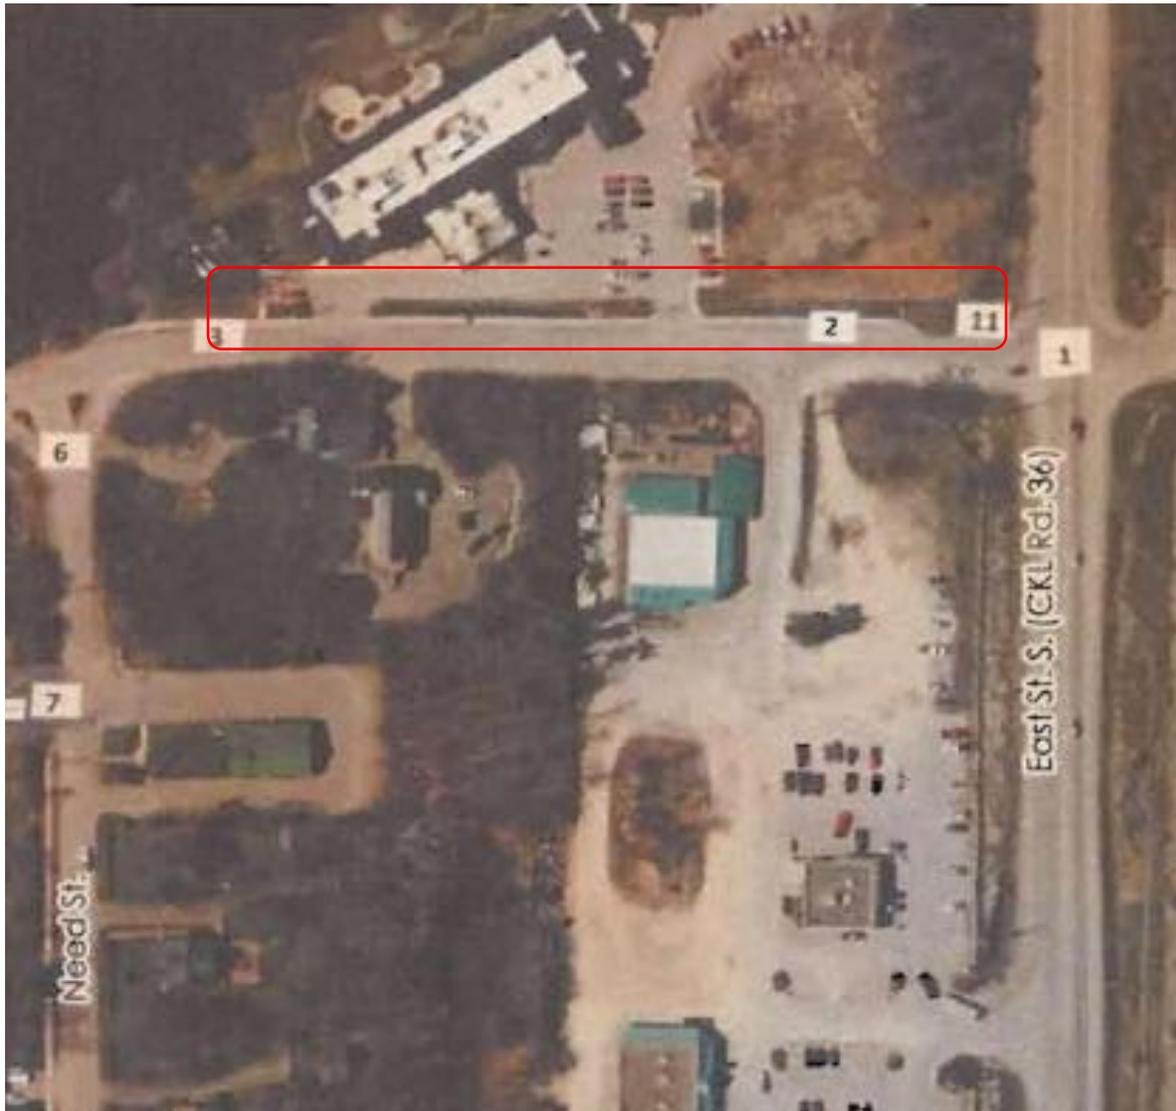
Figure 1 – Aerial View of the Stacked Wall

The above picture is cut from another source so the numbered references are not relevant. The Wall is on Canal Street in the Section [highlighted in Red.](#)

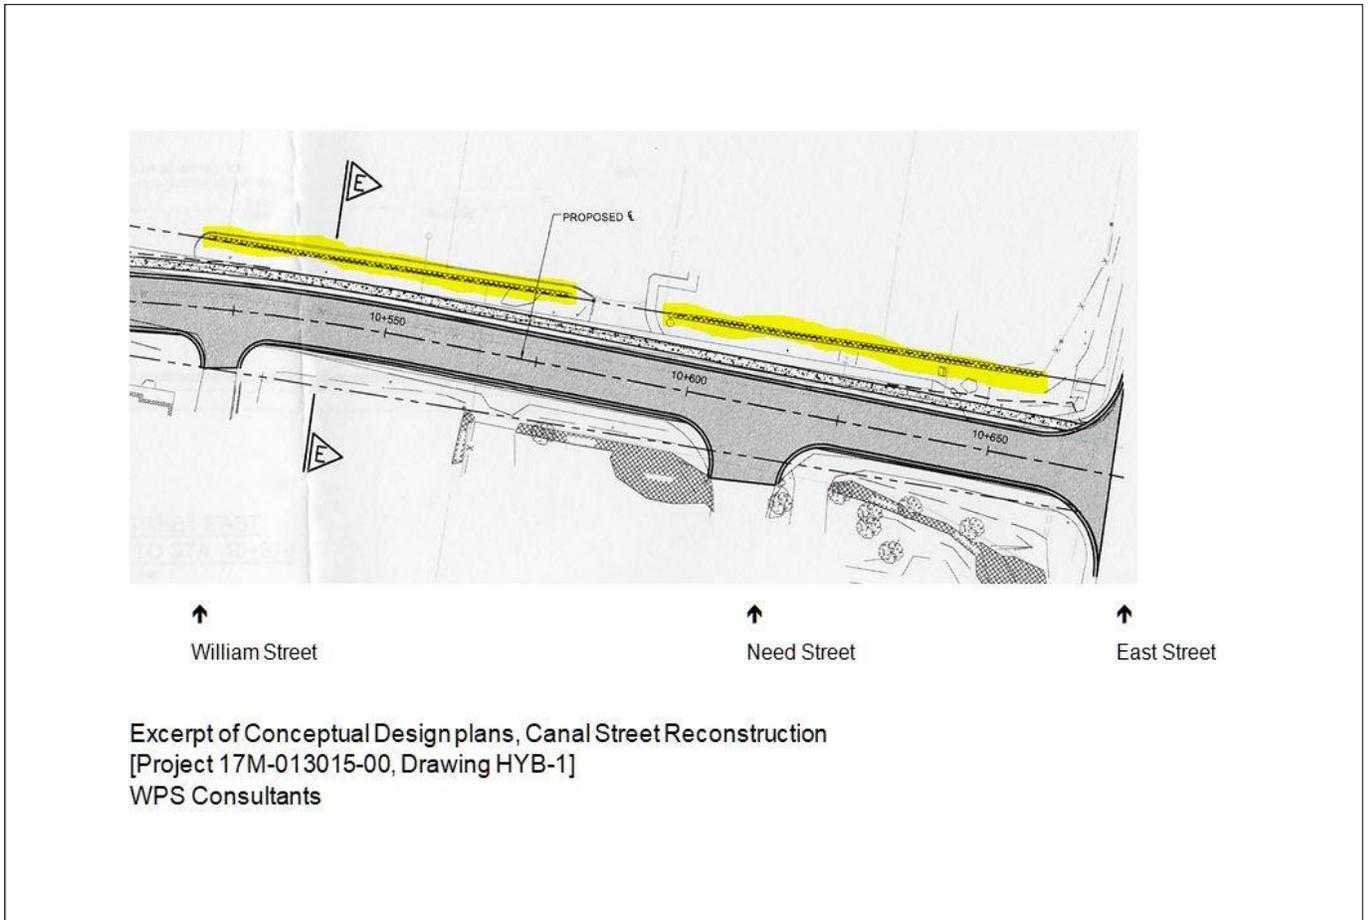
Figure 2 - Location of Stacked Wall

The above diagram shows the placement of the wall on the property as well as provides a reference location for the pictures taken. Each Numbered Box corresponds to the picture listed in the Pictures Section following this.

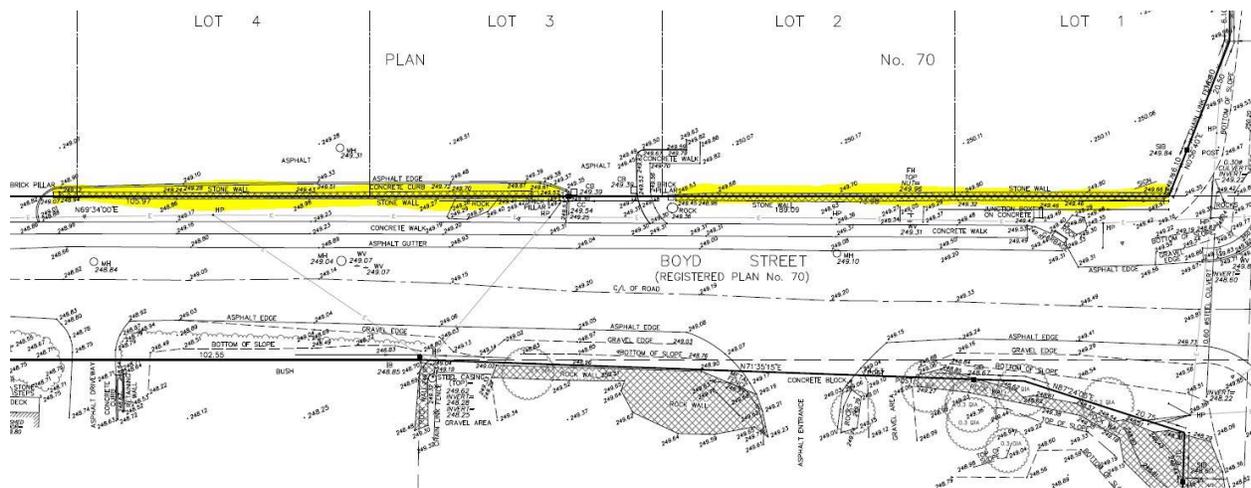
Figure 3 - Location of Stacked Wall – Coe, Fisher, Cameron - Topographic survey dated 4/1/17

Additional official survey documents are available from the City of Kawartha Lakes or the Surveyors Coe Fisher Cameron. The following is a scan of that survey. We have also included a subset of this file with the Wall highlighted in **Yellow**.

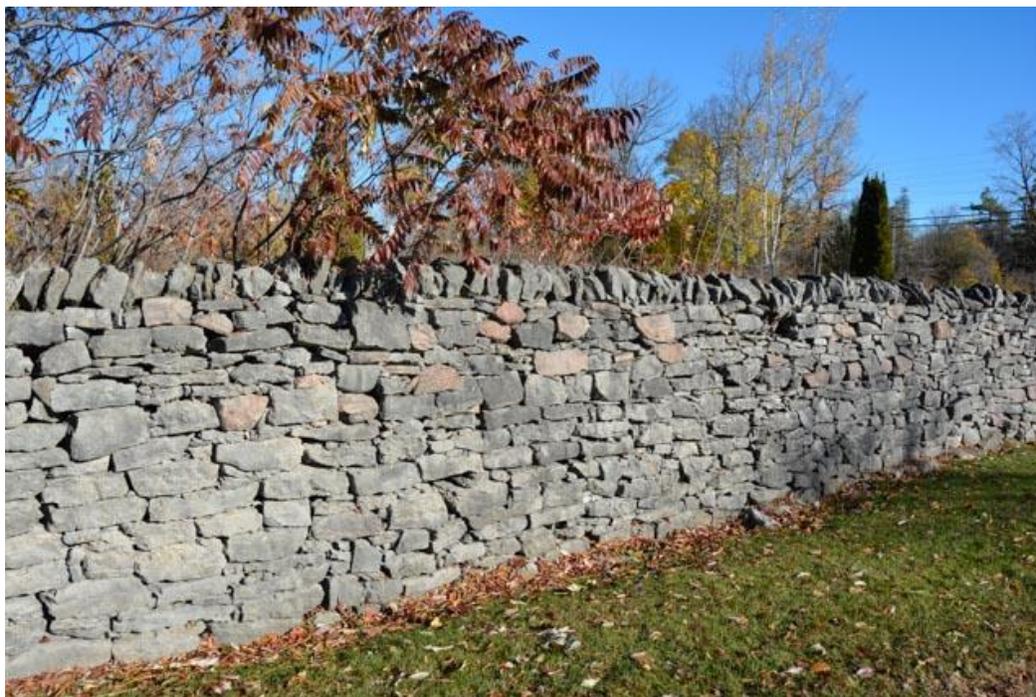
Figure 4 East Section Wall - Reasonable condition

This depicts a section of the wall in reasonable condition

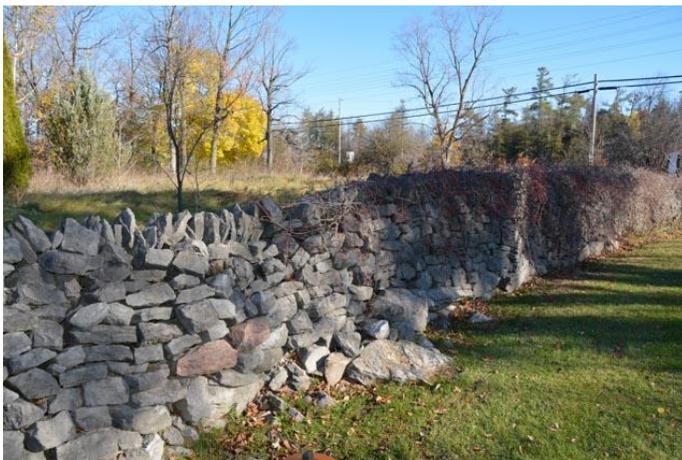
Figure 7 Wall collapsed

In order to restore the wall in keeping with the original construction, the project will involve deconstruction and reorganizing of the stone and carefully rebuilding to a height of approx. 1.37 meters (similar to existing wall height). The wall will be rebuilt in the same manner as the original construction - without mortar in a double wall construction technique using interior heart/filling stone, through stones to secure the stability of the walls and top coping stones. The wall will be rebuilt in the same location as it currently sits. See attached for location drawings, photos of the walls current state and the reconstruction/restoration method to be used.

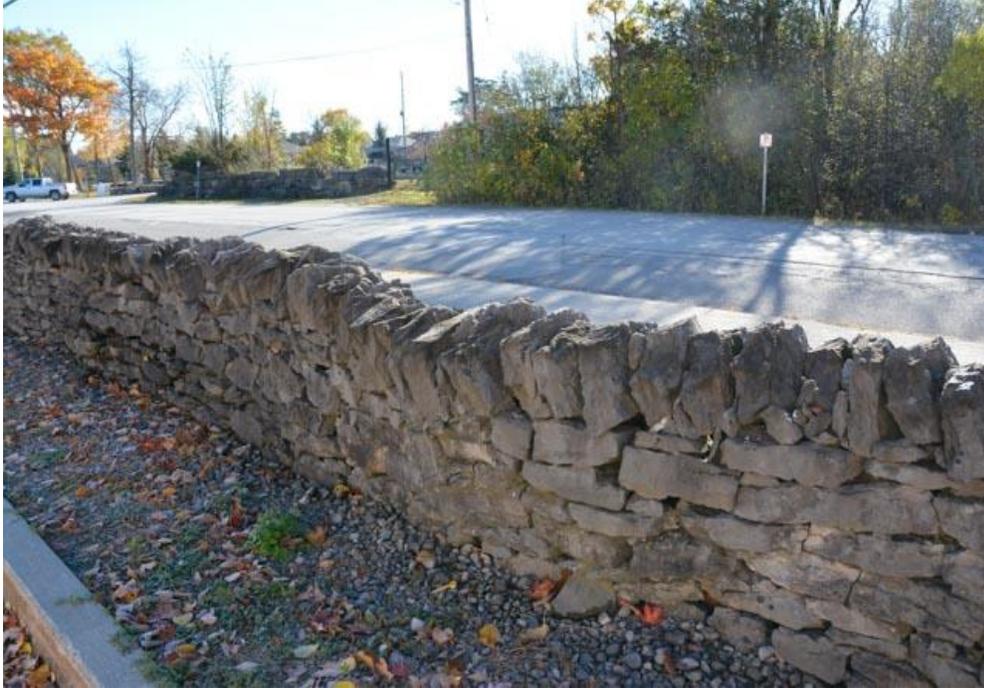
Figure 8 Wall at the West end of property “leaning”

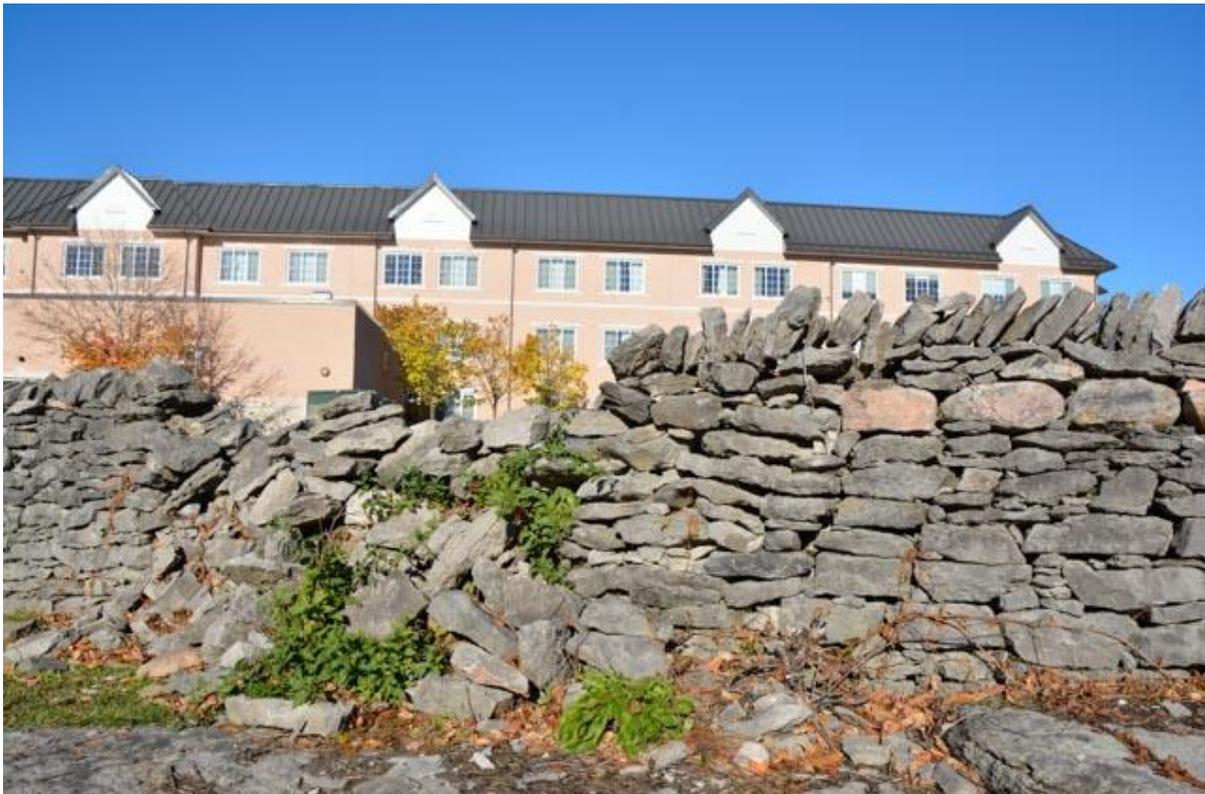
Figure 9 Wall at Mid-West end collapsed

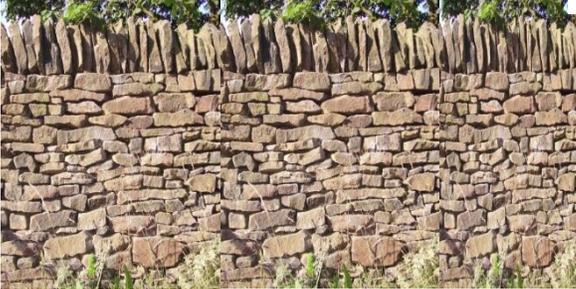
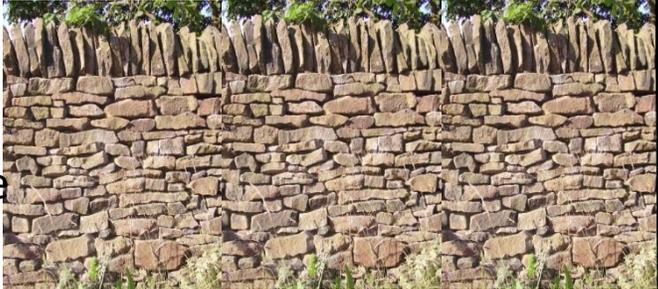
Wall Dimensions

Height 4 – 5 ft

Height 5 – 6 ft

- Each wall is double thick (two rows)
