Committee of the Whole Report

Report Number: ENG2021-012
Meeting Date: June 1, 2021
Title: Kenhill Beach Road and Long Beach Road Drainage Issues
Description: Road Drainage Issues
Author and Title: Michael Farquhar, Supervisor of Technical Services

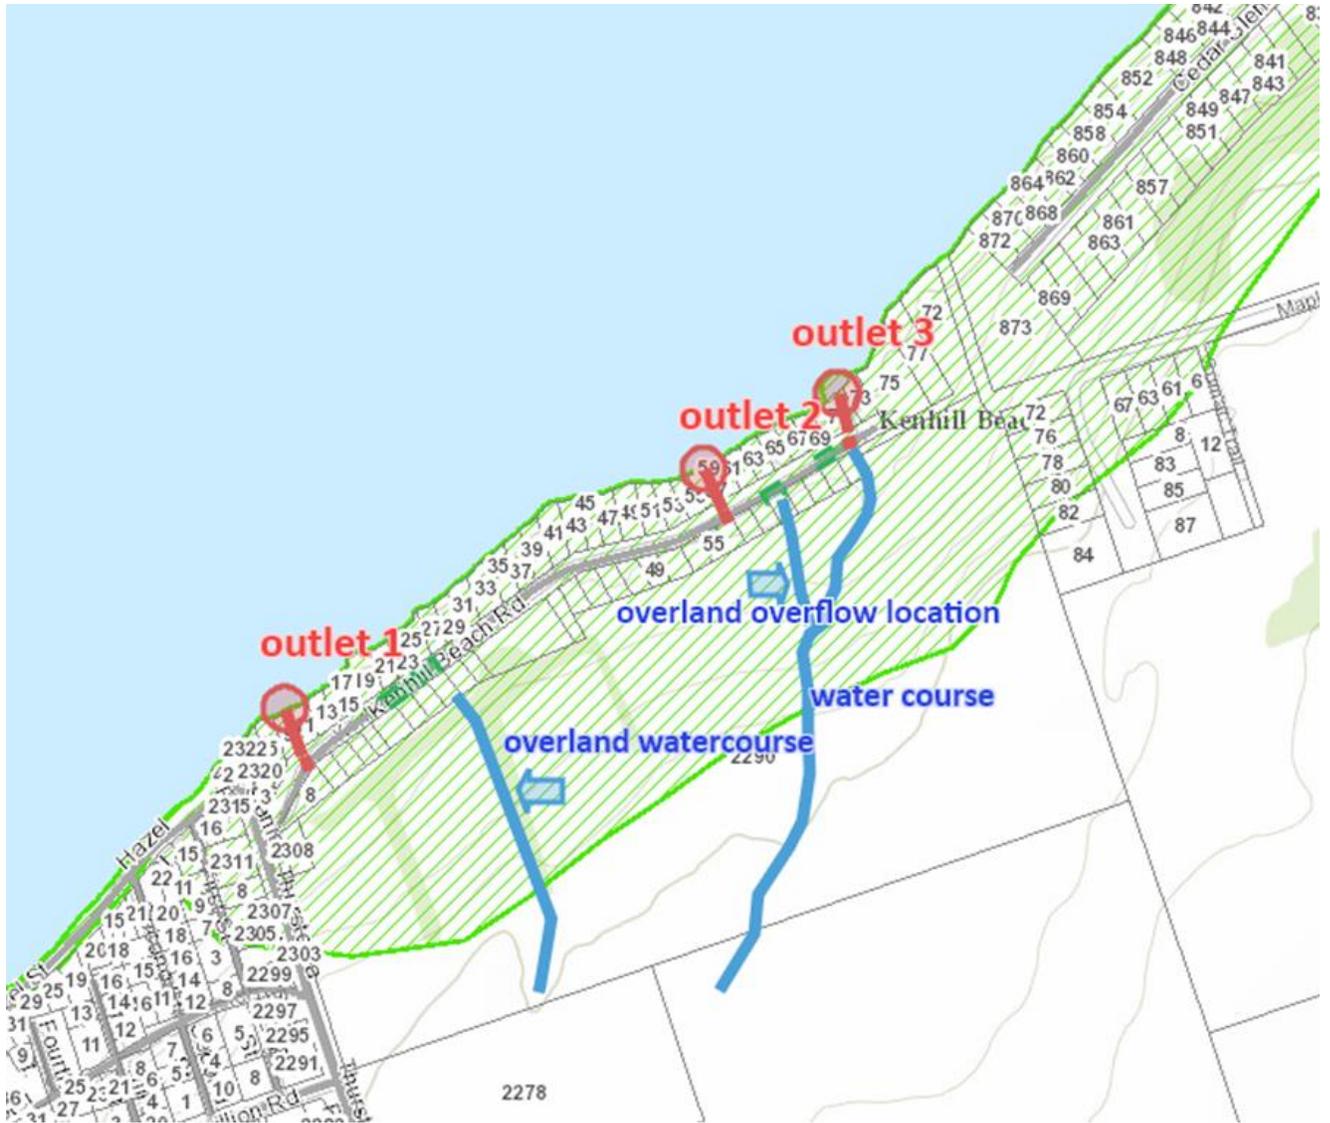
Image 1: (Map of areas of drainage concern – Kenhill Beach Road)

There are three locations (Please see Image 1 and Appendix A) that were observed on Kenhill Beach Road where water was overtopping Kenhill Beach Road, presumably due to the overland flow based on early spring thaw conditions. The location where water overtopped the road was witnessed in proximity to or between municipal address #19 – 27 Kenhill Beach Road, #57-59 Kenhill Beach Road and #69-74 Kenhill Beach Road. Close to each location there are cross culverts that lead to buried pipes that extend over private property to outlets at the lake (This can be seen in Appendix A). From staffs review at the time of thaw these pipes are seasonally inundated in the spring thaw scenario at the location of outlet 1 and 2 which seems not to be able to handle the hydraulic flow. This would seem to be in part due to the size of pipe and steep slope it travels to the lake. In Green on the maps in appendix A you will see the locations of where the flooding over topped the road. In blue are 3 separate locations of watercourses (creek), an overland overflow of the watercourse (creek) and an overland watercourse which is seasonal. At outlet location 3 there are twin 450 mm CSP pipes which take the flow of water from the watercourse (creek) across the road to a 600mm pipe which is a buried pipe to the outlet at the lake over private property. These twin pipes seasonally become blocked with ice which causes the flooding at this location. Due to the location and depth of these twin culverts it seems that it is difficult operationally to keep blockages at this location clear.

Based on the identified drainage issues a comprehensive drainage design looking at the hydrology of the drainage shed for the outlet areas of Kenhill Beach Road is required in order to properly propose capital improvements to alleviate the seasonal flooding in this area. The extent of the seasonal flooding of the road and surrounding areas would warrant this. A cost for this design is estimated at \$45,000. The design would recommend improvements for the area which could then be budgeted for in future capital budgets

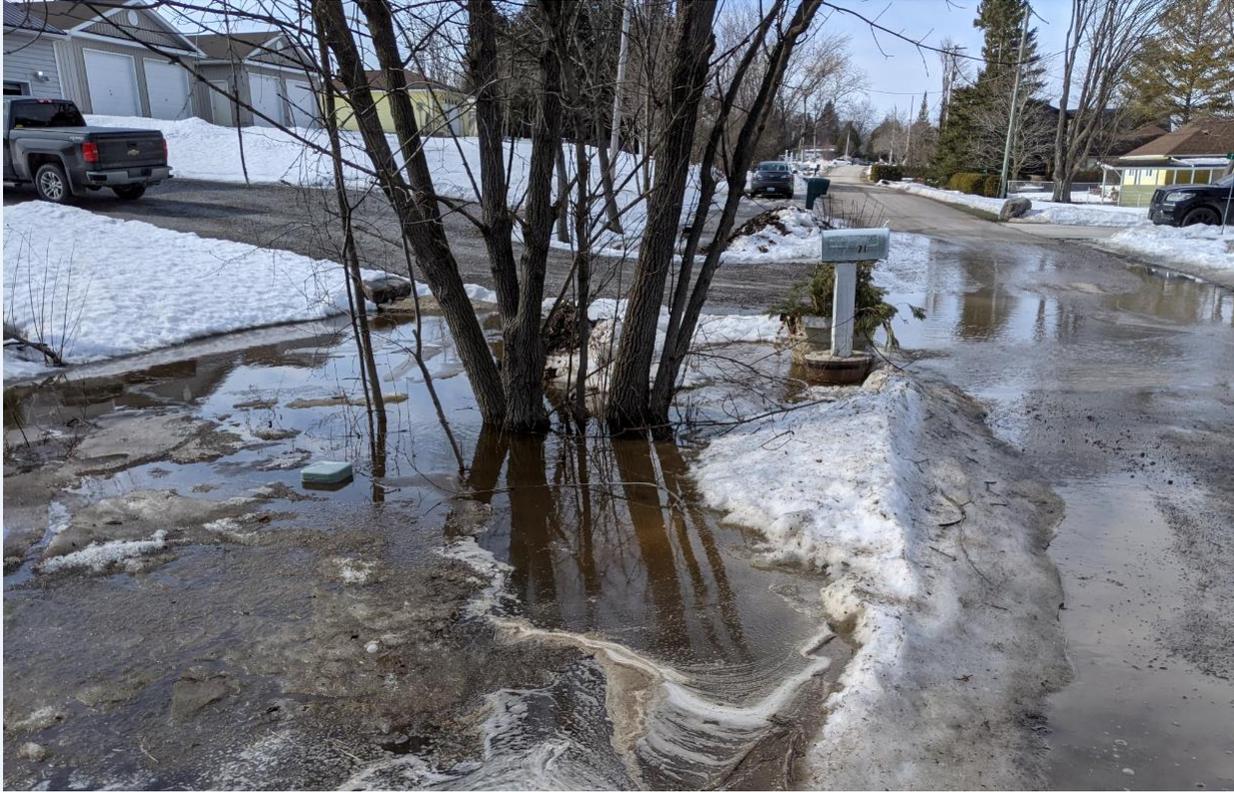
Image 2: (picture of flooding near #74 Kenhill Beach Road)

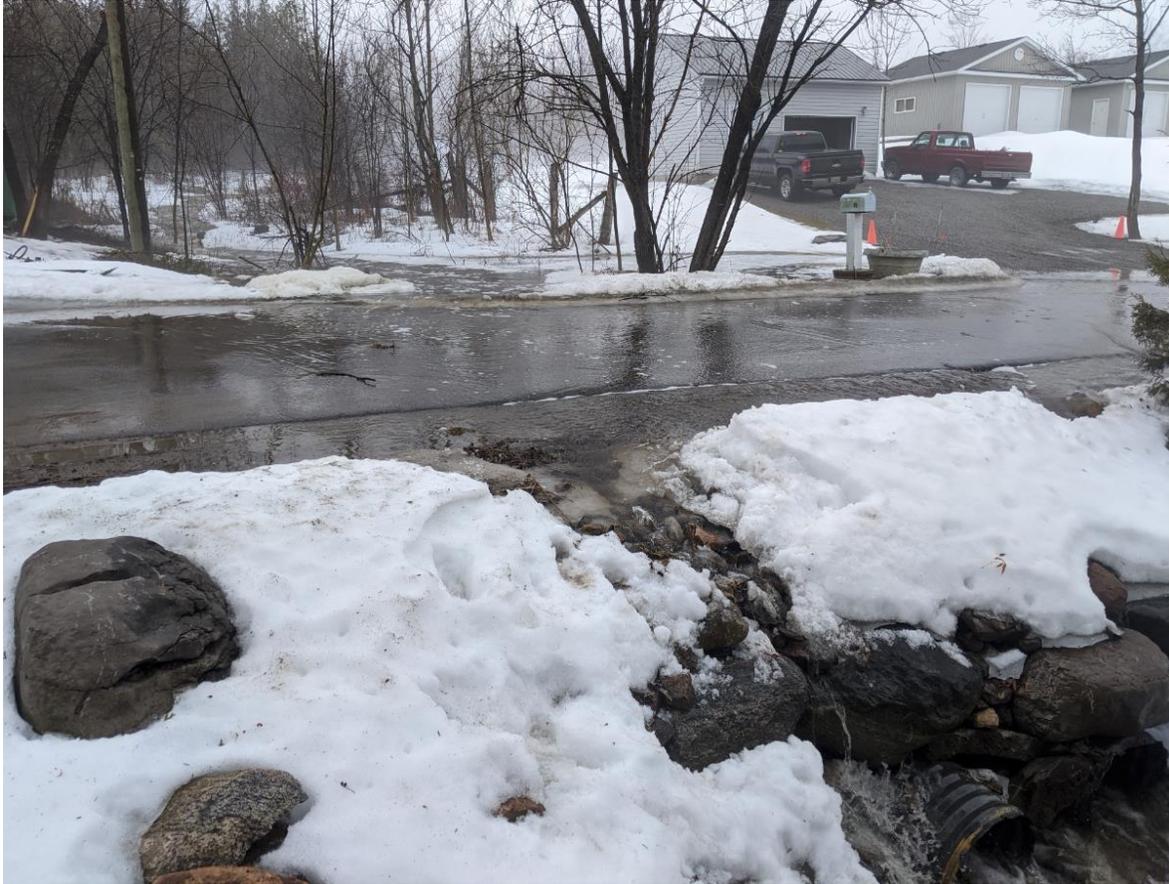
Image 3: (picture of flooding near #74 Kenhill Beach Road)

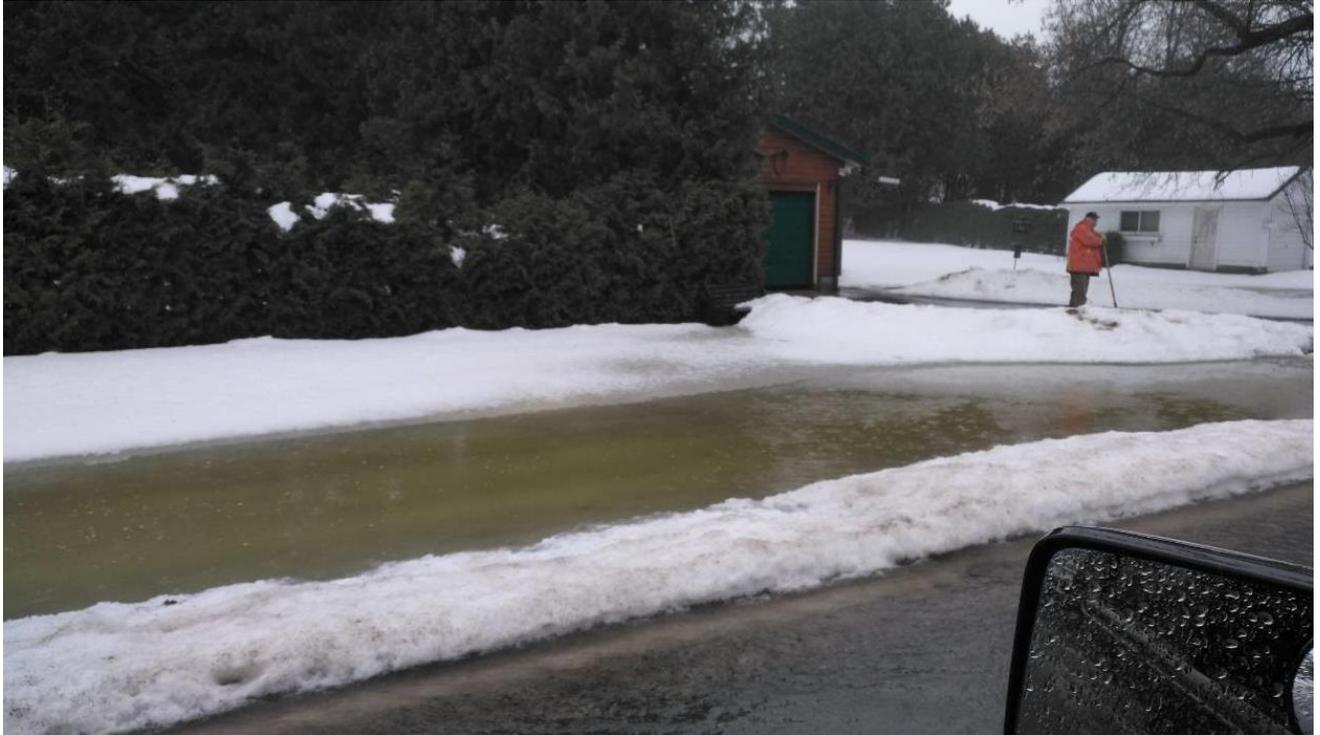
Image 4: (picture between #19-27 Kenhill Beach Road)

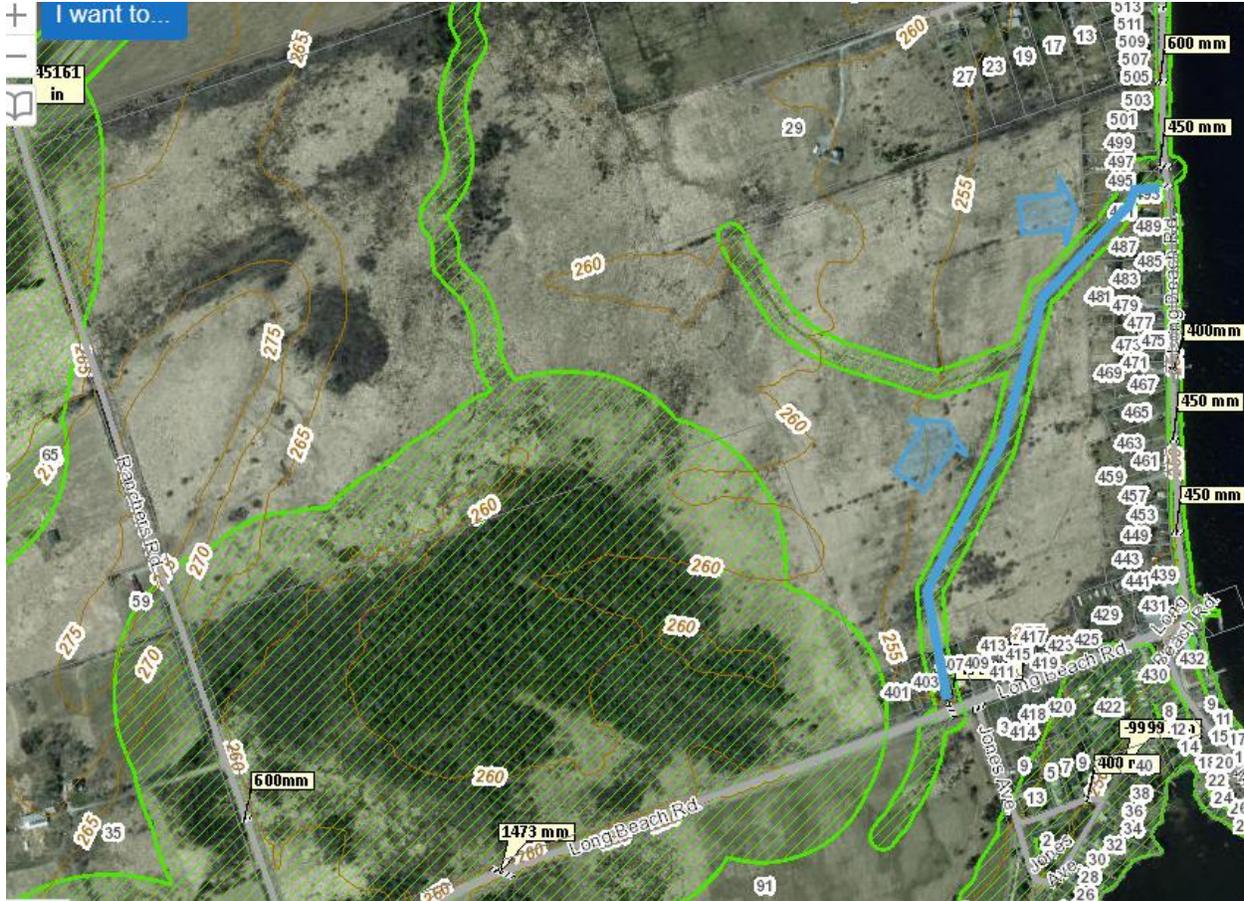
From site investigations on Long Beach Road there is an observed watercourse that begins at the south section of Long Beach Road and flows north over private property known as Concession 8 E PT Lot 10 former Fenelon Township as well as properties municipally addressed as 487 to 495 Long Beach Road. The south section of Long Beach Road where the water course begins is an Arterial road section constructed in the 1970's by the former County of Victoria. At the location of where the watercourse begins near #403 Long Beach Road, the roadside drainage for this section of Long Beach Road outlet to the watercourse through an approximately sized 750 mm CPS culvert that crosses Long Beach Road and outlets into the watercourse that then travels over the above described private land (see image 5 and Appendix B). The watercourse the over private properties is a straight and channelized watercourse which then turns and travels between addresses #493 and #495 Long Beach Road, where it outlets through an 800 mm CSP pipe under Long Beach Road into Sturgeon Lake. The watercourse in its total length is approximately 686 meters long.

Image 5: (map of Watercourse area on Long Beach Road)

Based on the identified drainage issues a comprehensive drainage design looking at the hydrology of the drainage shed for the identified outlet areas of Long Beach Road is required in order to properly propose capital improvements to alleviate the seasonal flooding in this area. The extent of the seasonal flooding of the road and surrounding areas would warrant this. At this point the recommendation would be for a scoped drainage shed review of the watercourse to determine improvement types if necessary within the City right of way to elevate drainage concerns. Once completed a decision can be made as to whether a petition by the road authority is required for a municipal drain to deal with any potential required improvements to the watercourse channel over private property that would help with the hydrology in the identified water shed for this watercourse. It is estimated that the cost for this exercise would be \$20,000.

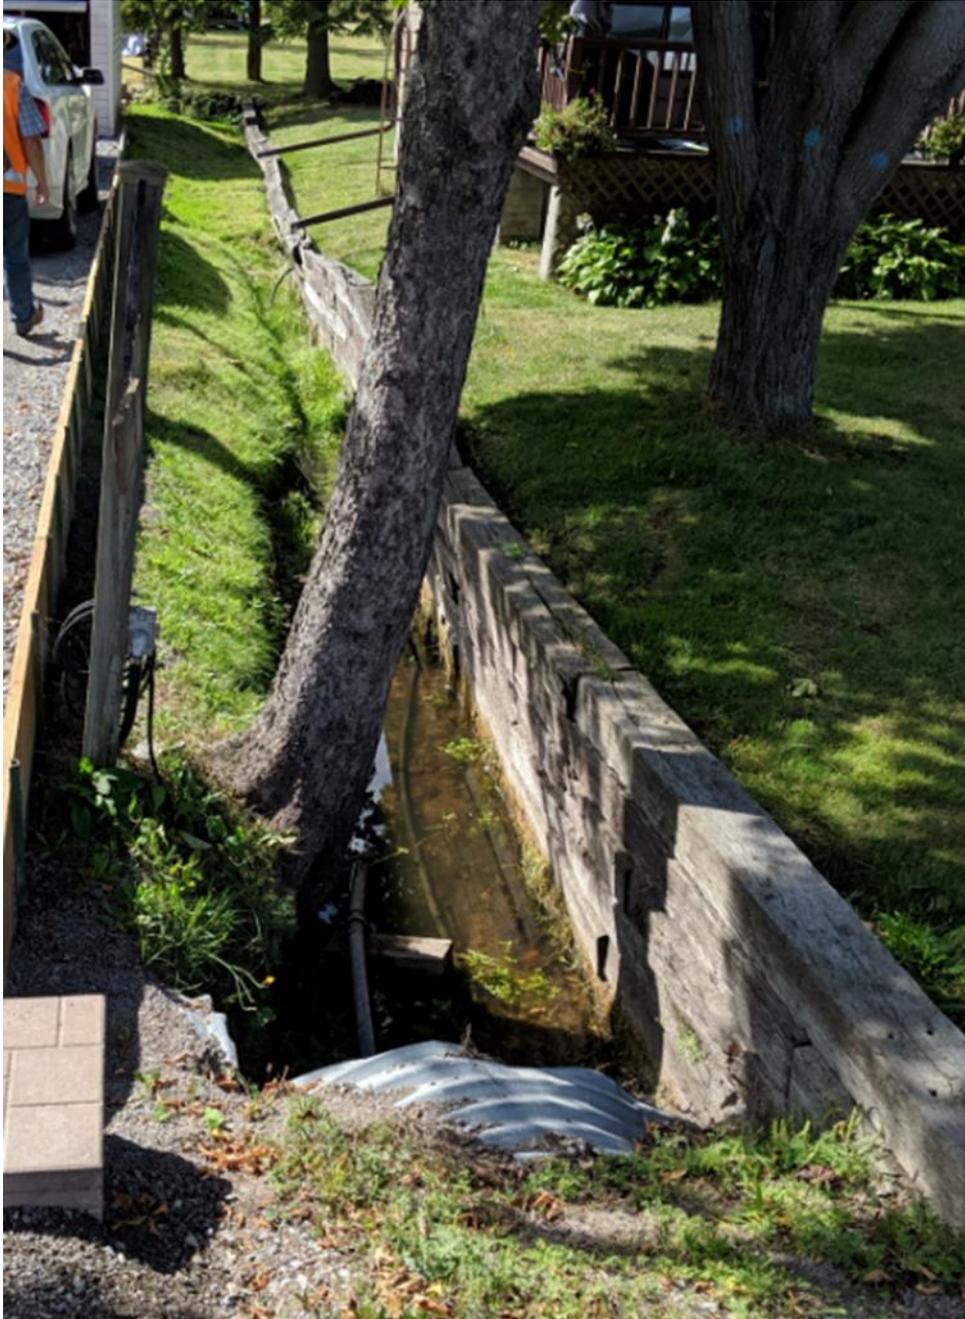
with water and travel overland. As well where as seen in image 6 seasonally the water course channel outlets to Long Beach Road there is an 800 mm CSP culvert that can become blocked with snow and ice which causes the flooding at this location. Due to the location and depth of this culvert it seems that it is difficult operationally to keep blockages cleared.

Image 6: (Picture of watercourse at inlet to 800 mm CSP pipe crossing Long Beach Road)

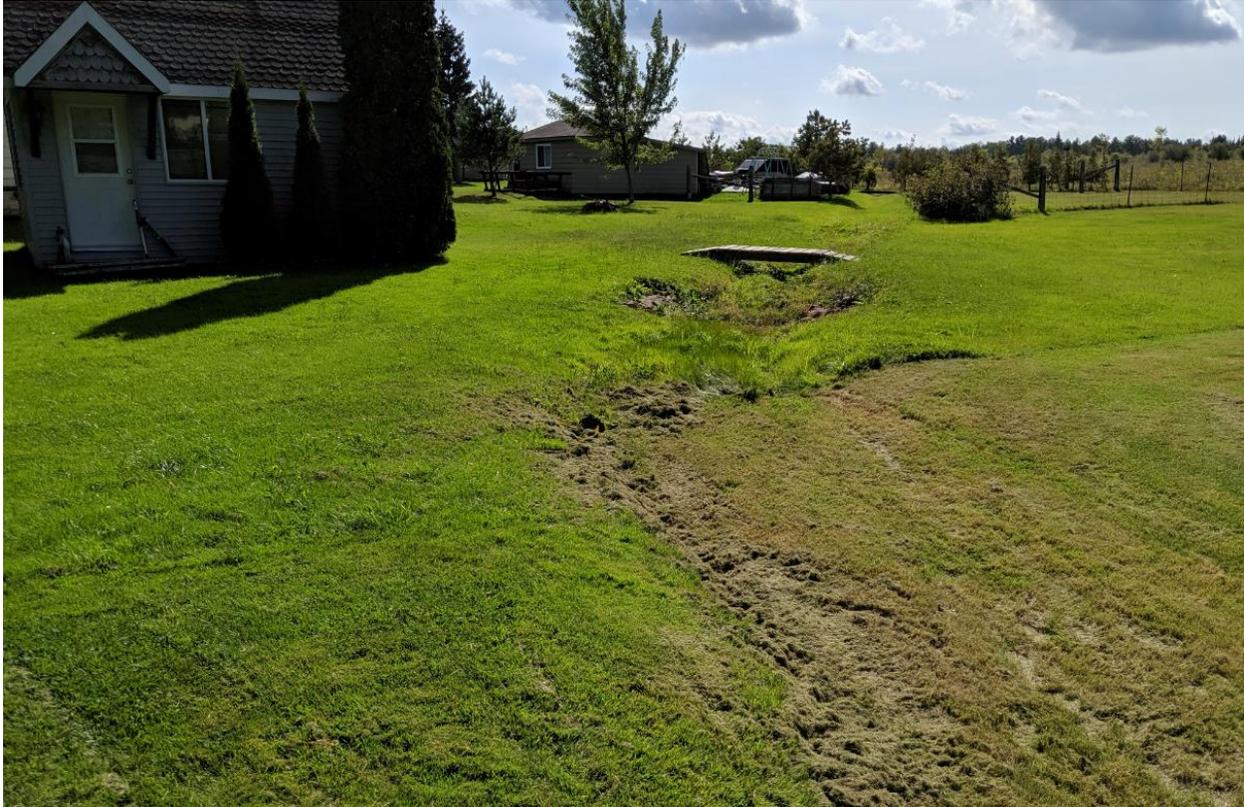
During spring time conditions locations along the watercourse over private property have been observed by residents to overtop the banks of the channelized watercourse

Image 7: (Picture of watercourse that spans over Concession 8 E PT Lot 10 Fenelon Twp and 487-495 Long Beach Road)
