2023 Lindsay Ops Landfill

Wetland Impact and Assessment Study Review

Prepared for: Lindsay Ops PRC
September 2024

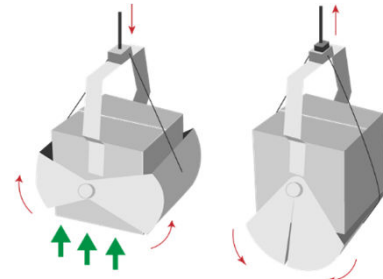
- Collected using **Ekman Dredge**

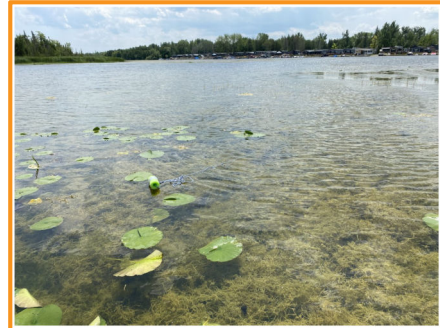
Photograph 13: Minnow Trap 1 deployed in Embayment B, typical dense aquatic vegetation.

- Sampling completed July 11-12th
- Riparian zone close to monitoring locations have naturalized, when compared to 2013 & 2018
- Embayment B and A1: mats of dense vegetation, aquatic vegetation was healthy
- Embayment A: filamentous algae mainly covered the bottom with little floating vegetation
- Algae indicates that the flow is low & the system is shallow.

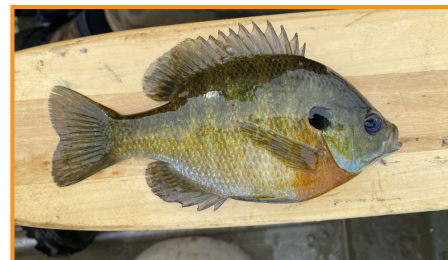
Photograph 4: Embayment B fish capture: Bluegill captured in hoop net.

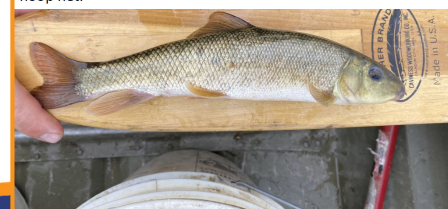
Photograph 6: Embayment B fish capture: White Sucker captured in hoop net.

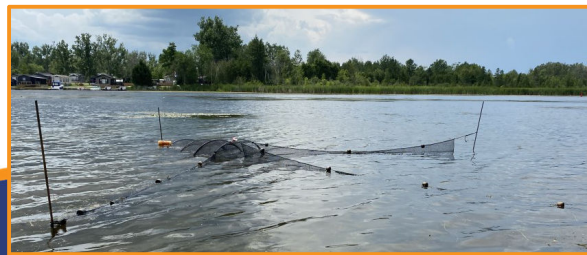
Hoop Net deployed
in Embayment B
