WINDOW UPGRADES - 21 FRANCIS STREET, LINDSAY

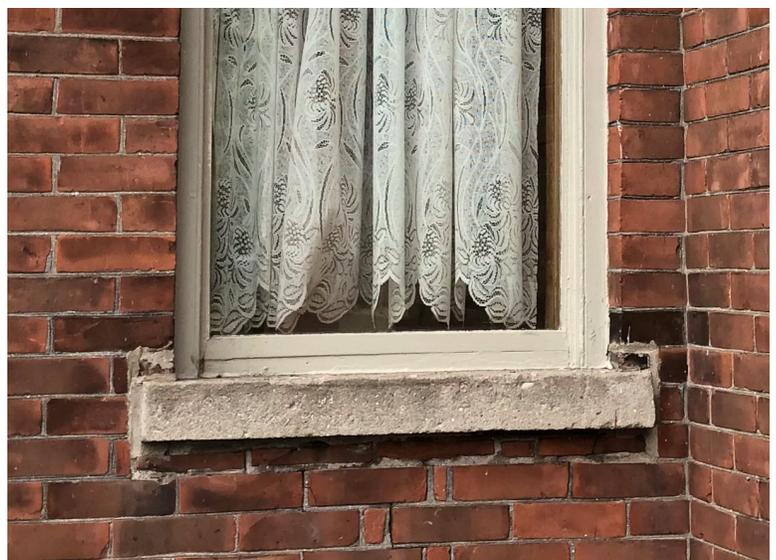
There are seven double-paned windows on the main floor that require replacement glass due to compromised seals; two of them also have cracked glass, and all of them have fog and/or mold between the panes.

Each window is a single double-pane window that does not open (glass is held in place via a wood surround).

We would like to replace these windows with thermal (Energy Star certified) awning windows that would look virtually the same from the outside but could open (slightly at bottom) to accommodate airflow.
