**FACILITY CONDITION ASSESSMENT
HARTLEY ROAD OPERATIONS DEPOT
574 HARTLEY ROAD, WOODVILLE, ONTARIO
Job No: 20130.101037.000**

Prepared for:
THE CITY OF KAWARTHA LAKES

Prepared by:
ALTUS GROUP LIMITED

Issued: **January 22, 2016**

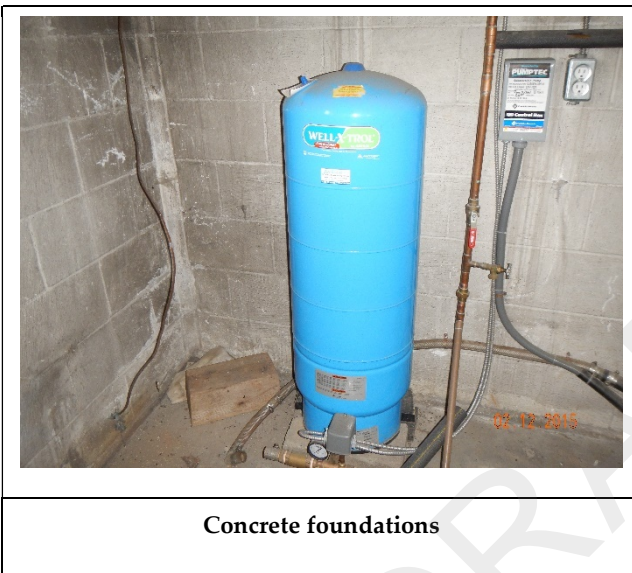
The foundation walls consist of poured concrete and are visible at a few locations at grade level at the building perimeter. The footings are not visible as they are concealed below grade level.

No significant signs of deterioration were present. No issues were reported. Based on a normal life span for this component replacement is not anticipated during the study period. Minor repairs in the interim are considered under operations and maintenance.

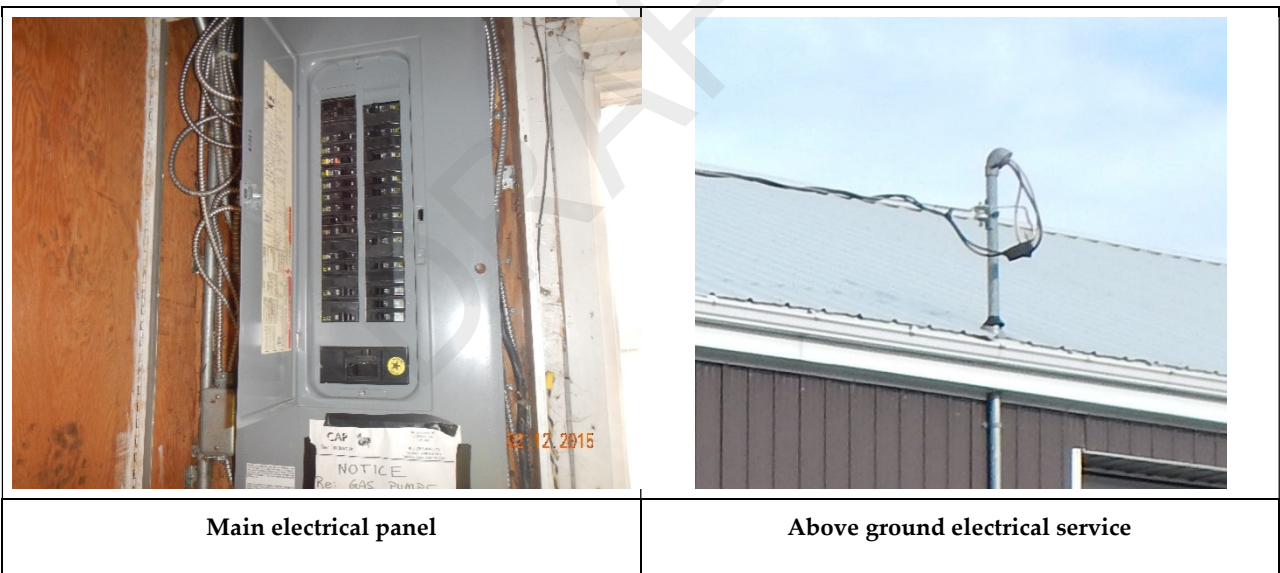
The incoming above ground electrical service enters the building at westside where the main service panel is located. The panel is rated for 200A, 120/240V, single-phase, three-wire. From the main panel the electricity is fed throughout the building to various outlets and light fixtures. The electrical equipment generally appears in good condition and there are no reported issues. No allowance is carried.

We recommend infrared thermography scanning of all electrical equipment (i.e. main, distribution etc.) to find "hot spots." This is considered under normal operations and maintenance as below the threshold limit. Repair allowances may require increases based on findings.

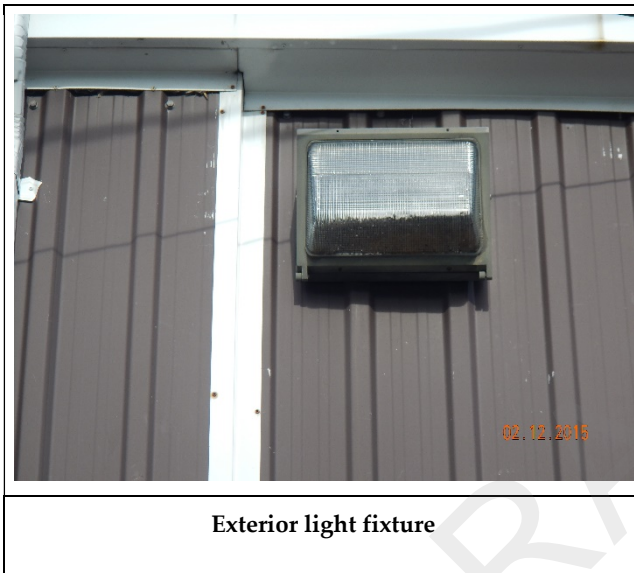
The common area lights are ceiling mounted 48 inch florescent light bulb fixtures. The exterior lighting is high pressure sodium light fixture controlled by a photo cell.

No significant signs of deterioration were present during our site visit. Future replacements of the lighting can be completed as-needed under operations and maintenance at a cost below the threshold of this report.

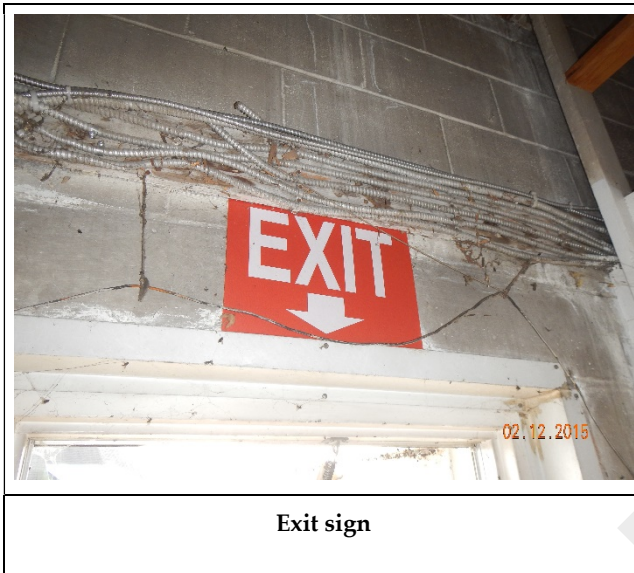
Emergency Exit Signs & Lighting

The building features and exit sign. No issues where reported.

The installation and repair of emergency lighting and exit signs can be managed and upgraded as part of operations and maintenance at a cost below the threshold of this report.

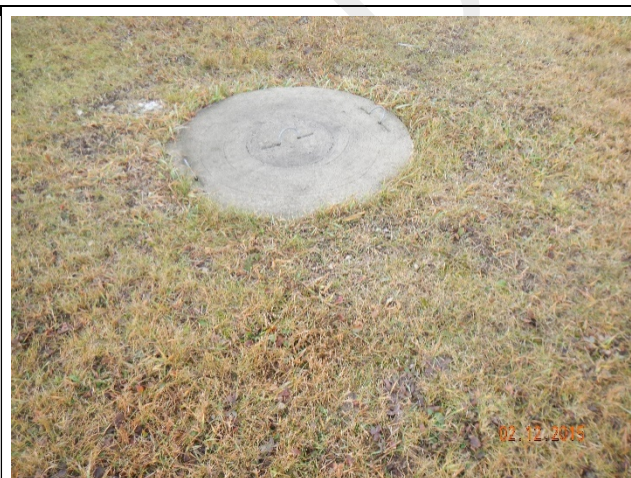
Well cover

The facility is supplied domestic cold water service from a well located on the north side of the building. The condition of the buried and concealed piping cannot be evaluated visually. No anomalous conditions were observed or reported that would suggest this system is not functioning as intended.

Based on a normal life span for this component, repairs and/or replacements are anticipated during the study period. Appropriate costs are carried.
