# **The Corporation of the City of Kawartha Lakes**

**Report Number ENG2019-006**

**Title:** Request for Speed Reduction – CKL Road 36

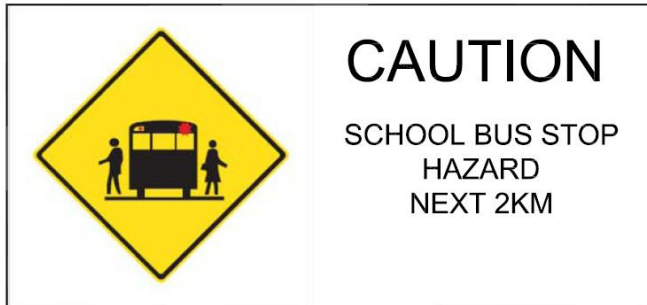
Install a large information board with both text and the visual school bus stop ahead warning. This is in keeping with the spirit of the OTM, while adding a large amount of education and emphasis. To reduce confusion the text could read “CAUTION SCHOOL BUS STOP HAZARD NEXT 2KM”

As a result of the justification review carried out by staff, it is recommended that Option 2 be selected.
