Bethany Bahá'í Centre of Learning

The BBCL is requesting the approval of a sign encroachment agreement for an existing sign located within the road allowance at Ski Hill Road and Bethany Hills Road.

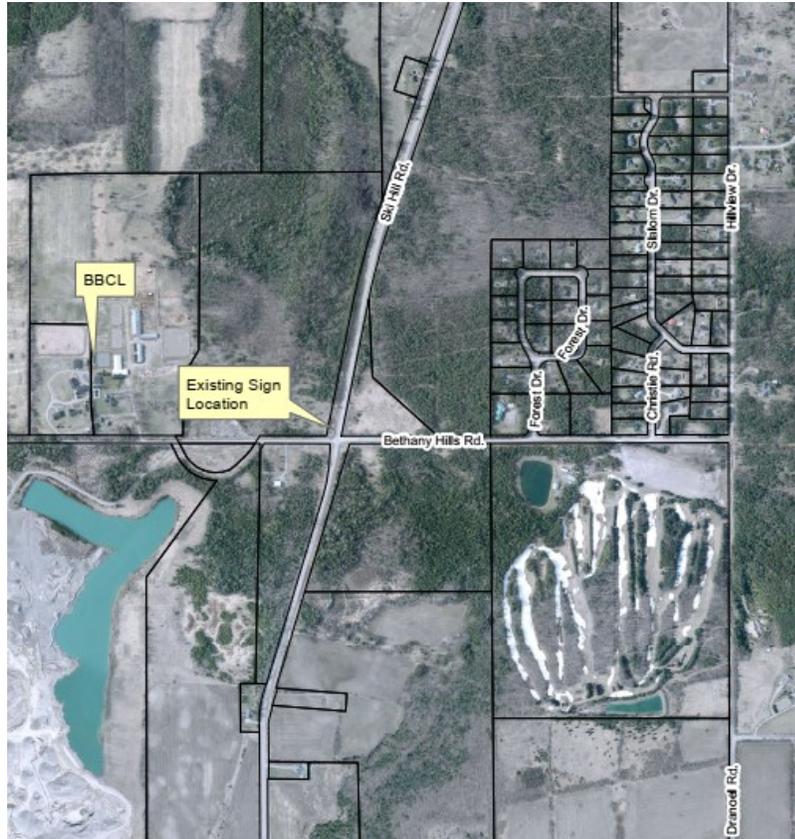
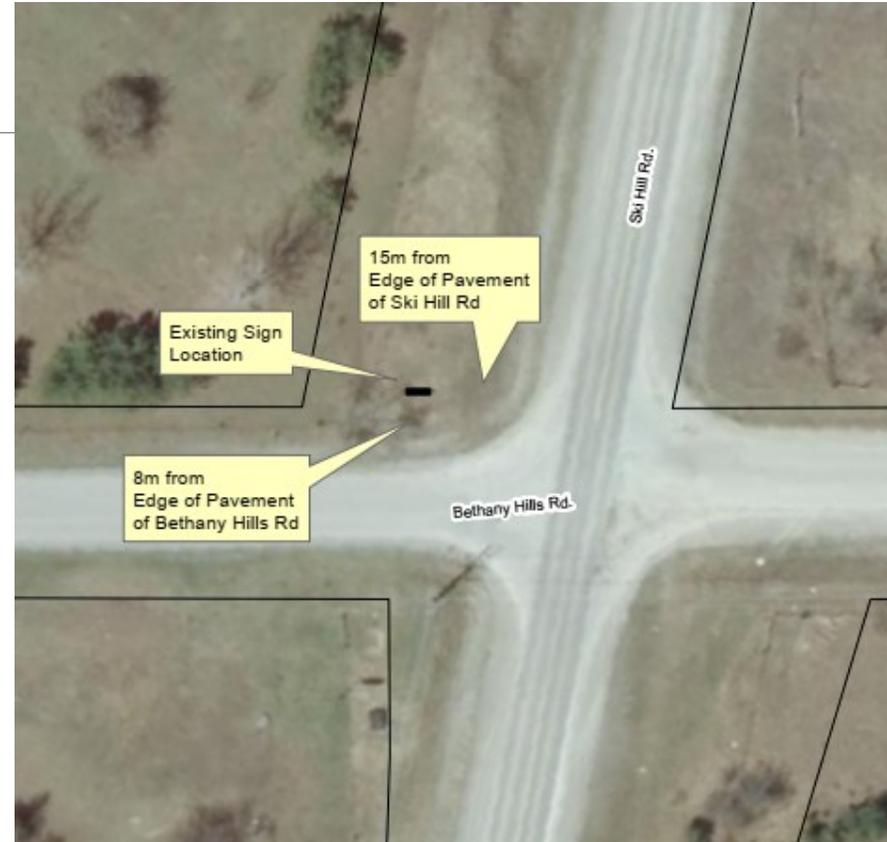
Sign Location

- Approximately 15 M from the edge of pavement on Ski Hill Road
- Approximately 8 M from the edge of pavement on Bethany Hills Road

- Under the Ontario Traffic Manual Book 1B – Sign Design Principles, the basic horizontal mounting offset for signs in rural areas without raised curbs is 2 to 4m from the outside edge of the outer traffic lane
- Sign is located approximately 15m and 8m from traffic lane
- Should a regulatory sign be installed in this area, the request would not present a visual conflict due to its distance from roadway and elevation on a berm
- No reasonable driver would expect road safety information to be located in such a location relative to their travel lane, including regulatory, warning, and green informational signs

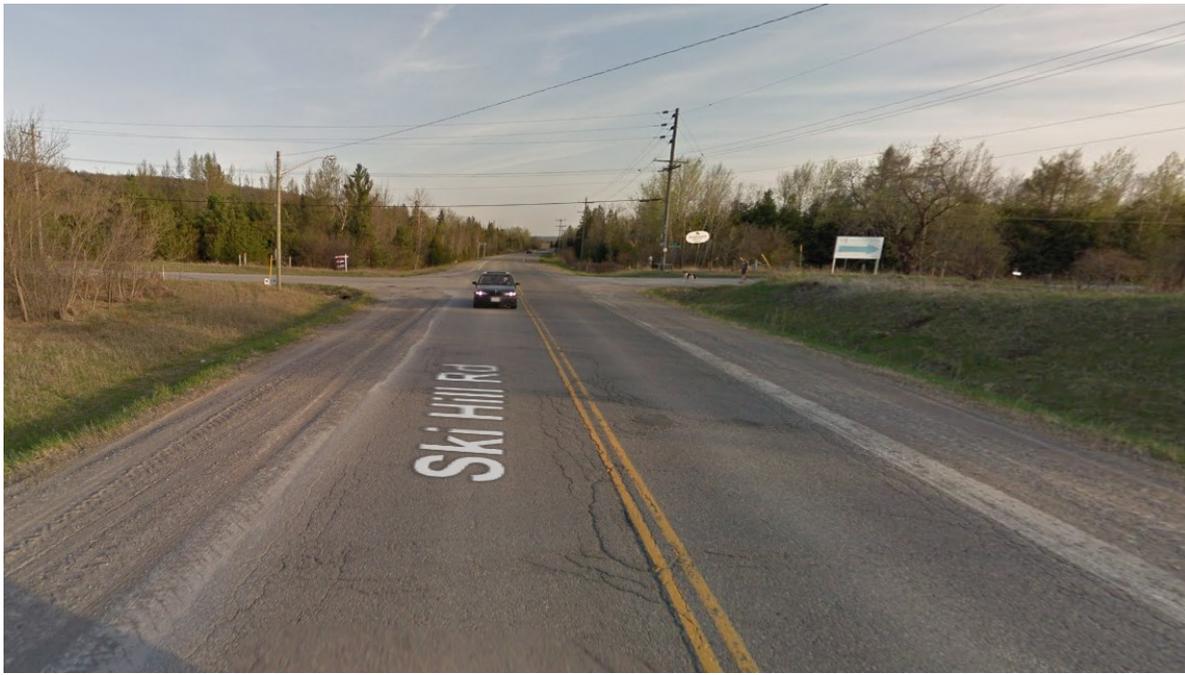
Street-view on Ski Hill Road approaching Bethany Hills Road facing south – Shows sign is in a location where no regulatory sign would reasonably be placed.

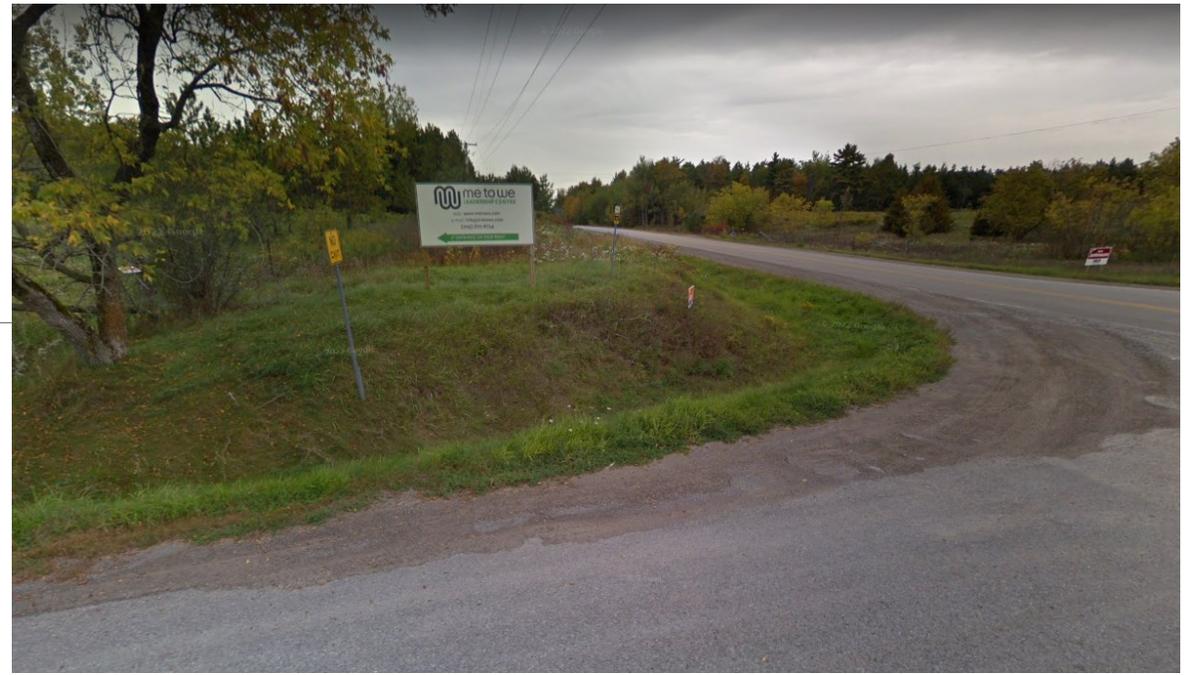
Street-view on Bethany Hills Road approaching Ski Hill Road facing north – Shows sign is in a location that does not contribute to sightline distance.
