Council Report

| Report Number: | ENG2024-012 |
| Title: | Southview Estate Drainage |
| Description: | Drainage Review |

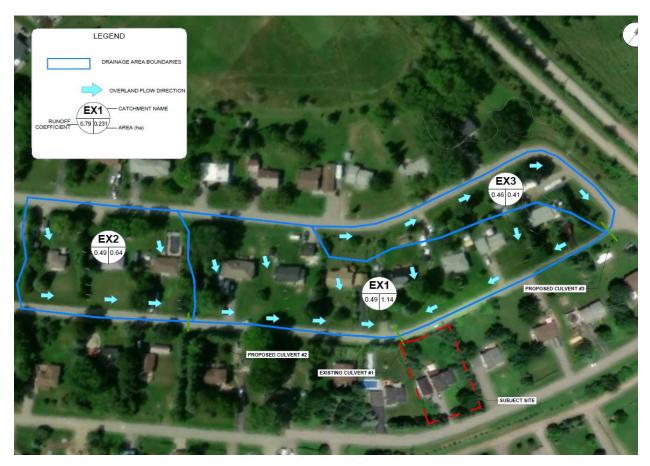
In Summary, approximately 2.19 ha of area currently flow to the existing culvert No. 1 located near 149 Fenelon Drive.

For this evaluation to determine a potential partial by-pass or diversion from existing culvert No 1, the existing drainage area was segmented into three areas in order to determine the flow rates that could be diverted.

The figure below shows the Drainage Area:

Proposed Culvert No 2 corresponds to installing a new culvert at the communal grass walkway and diverting a flow area of 0.64ha, (as per the homeowner of 149 Fenelon Drive request).

Proposed Culvert No 3 corresponds to installing a new culvert at the intersection of Cameron Drive and Fenelon Drive and diverting a flow area of 0.41ha.

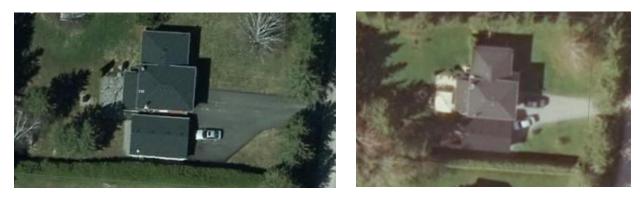
1. The driveway of 149 Fenelon Drive has been widened towards the Drainage Ditch.

Current Driveway

Driveway prior to widening

With the larger driveway the area for snow storage has been reduced. During the winter months, it appears the snow is being shovelled downstream of the drainage ditch / culvert, thus possibly impeding the drainage.

Placing the driveway snow on the boulevard or lawn area would aid in ensuring that there is positive drainage and limit the erosion concerns.

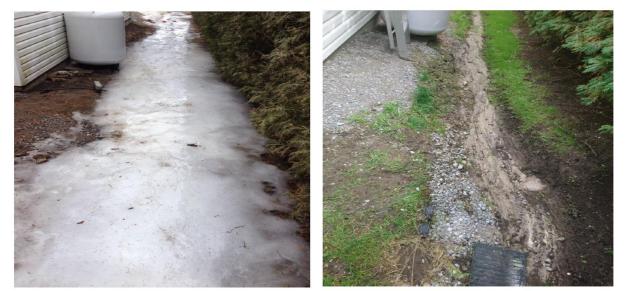
The thaw and freeze

Summer Erosion after a typical rain storm

The pictures above were provided to Council by the owner of 149 Fenelon Drive at the March 5th, 2024 Committee of the Whole meeting.

The Propane tank is located beside the invert of the drainage ditch, during freeze thaw cycles, the ice is constrained by this pinch point of the drainage corridor. By relocating or raising the propane tank, it would reduce the potential erosion concerns.

2. Raising or relocating the garage propane tank adjacent to the Ditch.

In addition, the invert of the ditch could be reinforced with rip rap.
