Council Report

Report Number: ENG2024-012
Meeting Date: May 21, 2024
Title: Southview Estate Drainage
Description: Drainage Review
Author and Title: Juan Rojas, Director Engineering and Corporate Assets

Engage Engineering Limited (Engage) has been retained to complete a review of the existing drainage patterns upstream of 149 Fenelon Drive in the City of Kawartha Lakes. The purpose of this review is to assess the upstream drainage area from 149 Fenelon Drive (the subject site) and explore possible interventions to limit flows passing through the swale on the south side of the property.

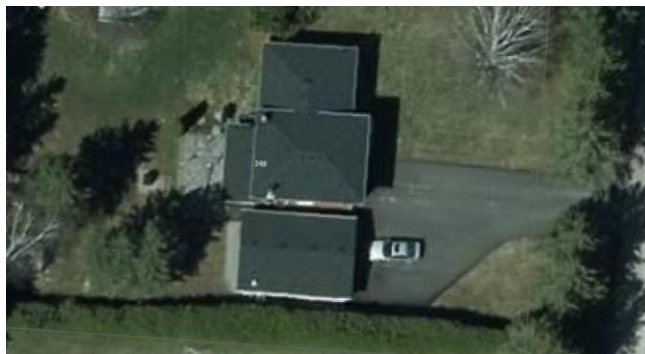
Current Driveway

1. The driveway of 149 Fenelon Drive has been widened towards the Drainage Ditch.

With the larger driveway the area for snow storage has been reduced. During the winter months, it appears the snow is being shovelled downstream of the drainage ditch / culvert, thus possibly impeding the drainage.

Placing the driveway snow on the boulevard or lawn area would aid in ensuring that there is positive drainage and limit the erosion concerns.

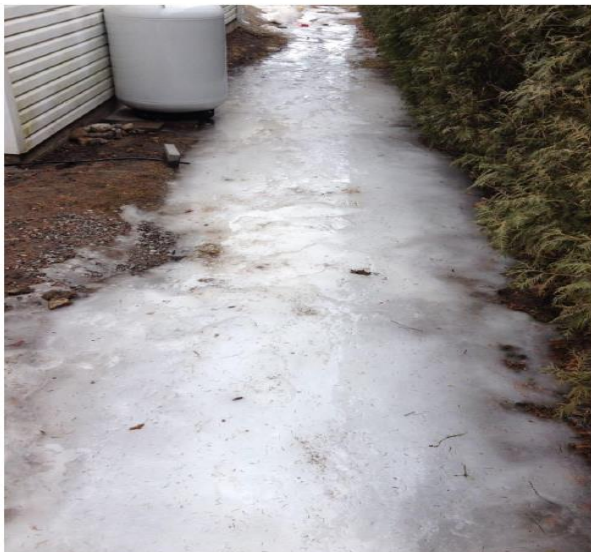
The thaw and freeze

The pictures above were provided to Council by the owner of 149 Fenelon Drive at the March 5th, 2024 Committee of the Whole meeting.

The Propane tank is located beside the invert of the drainage ditch, during freeze thaw cycles, the ice is constrained by this pinch point of the drainage corridor. By relocating or raising the propane tank, it would reduce the potential erosion concerns.

2. Raising or relocating the garage propane tank adjacent to the Ditch.

In addition, the invert of the ditch could be reinforced with rip rap.
