**Bobcaygeon Composite Elevated Tank
Remotely Operated Vehicle Inspection and Report
July 16, 2018**

Re: **LMS Job #LM18041**
Remote Inspection & Report - Bobcaygeon Composite Elevated Tank

COMPOSITE ELEVATED TANK INSPECTION REPORT

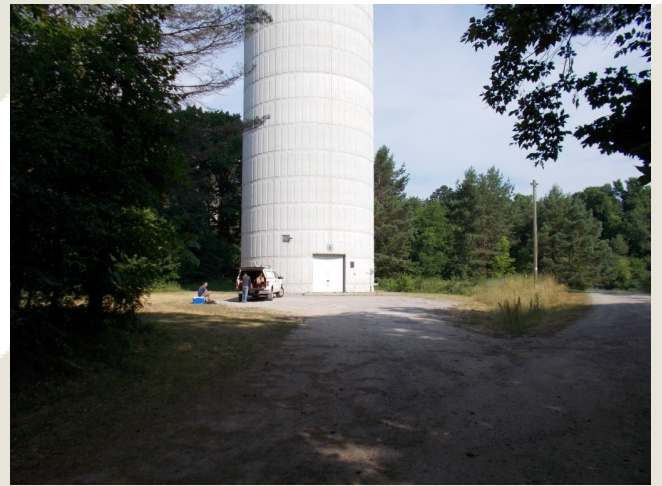
1

Security fence recommended
around tank perimeter

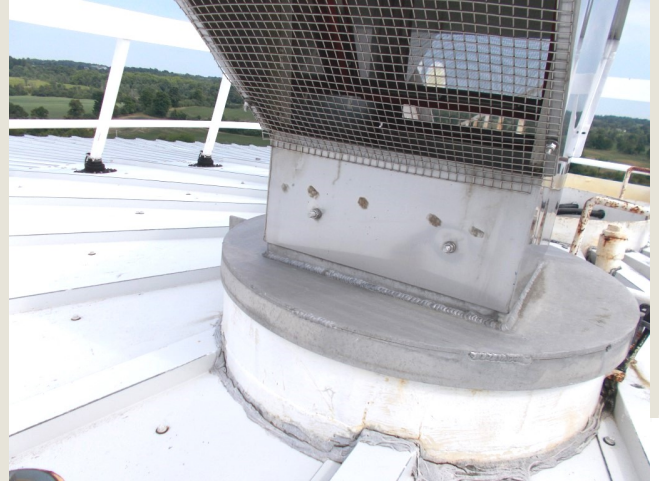
LOCATION	YES / NO	CONDITION	
* At roof access hatch	Yes	Cap installed	75
* At tank access hatch	Yes	Cap installed	75
* At Top Landing	No	--	53

Watertight cap installed during inspection

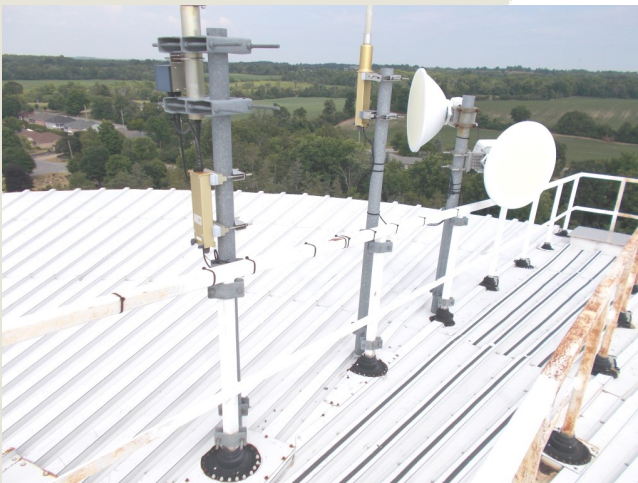
* Manufacturer	Corrosion Services Ltd.	7
ANTENNAE	* Anchorage / Mounting	Fair	78 - 79, 91
	* Cable Routing	Poor - Antenna cables mounted to ladder siderails in pedestal and access tube. Cable tray system required	70

Repaint roof handrail

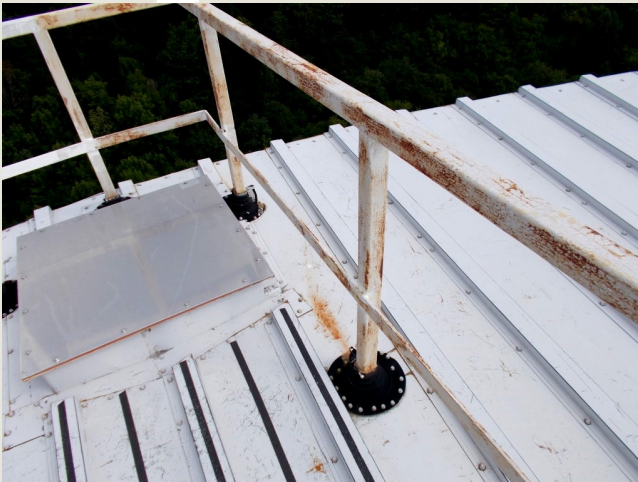
84

Surface prep and paint roof handrail

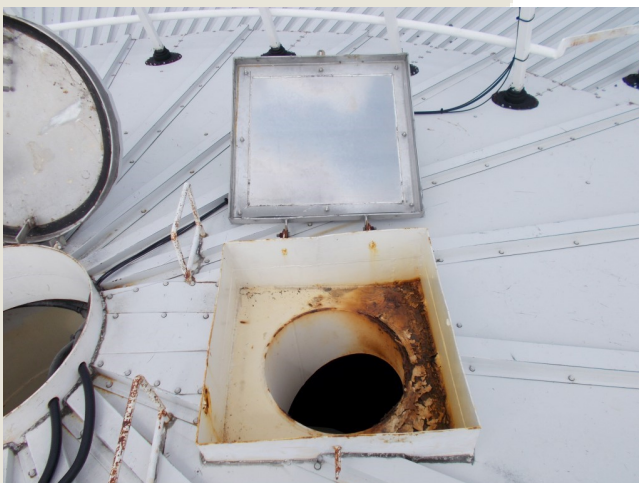
94

Padlock required on hatch to tank interior

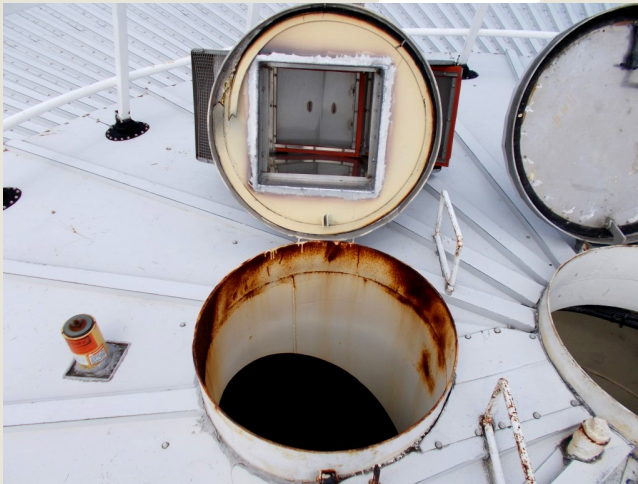
98

Padlock required on hatch to tank interior

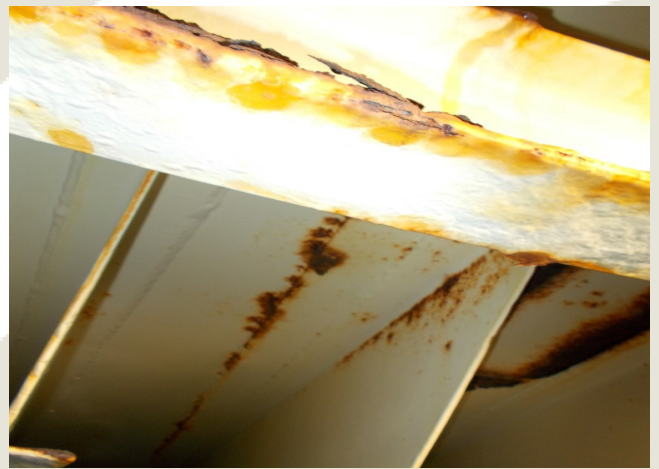
105

Remove and replace corroded paint rail

11) Remove and replace paint rail system **\$ 40,000**

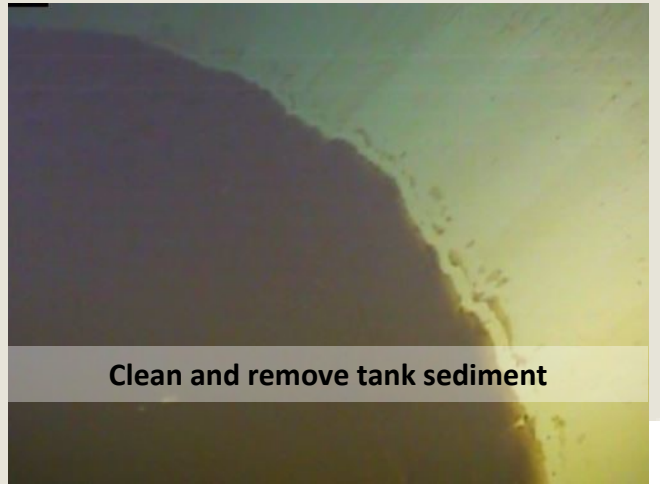
171

Clean and remove tank sediment
